# VW T6 - replacing the differential pressure sensor

| Vehicle model | Transporter T6 |
| Engine code | CXHA |

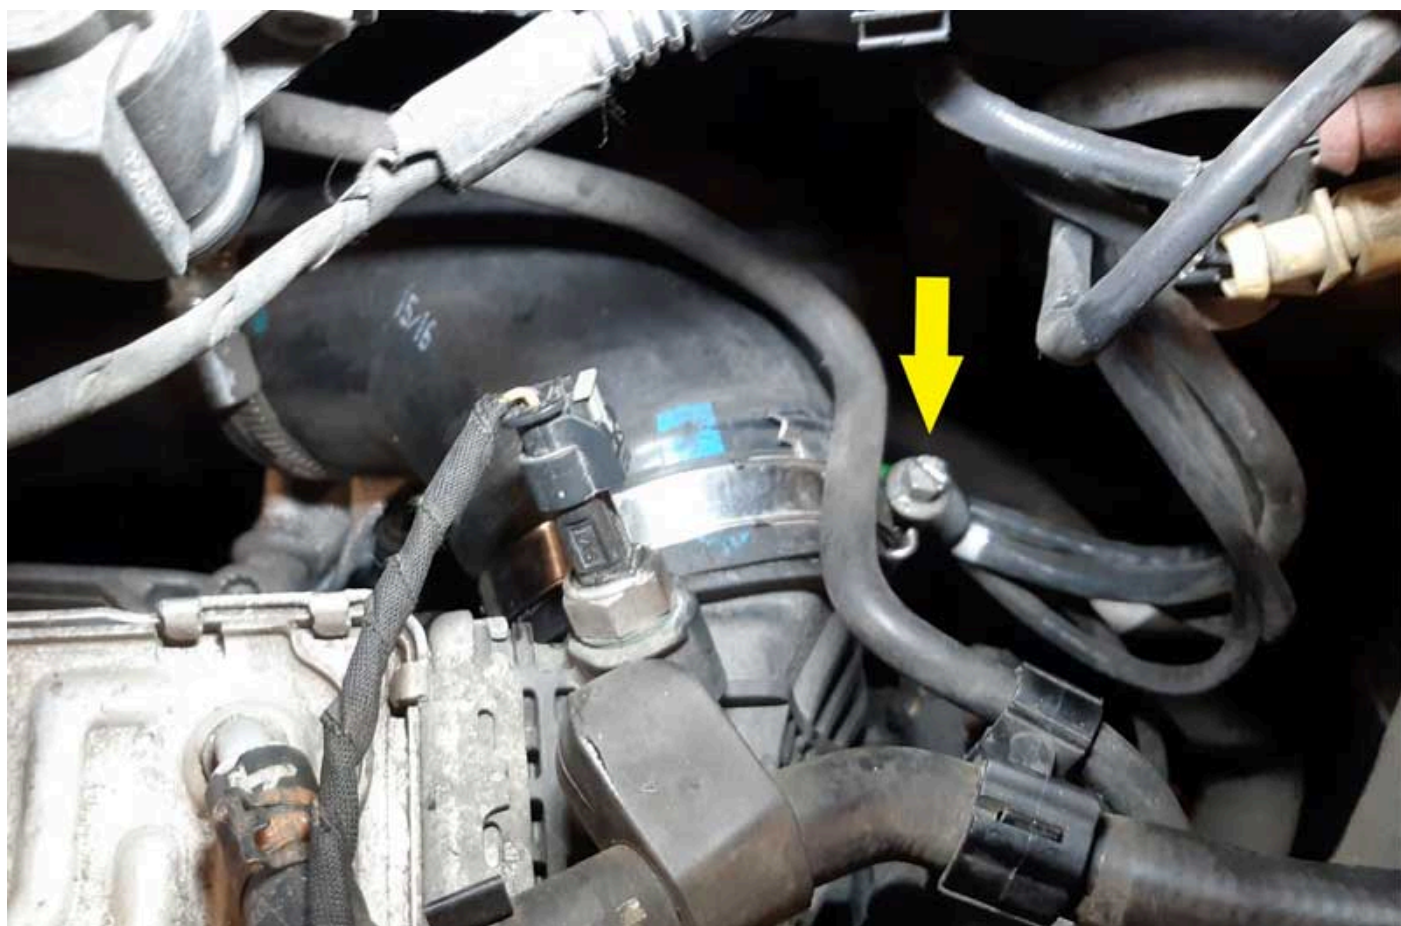
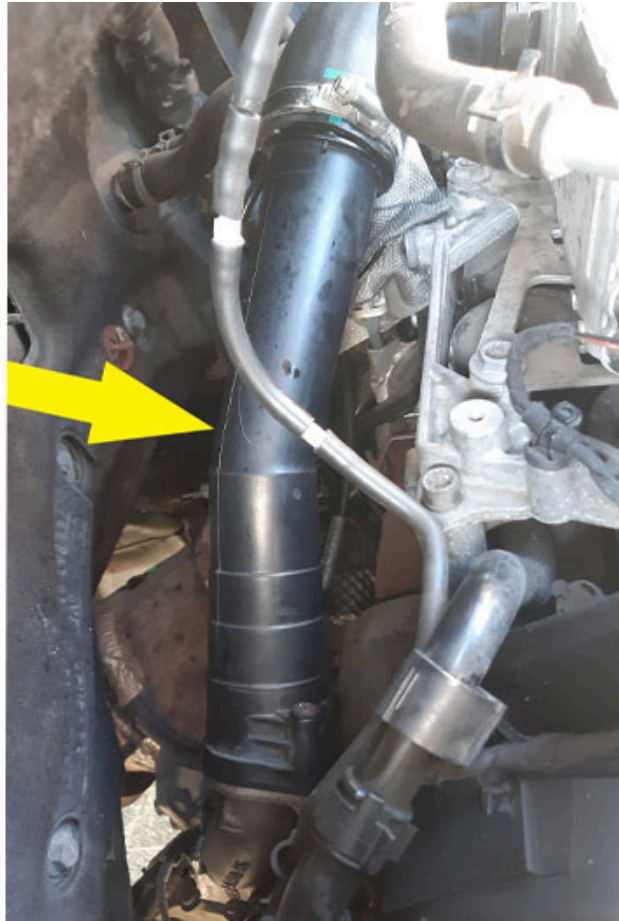
The sensor, wrapped in heat protection foil, is located behind the hose of the charge air cooler, as shown in ([Fig. 1](#)). In order to access the sensor, the charge air hose or the charge air pipe has to be removed as seen in ([Fig. 2](#)). This is done by removing 2 screws in the lower section. Loosen the hose clip at the top of the charge air cooler([Fig. 3](#)). Now it will be possible to remove the hose/pipe combination ([Fig. 4](#)). After opening/removing the heat protection foil, the sensor becomes visible. It can now be replaced with a sensor, for example, from HELLA (Part no: 6PP 009 403-221).

After replacing the sensor, the error memory should be cleared with the aid of a diagnostic device, e.g. the Hella-Gutmann Mega-Macs series, and a test drive carried out.

On this vehicle with the engine code CXHA, the differential pressure sensor “teaches” or programs itself, while the vehicle is being driven.
