Skoda Enyaq - Faulty beam setting

Data sheet	
Manufacturer	Škoda
Vehicle model	Enyaq
Drive unit	Electric
Engine code	EBJC
Year of manufacture	2021 to 2024
Hella spare parts	Left headlamp: 1EX 014 773-911Right headlamp: 1EX 014 773-921
Symptoms	Dazzling oncoming traffic after beam setting
Recommended tool	mega macs X, SEG V

Incorrect beam setting after maintenance

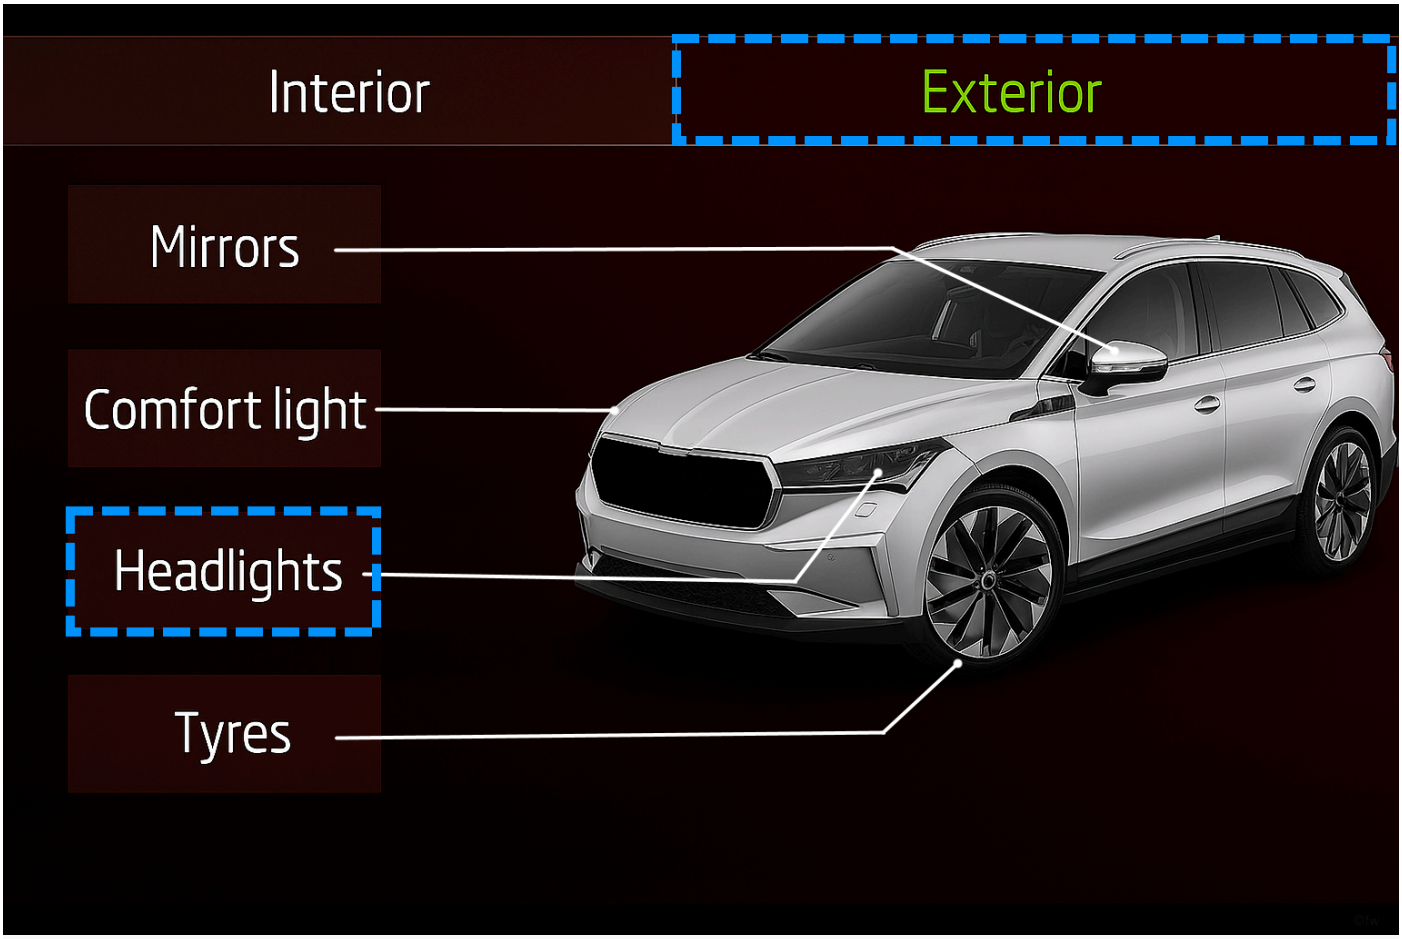
Exemplary menu structure in the infotainment system: In the "Exterior" section, the "Headlamps" menu item opens the headlamp levelling adjustment menu.

Example illustration: Reset automatic headlamp levelling to zero in this menu item.

For this reason, automatic headlamp levelling must be reset to zero beforehand in the above menu to correctly adjust the components. Only then can headlamp basic setting be carried out using a suitable beamsetter as per the manufacturer's specifications. Finally, check it is operating correctly and go for a test drive.

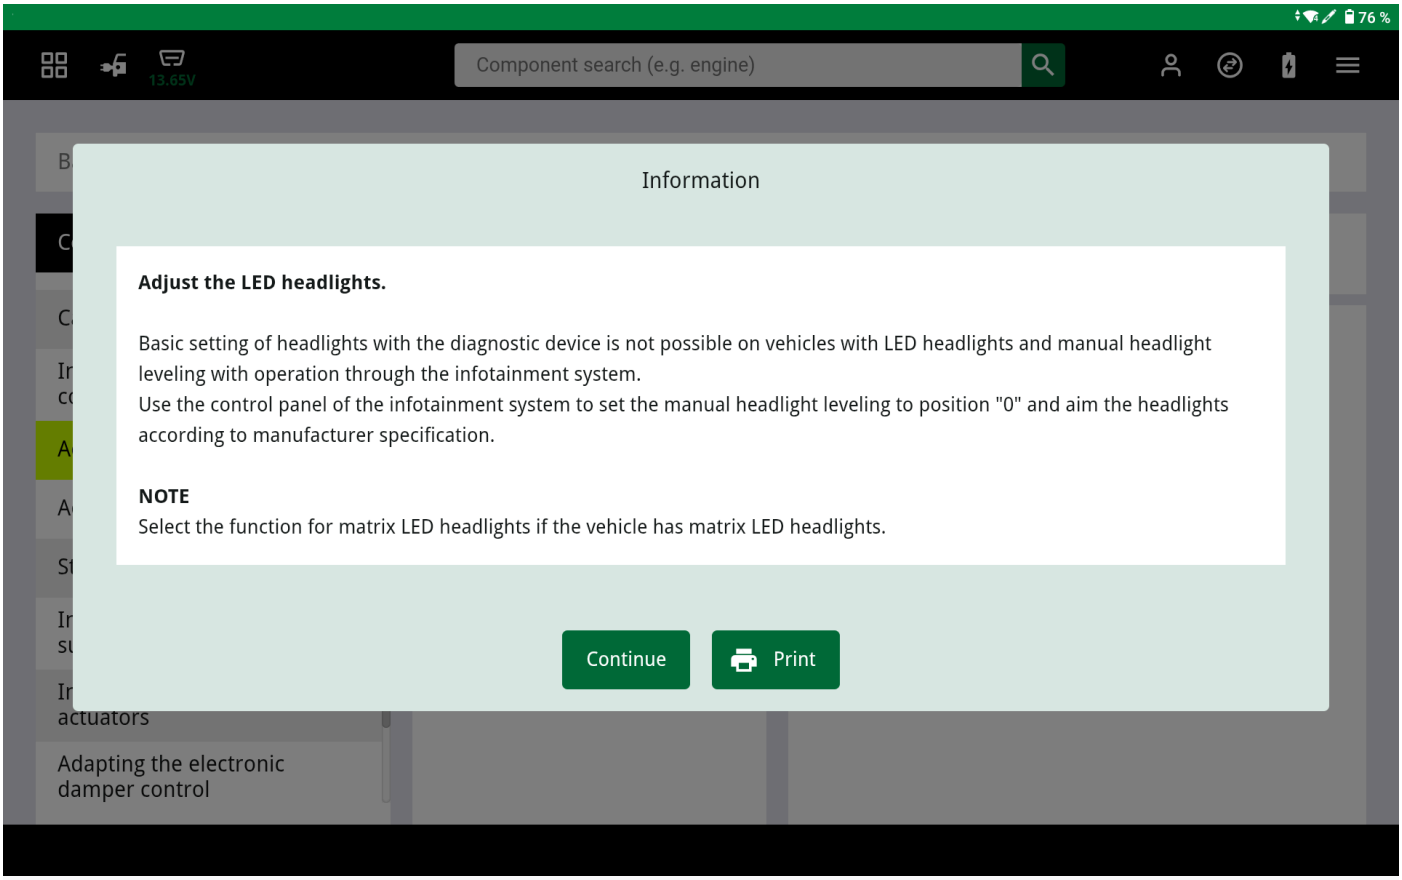
Note in the diagnostic unit on the headlamp adjustment procedure
