BULLETIN

Service reset Condition Based Service (CBS) – brake pads BMW model series E81/E82/E87/E88/E90/E91/E92/E93

Service reset – brake pads

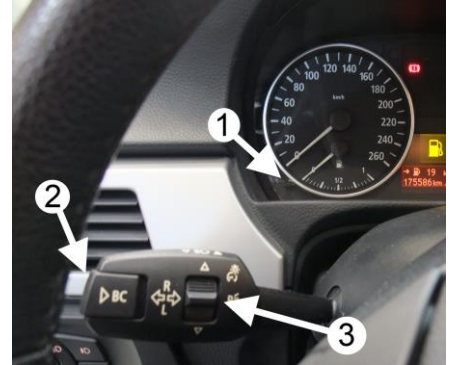
1. Close the doors
2. Switch on the ignition and wait approx. 10 seconds until the external temperature display and time are displayed (If another service warning message (e.g. fuel) is displayed, confirm this with the BC button (2).)
3. Press on the trip mileage reset button (1) until the service data is displayed
4. Then actuate the rocker switch (3) until the desired service is displayed.
5. Keep pressing the BC button until 'RESET?' is displayed
6. Press the BC button again until the displayed time symbol disappears.
7. Switch off the ignition
