VW Passat - whistling noises during acceleration

Data sheet	
Manufacturer	VW
Vehicle model	Passat 3G2/3G5
Engine	2.0 16 V TDI
Engine code	DFGA / CRLB
Year of manufacture	2014-2019
Symptoms	Exhaust system whistles during acceleration

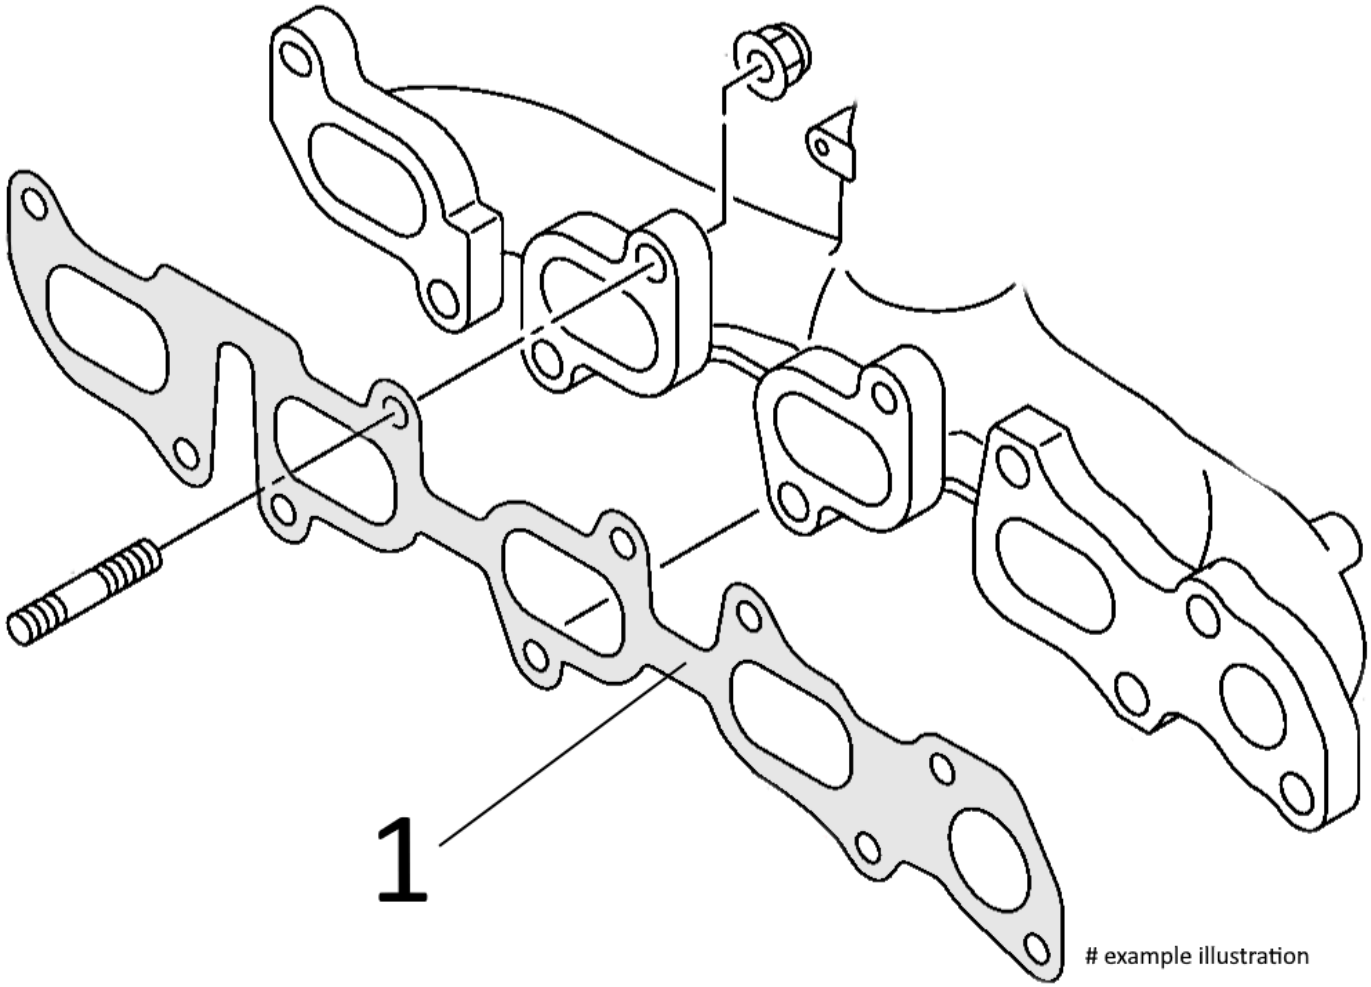
Figure 1

If whistling noises are detected coming from the area of the exhaust system during acceleration, a possible cause may be a defective gasket on the exhaust manifold.

In certain cases, leaks may occur on the sealing surfaces of the first and fourth cylinders as a result of the vehicle design. If no other defects are found in the exhaust system during the fault diagnosis, the seal (1) should be checked and replaced if necessary.

- Visual inspection of the exhaust manifold to check for leaks
- Removal of the exhaust manifold and thorough cleaning of the sealing surfaces
- Installation of the exhaust manifold with new gasket and new fastening nuts

- Exhaust manifold gasket: 04L 253 039G
- Fastening nut: N 908 946 01
