BMW i3 (I01) - Noises in the area of the doors | HELLA

Noises in the area of the doors

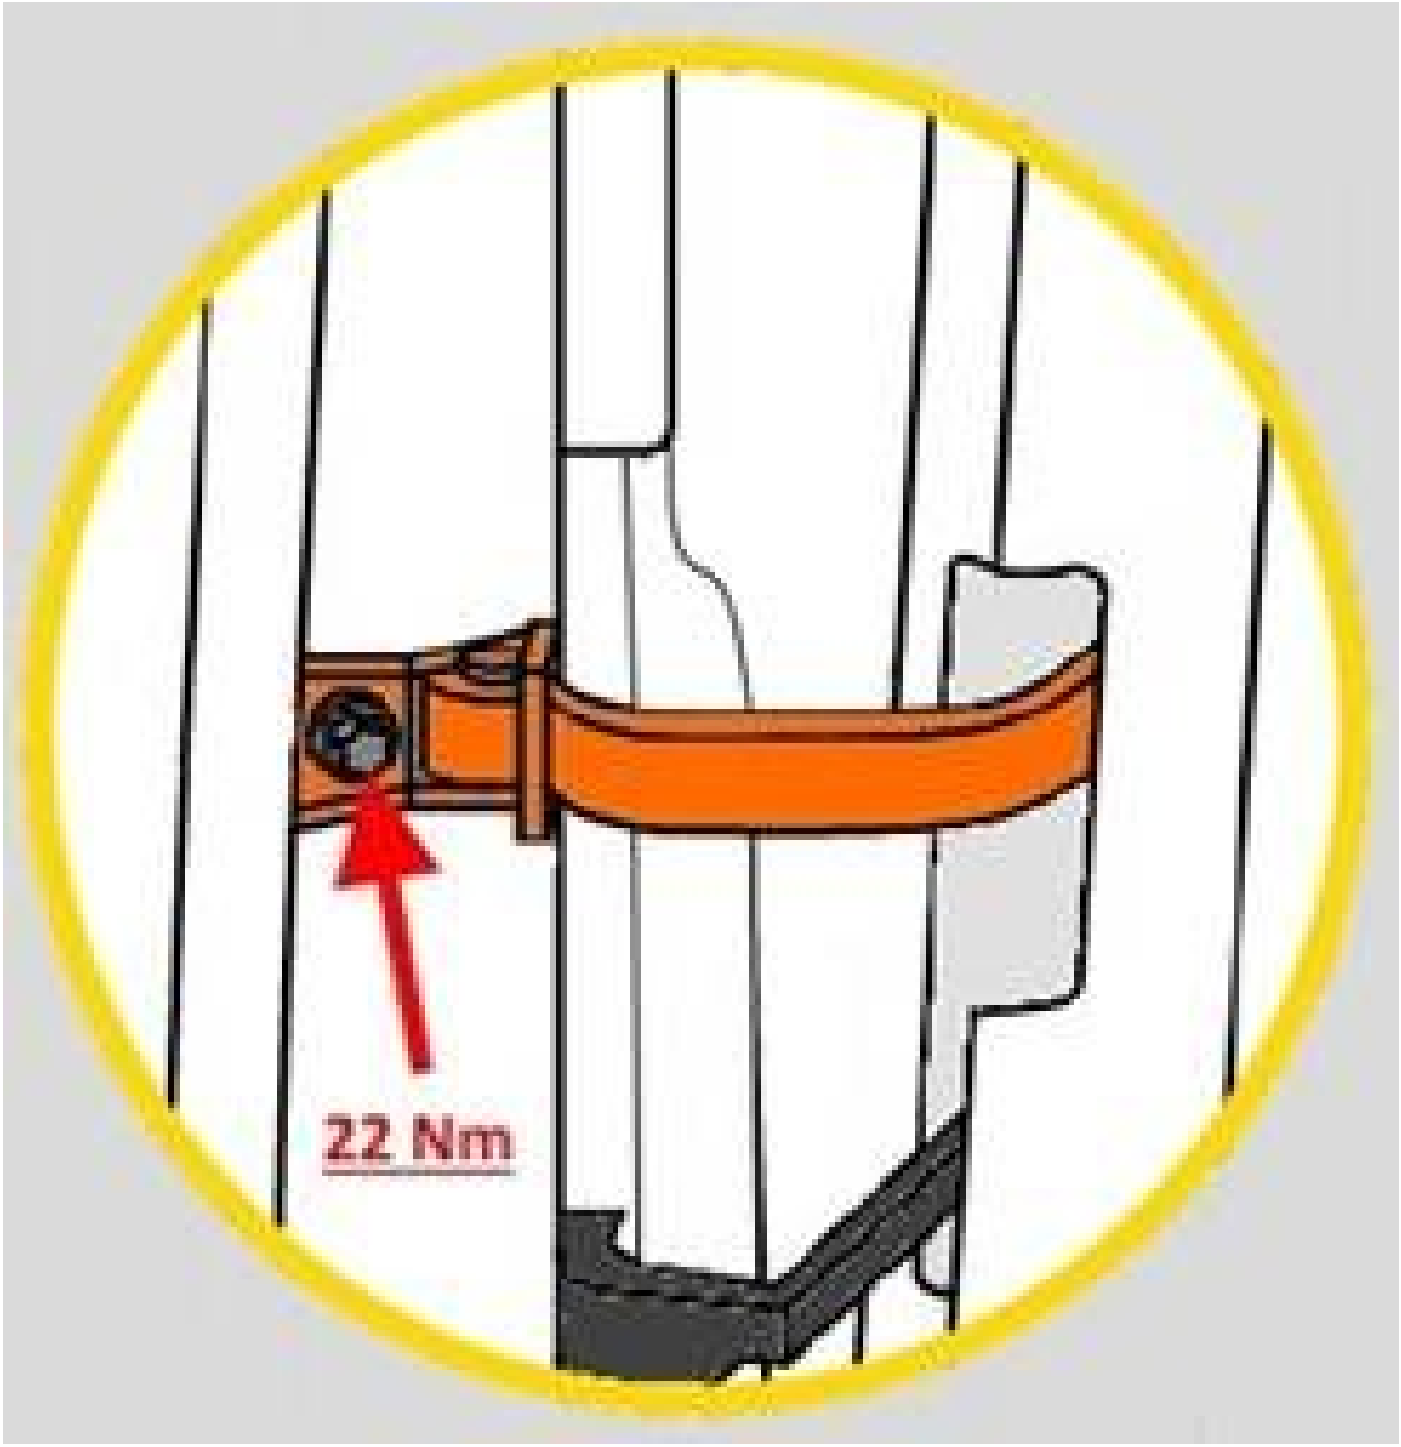
A closer look at the door mechanism revealed that the fastening screw of the door check strap had come loose.

(It is possible that all doors can be affected).

- Disassemble the fixing screw

- Check the mounting hole and the screw for damage (thread, etc.) and repair or replace if necessary

- Tighten the fixing screw to torque as specified by the vehicle manufacturer (22Nm) (see picture)

- Repeat this procedure for all doors

-Fixing screw (ASA M8x22) OE No. 07147248803
