Fiat Grande Punto - Warning light for electronic stability program (ESP) lights up | HELLA

Grande Punto

Model Year 2005-2009

Warning light for electronic stability program (ESP) lights up

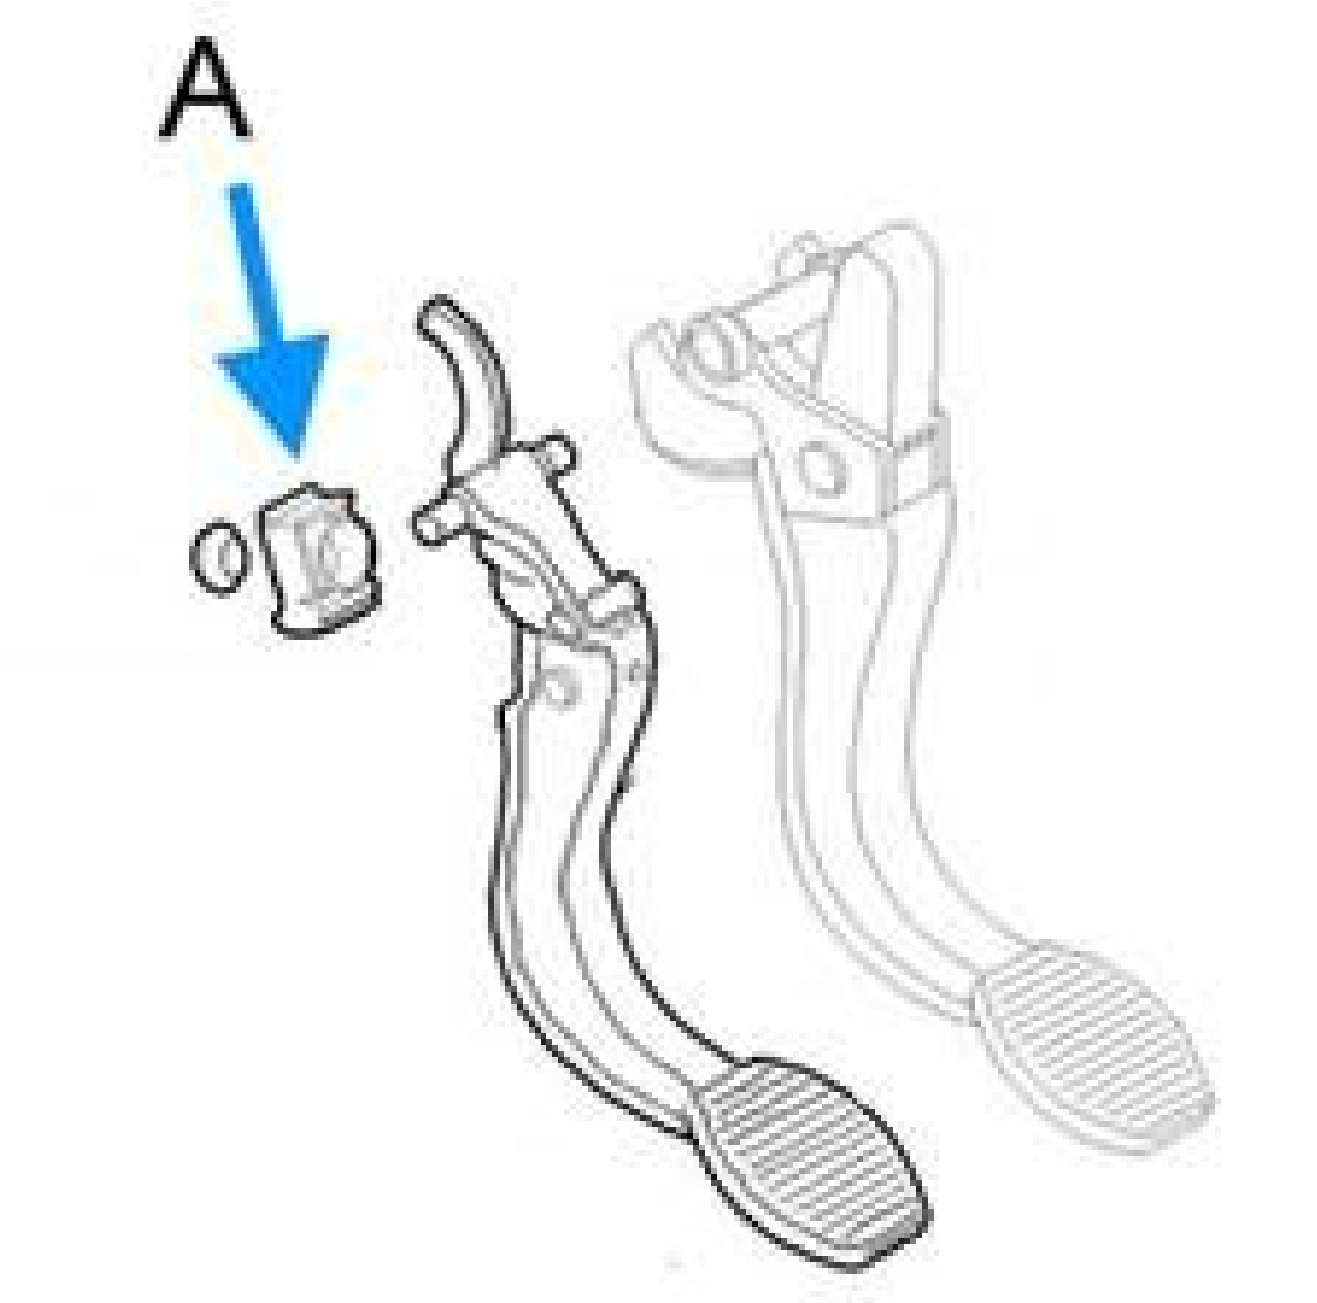
If the above-mentioned defect is discovered in connection with permanently lit-up stop lights, a possible cause responsible for this is a faulty fastening element.

The fastening element fixes the pressure rod for the brake booster on the brake pedal.

Occasionally it is also not possible to engage the first gear in vehicles which have the "Dualogic" automatic transmission.

Check the fastening element (A) of the pressure rod above the pedals and, if necessary, replace.

Fiat - service part number: 46755874
