Opel Meriva A - Starter does not turn

Data sheet	
Manufacturer	Opel
Vehicle model	Meriva A
Engine code	Y17DT (1.7 DTi)
Symptoms	Starter does not turn over | Renewing the starter

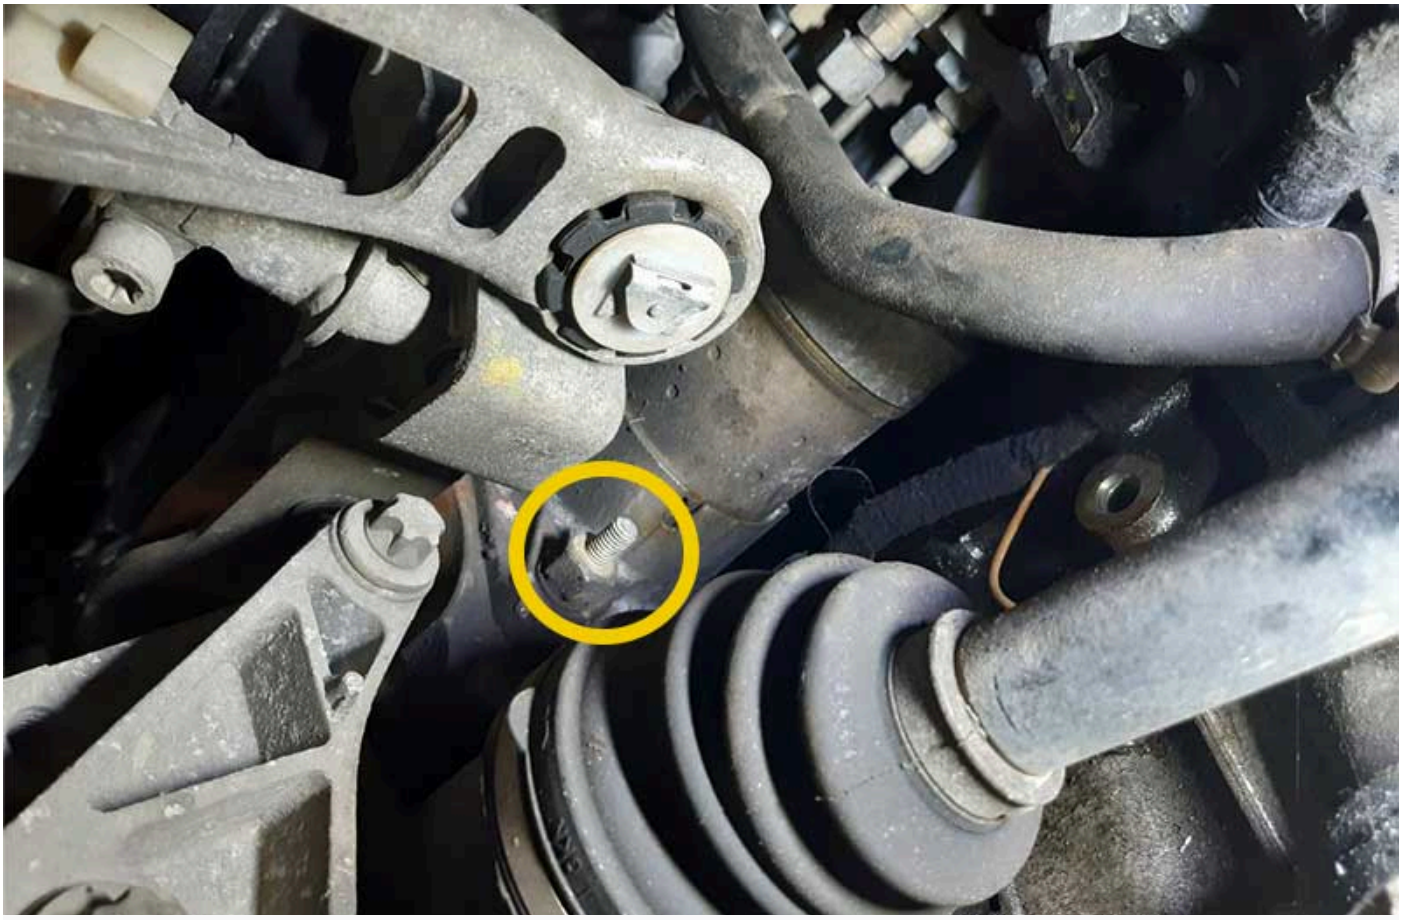
Starting from the underbody, steering control unit

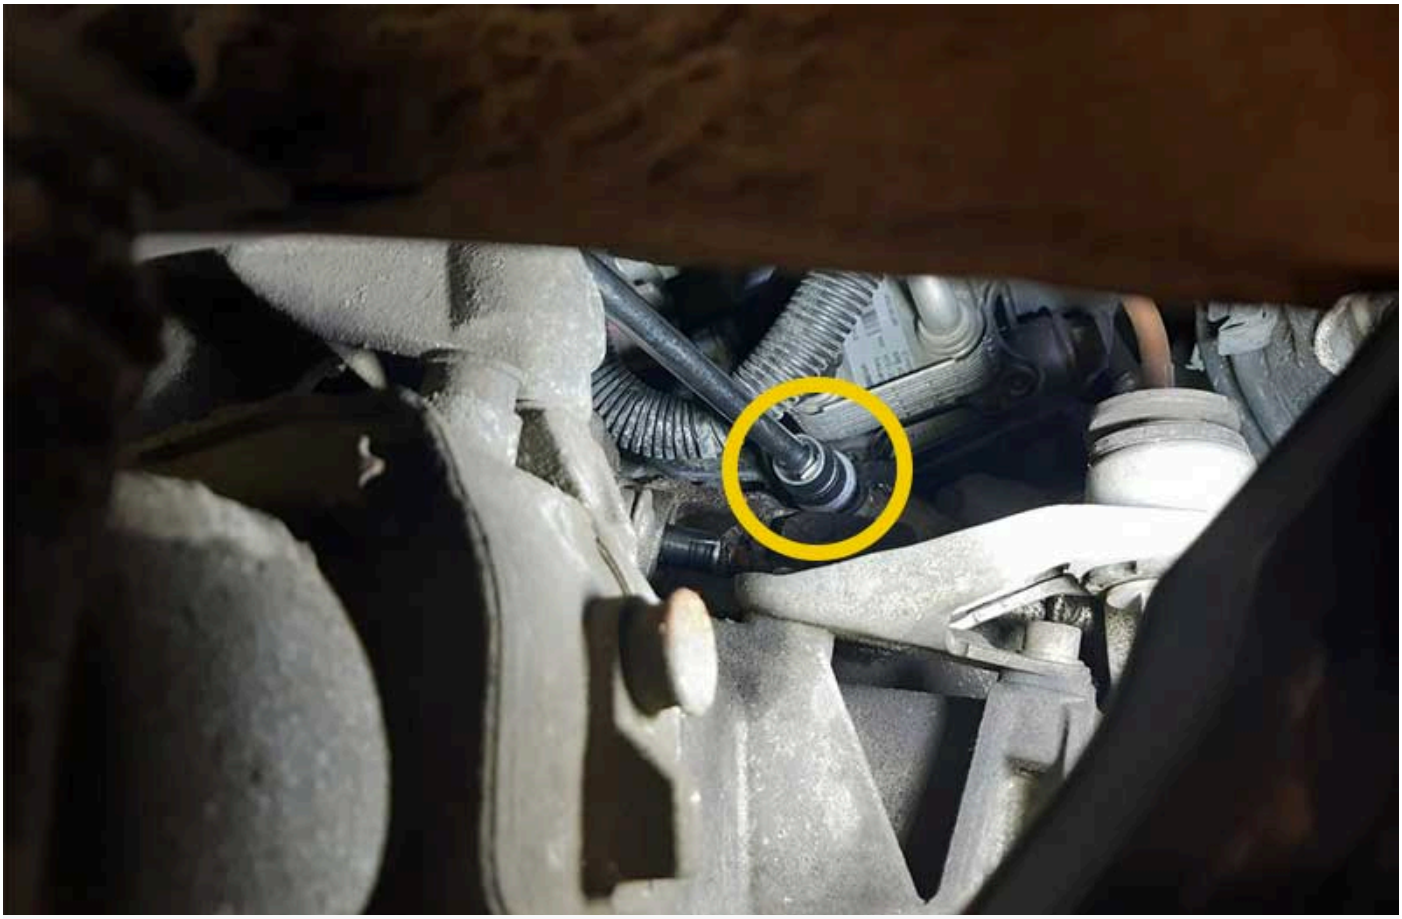
Starter screw

Loosen/remove screw from starter
