Vauxhall Astra-J Sports Tourer: display code 16

Data sheet	
Manufacturer	Vauxhall
Vehicle model	Astra J
Symptom	Display code 16

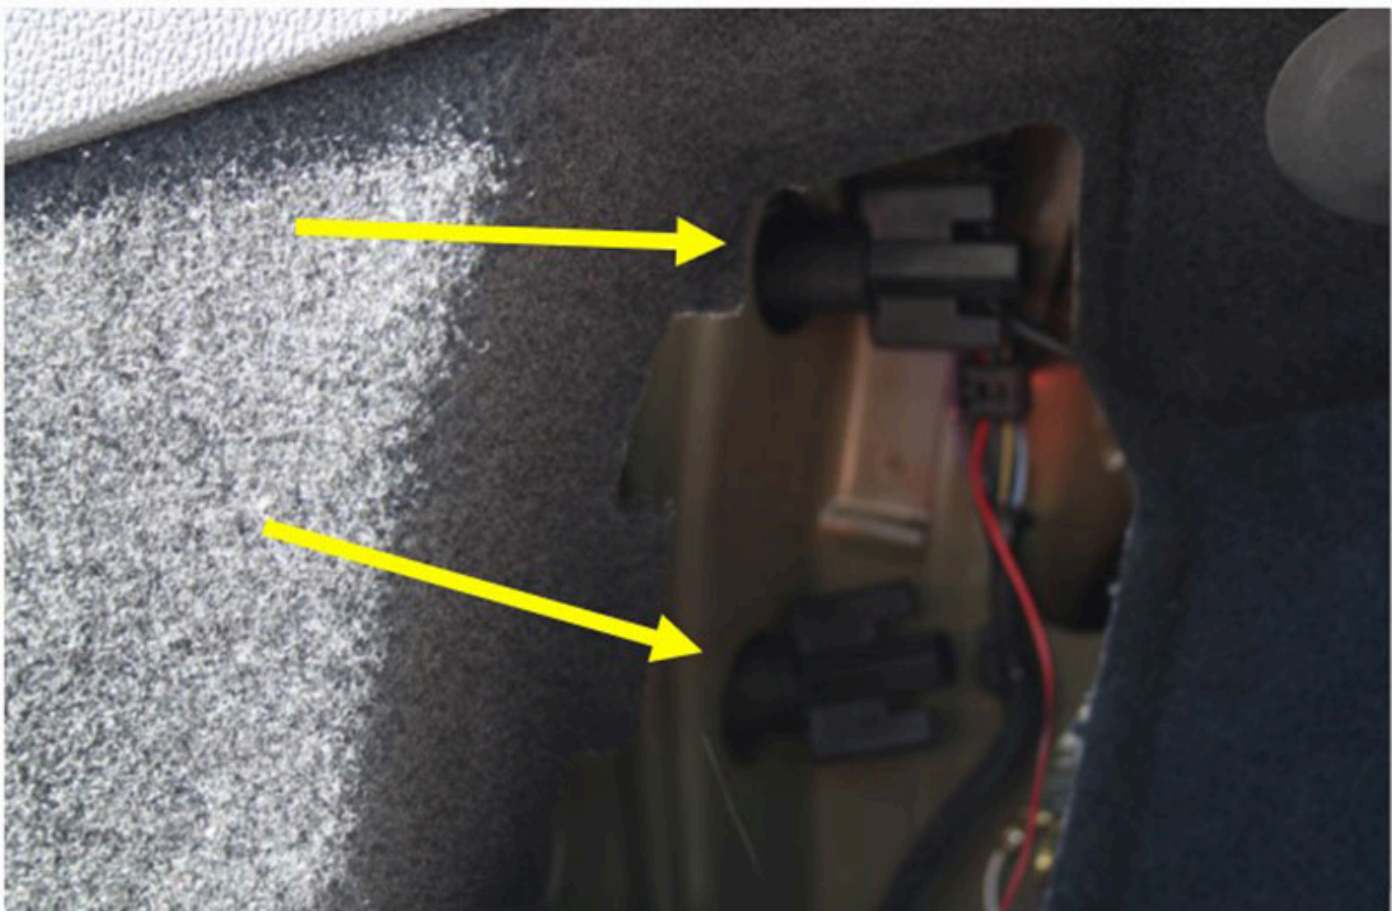
Code 16 appears on the display (Fig.1) with information, see operating instructions. Error code Diagnosegerät_B3881 corresponds to faulty tail light lamp or circuit.

Fig. 1: Code 16 appears on the display
