Mazda 3, 5 - Loss of coolant | HELLA

Loss of coolant

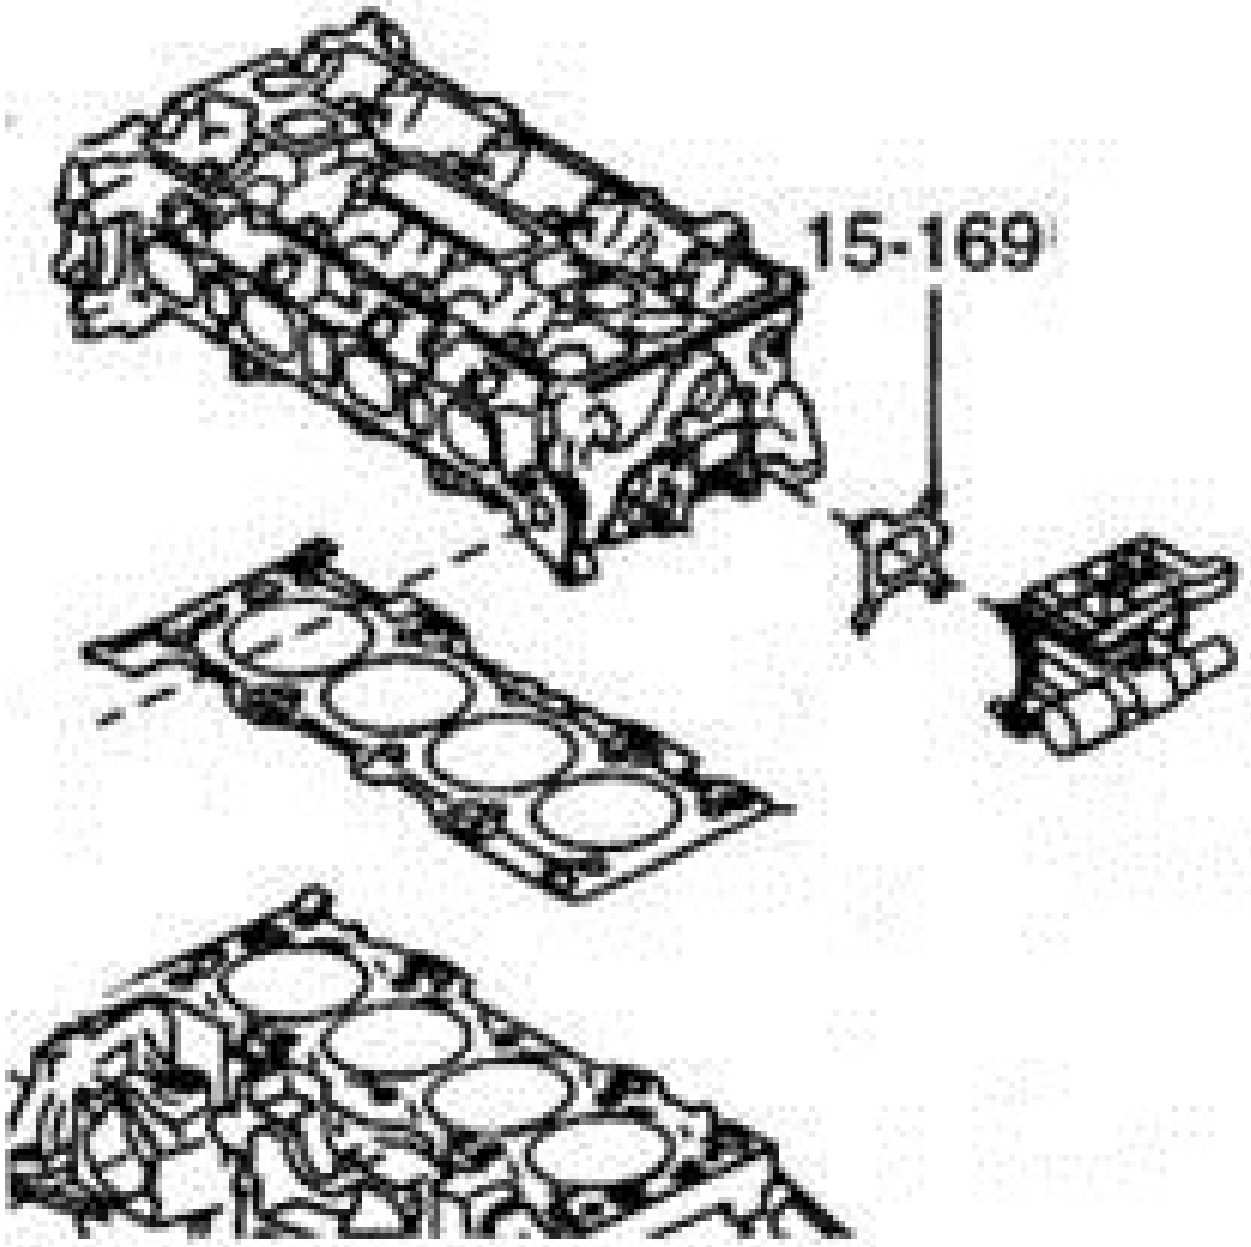
15-169

On the above vehicles (except for the Mazdaspeed 3), there is the possibility for coolant to leak out at the cylinder head flange.

In case of coolant loss, special attention should be paid to the coolant flange gasket on the cylinder head (drawing 15-169). It may need to be replaced with a modified variant (LF1F-15-169).

After the repair, refill and bleed the cooling system as per the manufacturer's specifications.
