# **BMW 3 series (E90/E91/E92) - Poor air-conditioning system performance | HELLA**

## **Poor air-conditioning system performance**

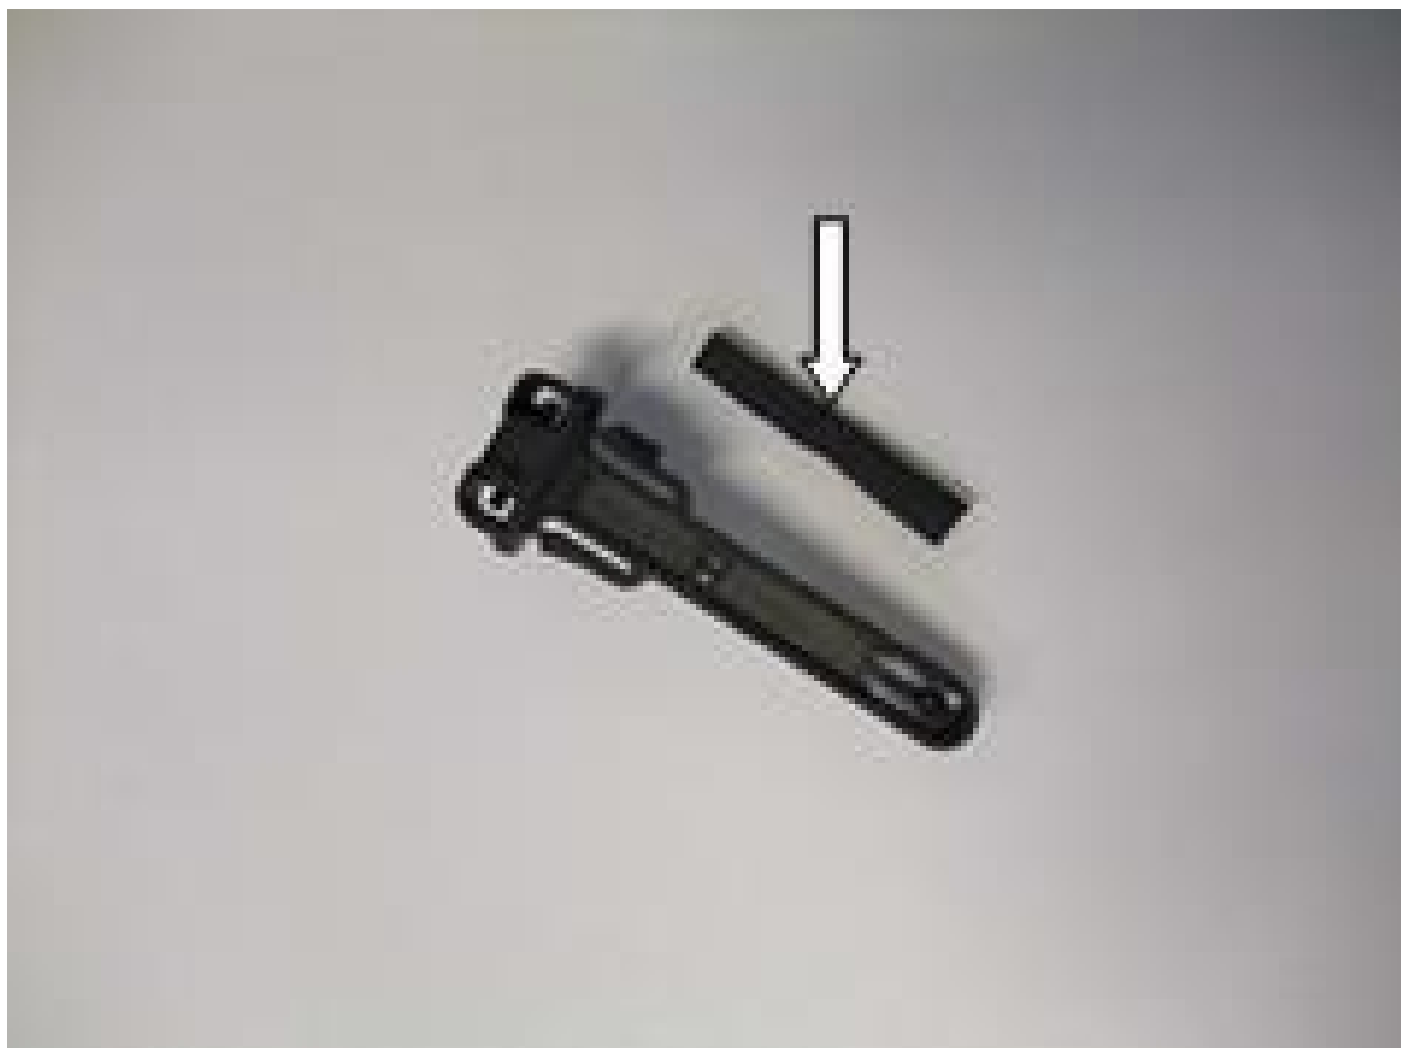
Figure 3

- Pull out the sensor connector plug
- Remove sensor
- Cut foam strips to size (Figure 3) and stick on

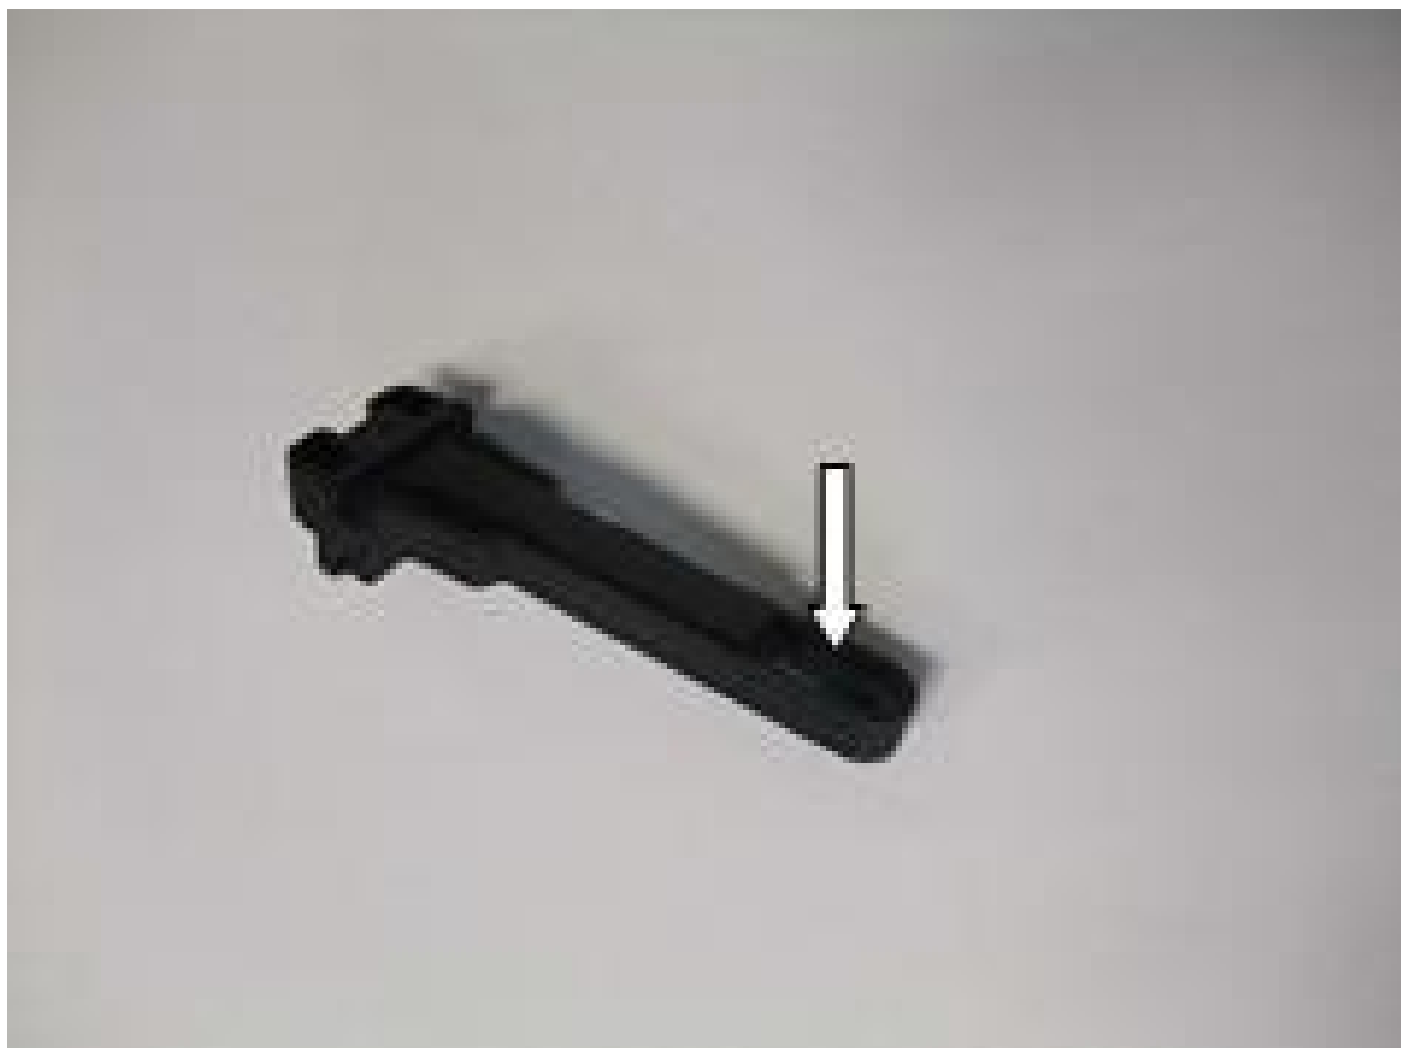
Figure 4

Make sure that the sensor's measuring cell is not covered over (Figure 4)

- Install the sensor and connect the plug
- Reposition the cover
- Carry out functional test
