## Mini R56/R57: air conditioning making noise

## Mini R56/R57: humming noise when air conditioning is on

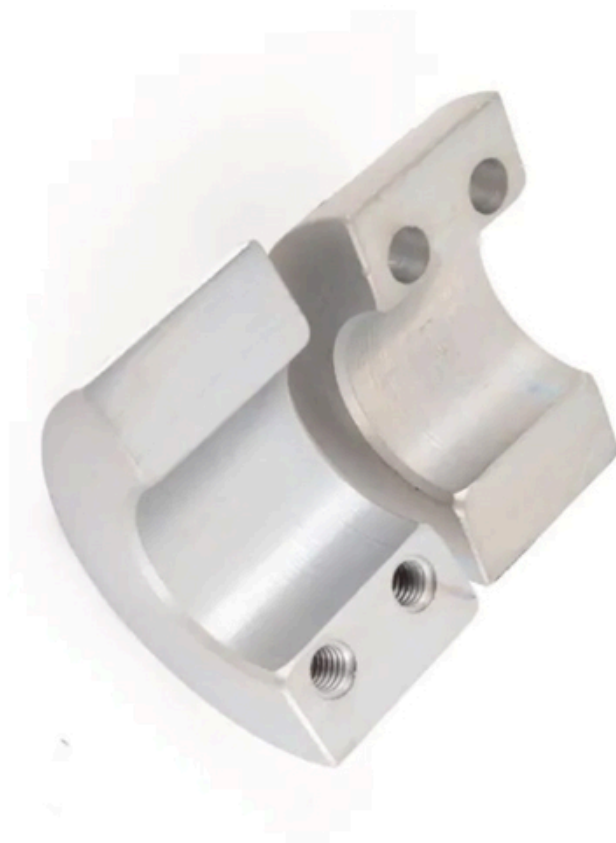
Figure 1: Vibration damper for retrofitting

The vehicle manufacturer offers a vibration damper ([Figure 1](#)) that can be retrofitted to remedy this. Use two screws (07129903806) to attach the two half shells (64509231714) approx. 80 mm from the hose connection's crimping ([Figure 2](#)).

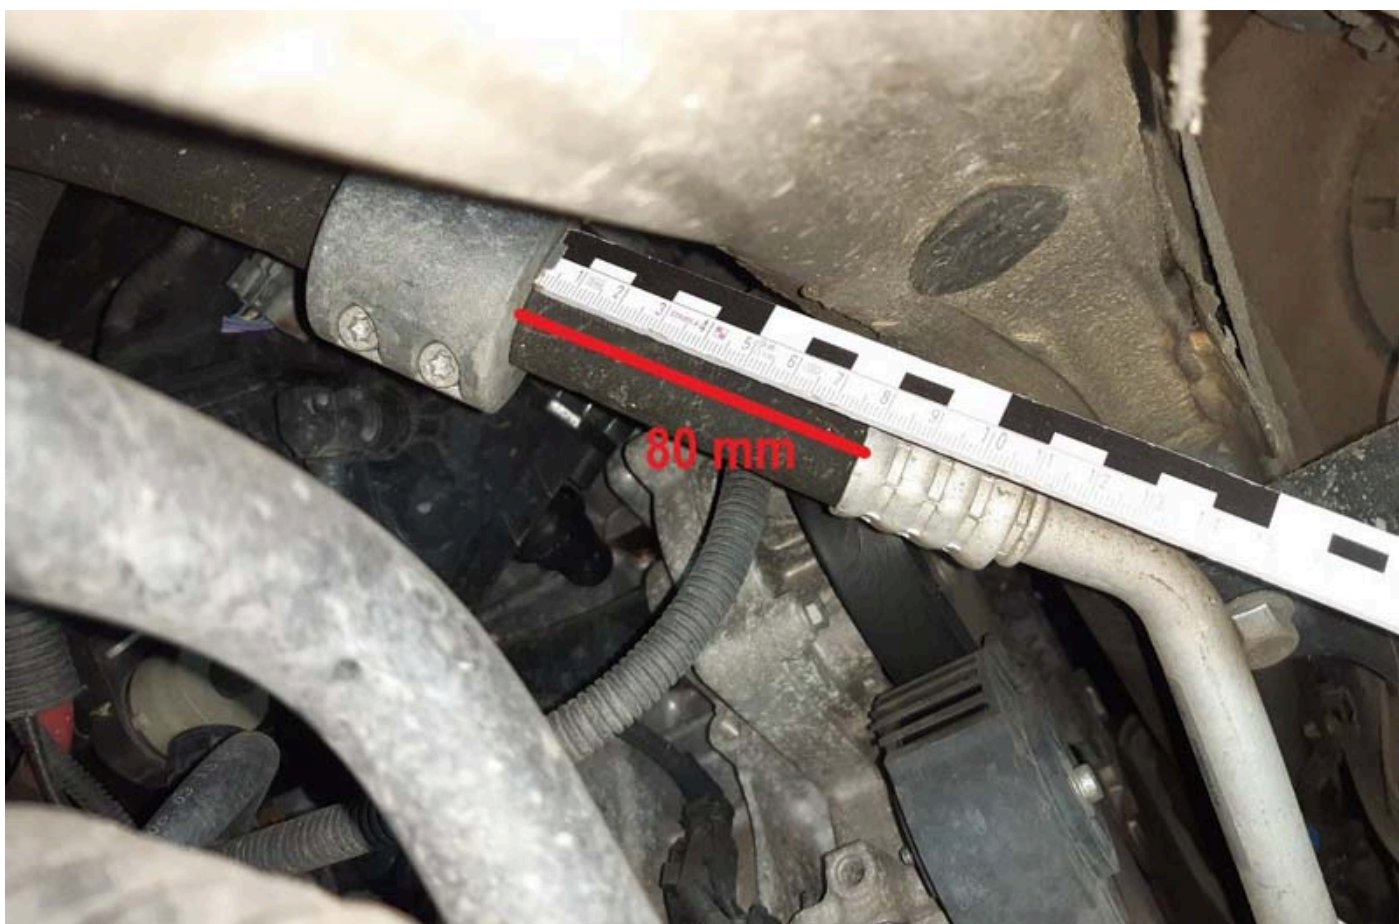
Figure 2: Install the vibration damper approx. 80 mm from the hose connection's crimping

The low-pressure line is located near the wheel well. Prior to installing the vibration damper, check the air conditioning contains the correct amount of refrigerant and the pressure is correct.
