# Renault, Citroen, Peugeot - Poor braking with the driving brake | HELLA

Renault, Citroen, Peugeot

All models with drum brakes

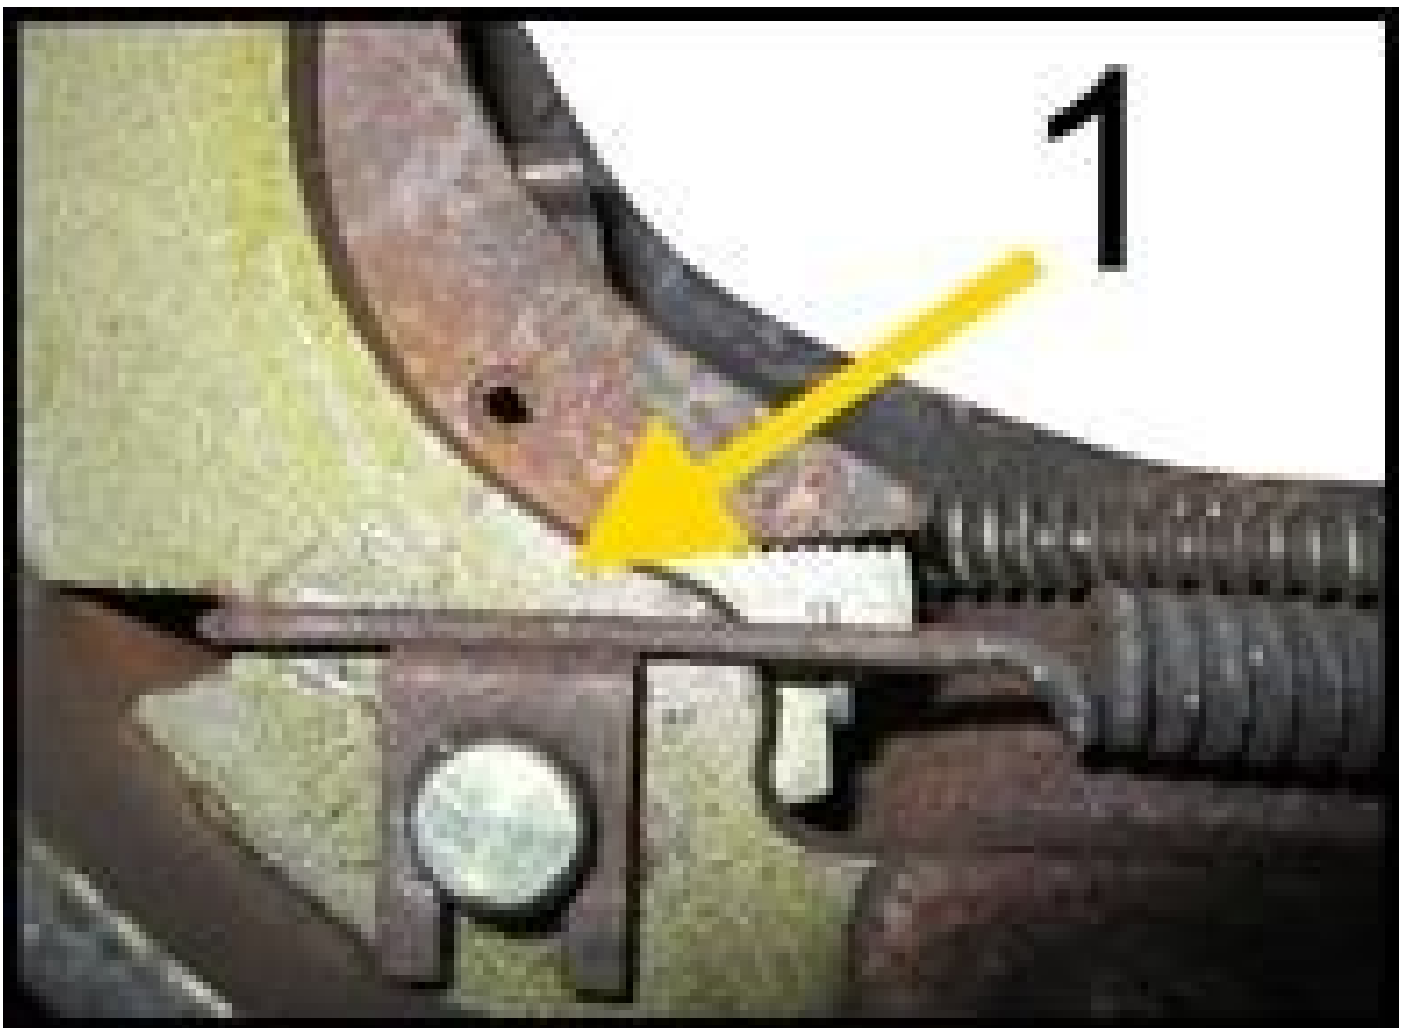
**Malfunction of the automatic adjusting device on the rear axle drum brake system.**

If one of the errors listed above occurs on these vehicle models, the cause may stem from a vertically mounted safety clip on the brake shoe.(Fig.1)

Please remember to always follow the general assembly instructions for installing and removing drum brakes and other special installation instructions from the brake pad or vehicle manufacturer in this regard.
