# BMW 2 Series Active Tourer - changing the cabin air filter

| Vehicle model | 2 Series Active Tourer (F45) |
| Year of manufacture | 2014 - 2021 |

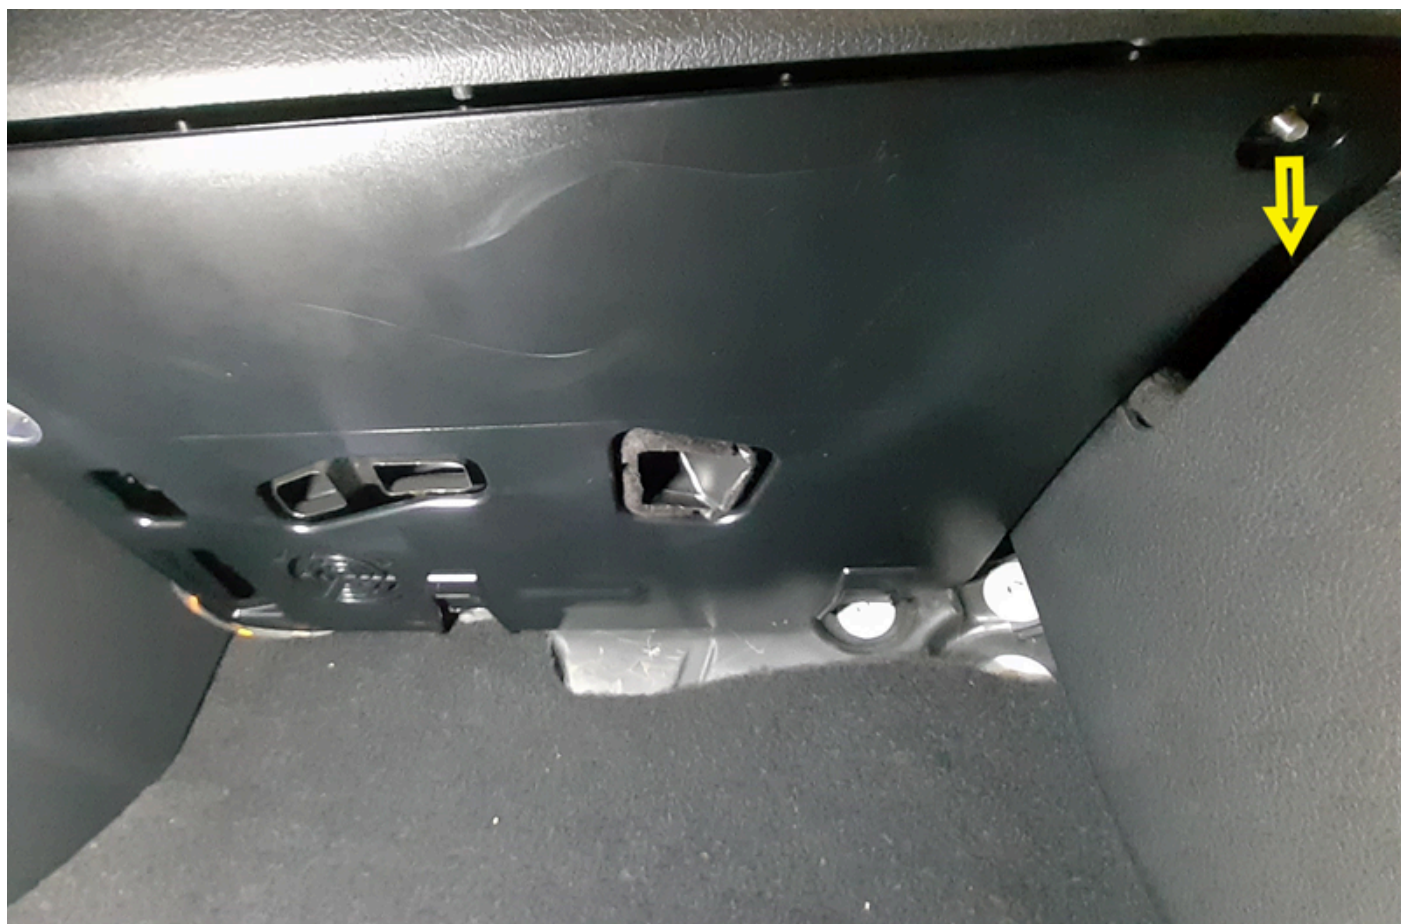
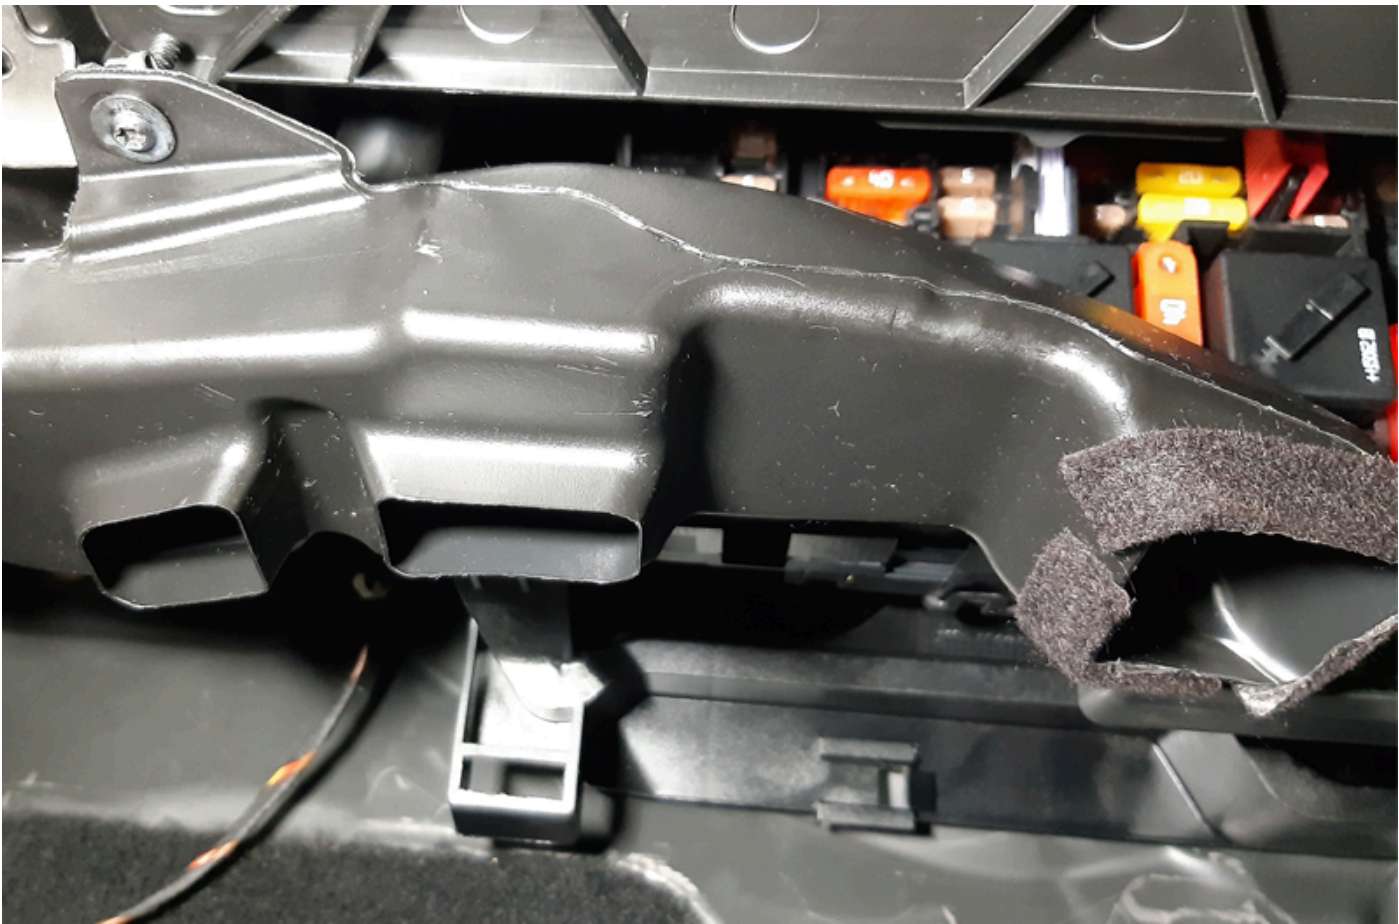
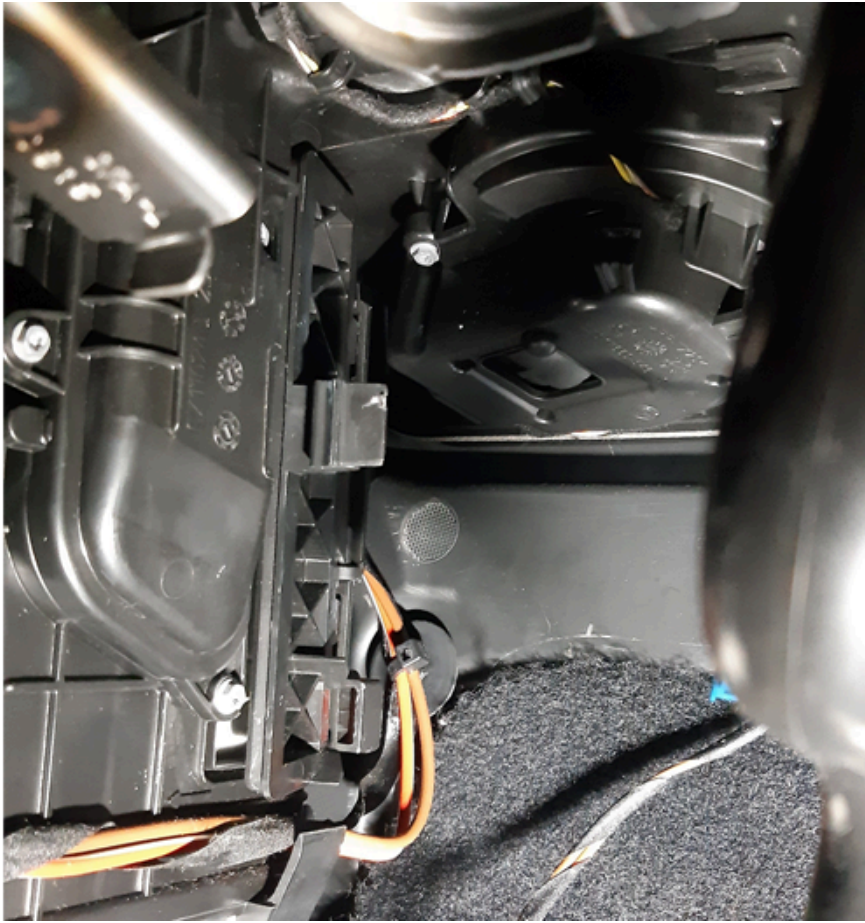
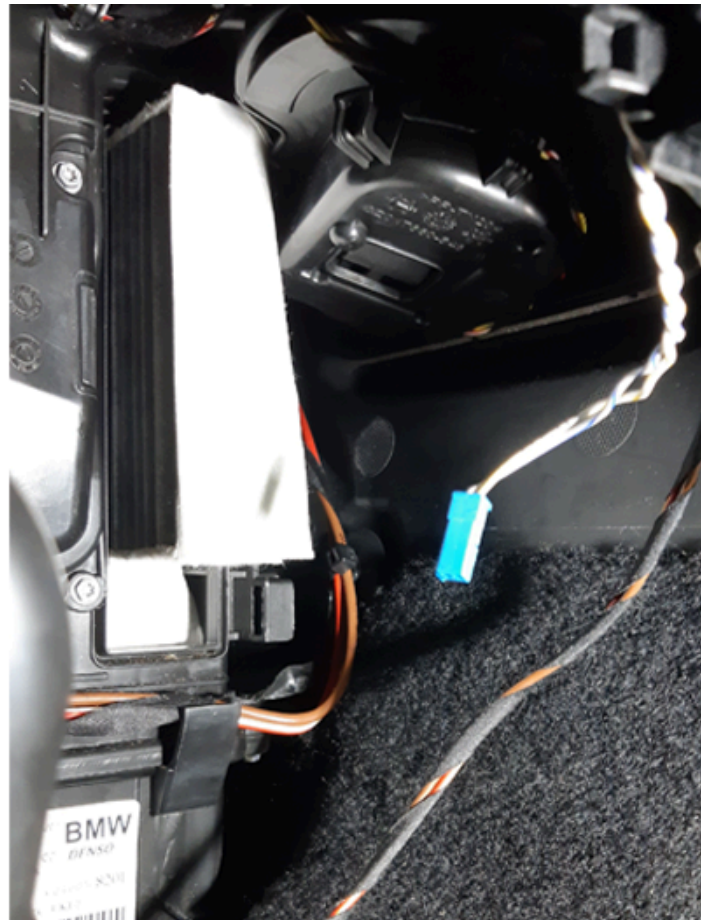
- [Figure 1](#): Remove the trim in the footwell on the passenger side by first of all removing the screws (2x).
  - [Figure 2](#): Remove the left cover in the footwell on the passenger side, again by first removing the two screws
  - [Figure 3](#): Remove the air outlet by removing the screw (1x) and pulling the air outlet to the right
  - [Figure 4](#): Pull off the hose from the heating/air-conditioning housing to the right
  - [Figure 5](#): Unlock and remove the cover from the heating/air-conditioning housing
  - [Figure 6](#): Pull out the cabin filter
- In order to install the new filter, proceed as above but in reverse order.
