# **Opel Astra - lamp illuminates sporadically | HELLA**

**Astra H model year: 2004 - 2007 engine code: Z16XEP**

## **Insufficient engine power malfunction indicator lamp illuminates sporadically**

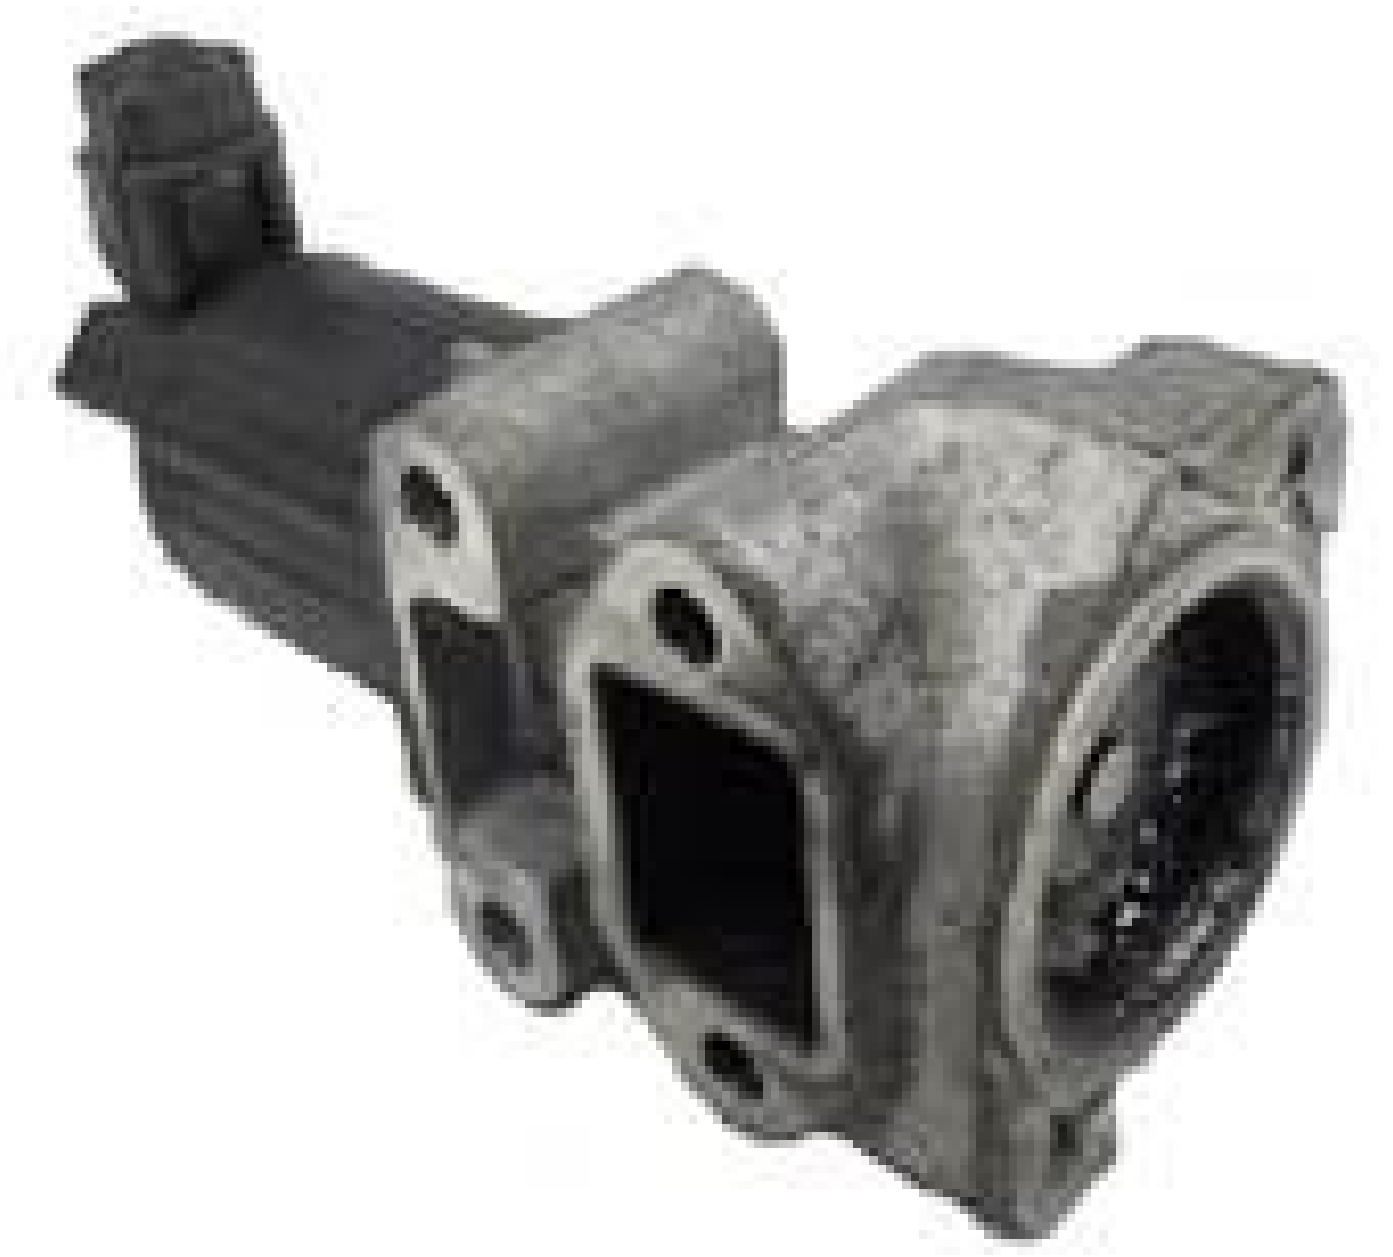
Figure 1

The cause of the aforementioned problem can be a dirty EGR valve (exhaust gas recirculation valve) (figure 1 / 2) and/or an EGR channel that is blocked with impurities

- Release the plug connection and remove the EGR valve
- Check the EGR valve and replace if necessary

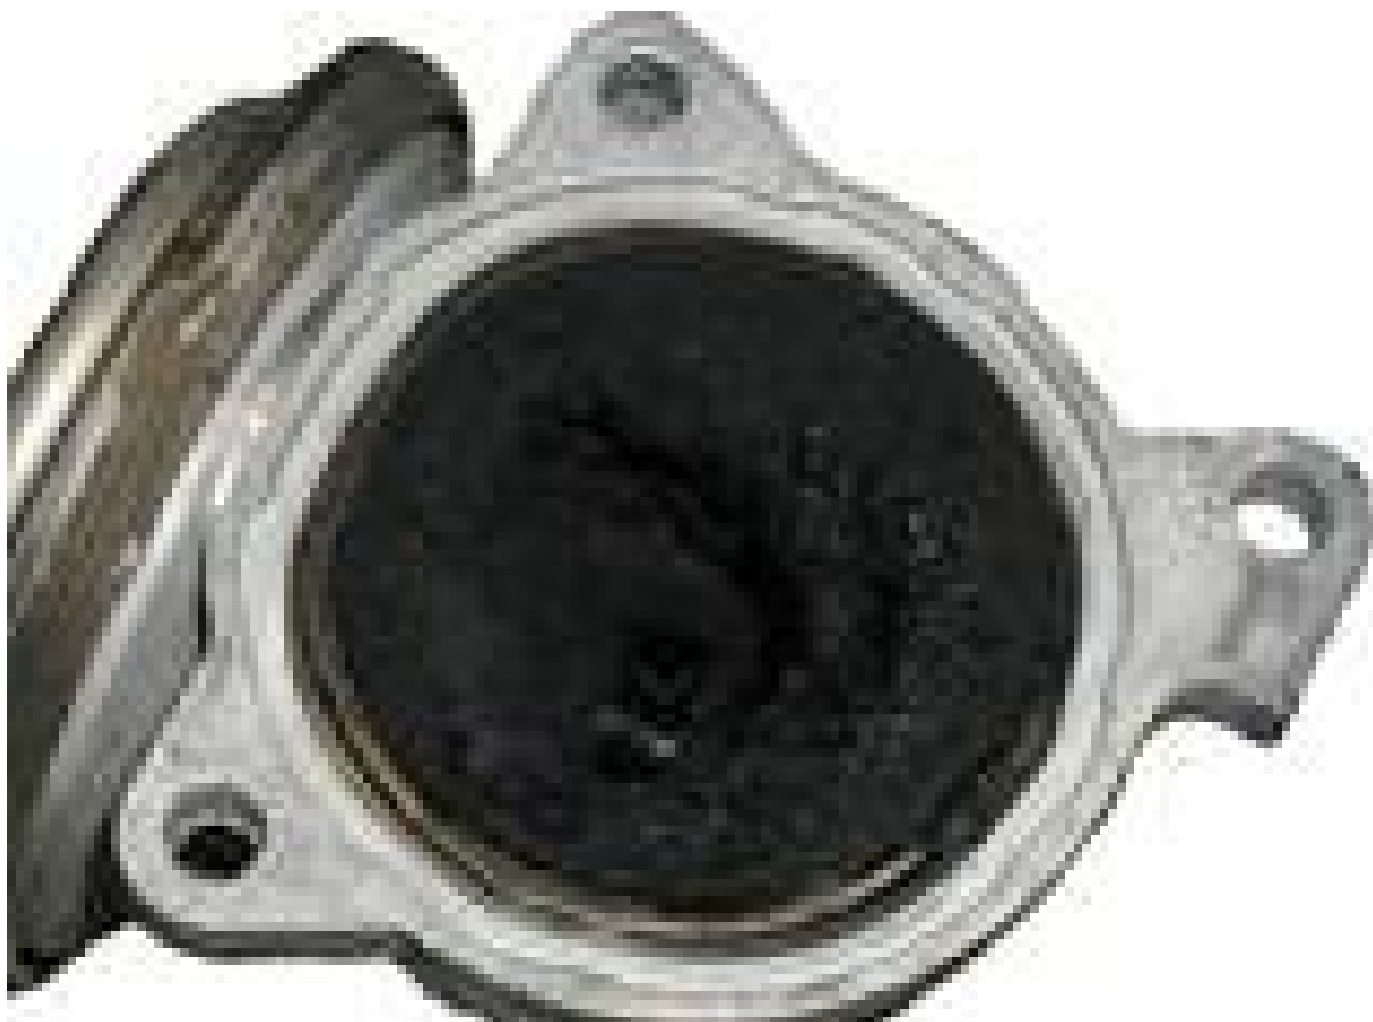
Figure 3

(figure 3) in the intake manifold.

- Remove the intake manifold
- Check EGR channels for impurities and clean if necessary (use a suitable tool)
- Install the intake manifold
- Carry out a test drive
- Read the faults using a diagnostic unit and delete them if necessary
