# Opel Meriva A - Starter does not turn

| Symptoms | Starter does not turn over Renewing the starter |

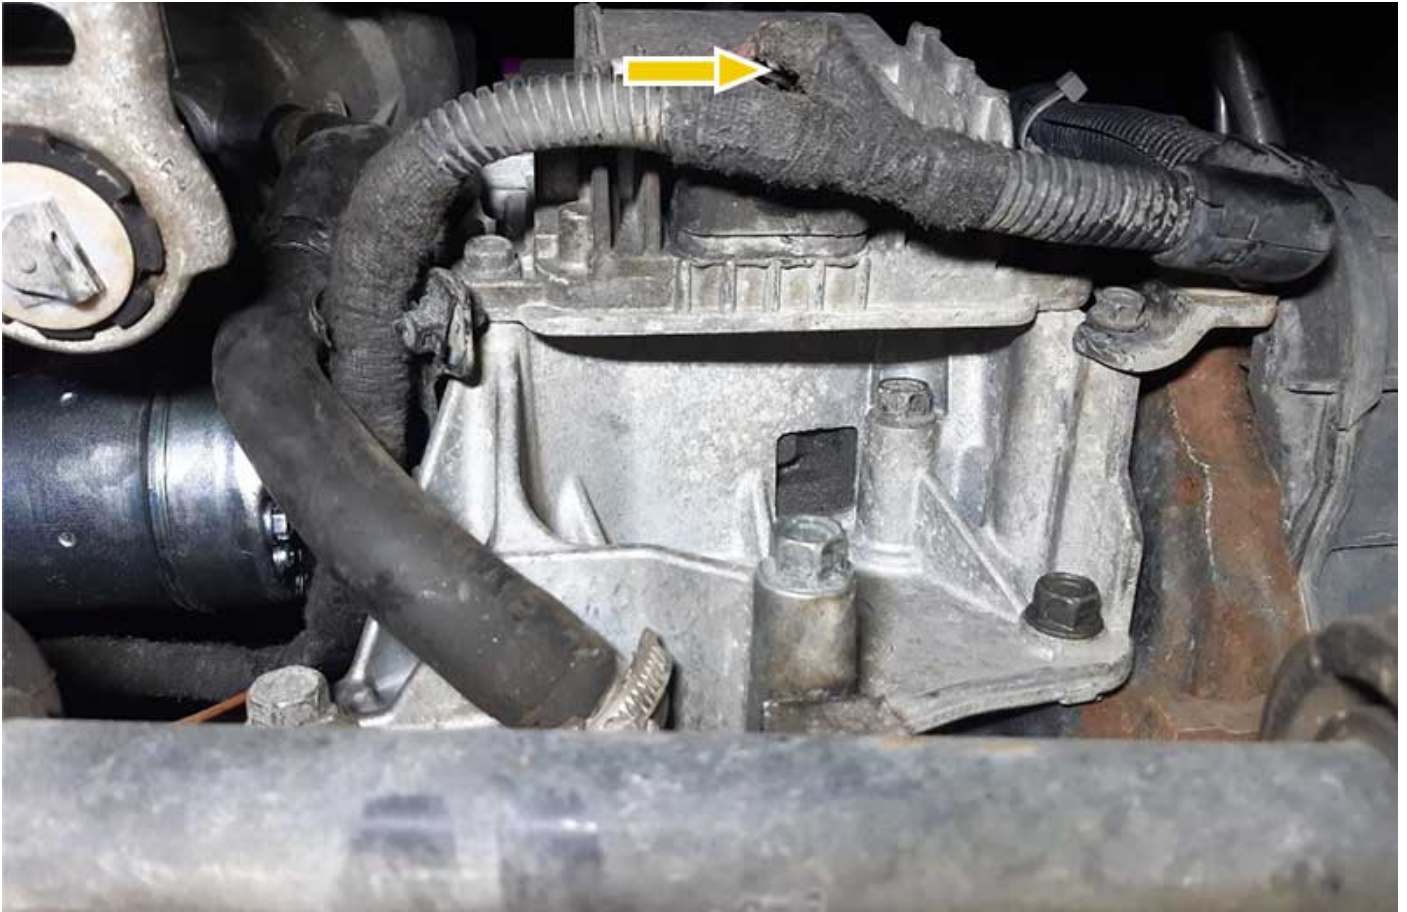
Starting from the underbody, steering control unit

- Remove ground connection of the battery (note the radio code if necessary)
- Raise vehicle on a lifting platform
- Starting from the underbody, remove the steering control unit <span class="gallery-mode--link" data-order="1">(Fig. 1)</span> from the metal carrier
- Unscrew and remove the carrier <span class="gallery-mode--link" data-order="2">(Fig. 2)</span>
- Disconnect electrical connections on the starter
- Loosen / remove the screw from the starter <span class="gallery-mode--link" data-order="3">(Fig. 3)</span>
- Remove left wheel well trim
- Loosen / remove screw of the starter from the wheel well or from the engine compartment <span class="gallery-mode--link" data-order="4">(Fig. 4)</span>
- Remove starter

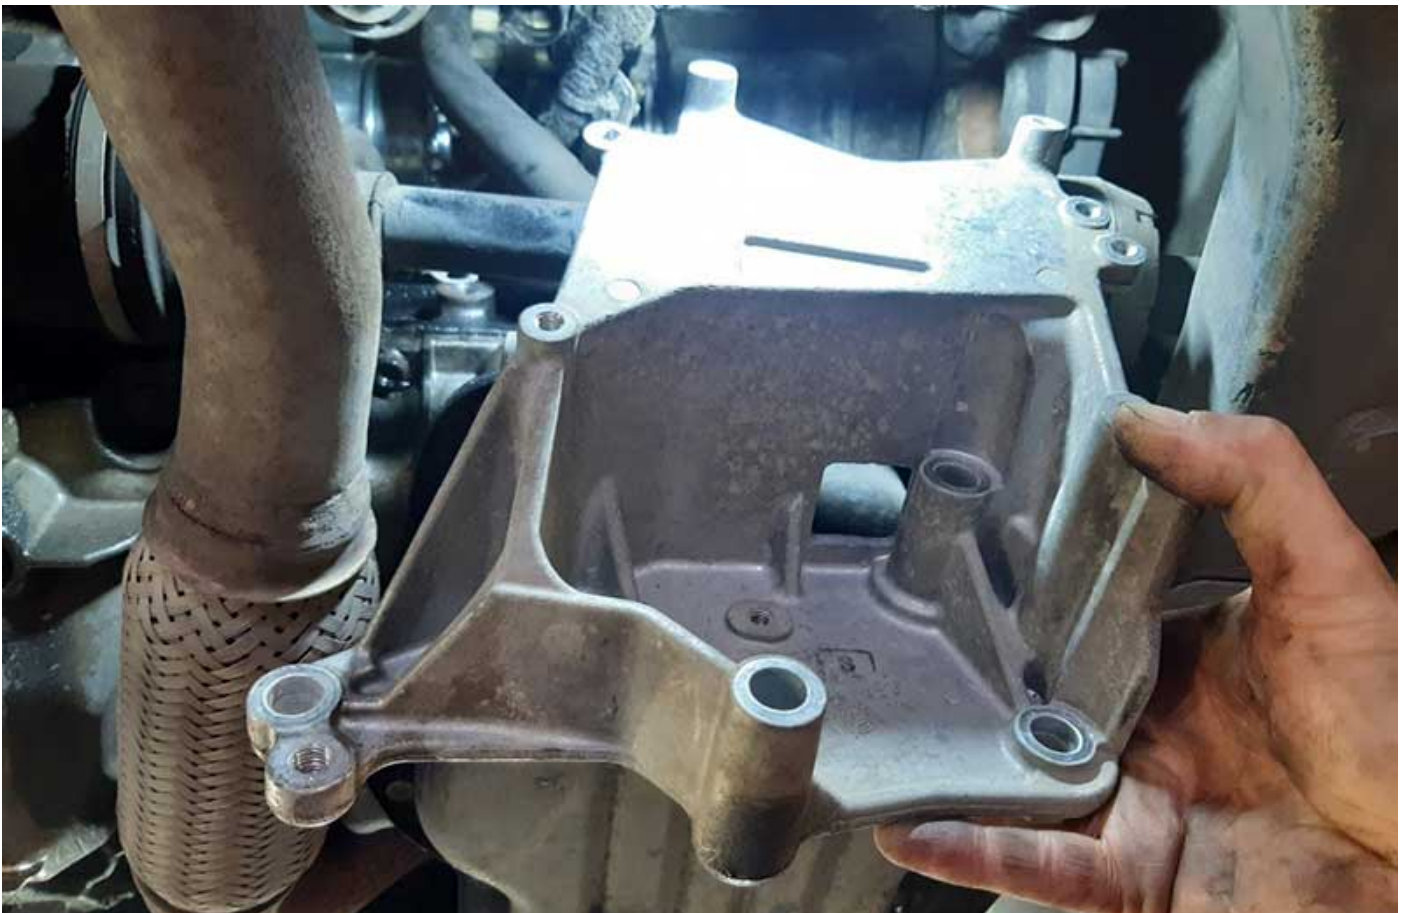
Carrier is to be unscrewed and removed

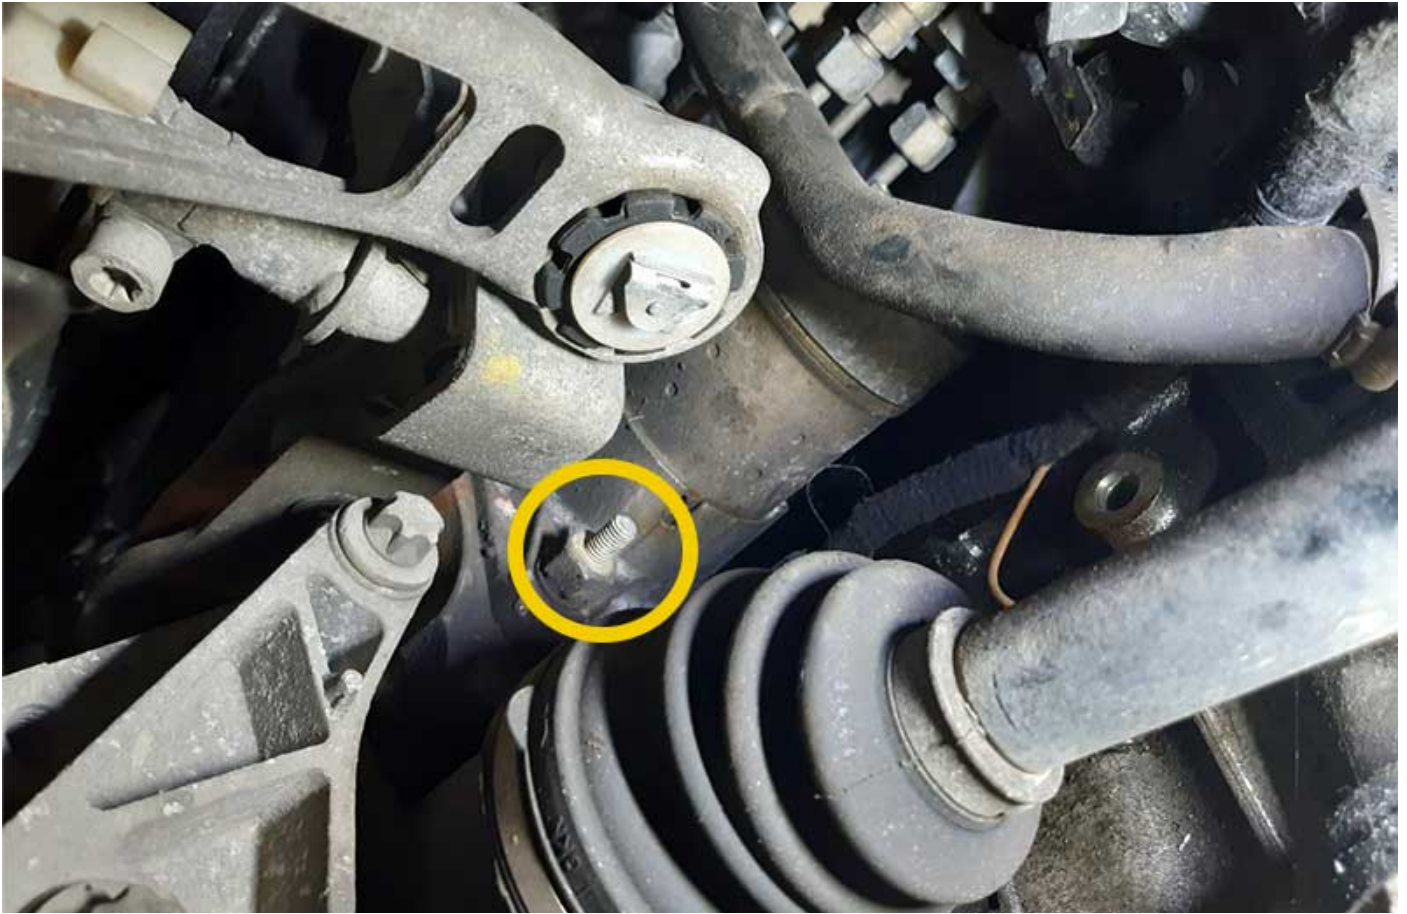
Loosen/remove screw from starter
