## Porsche 911 (991): radiator fan error message

| Symptoms | Error message: "Radiator fan error, avoid full engine load, you may continue driving" |

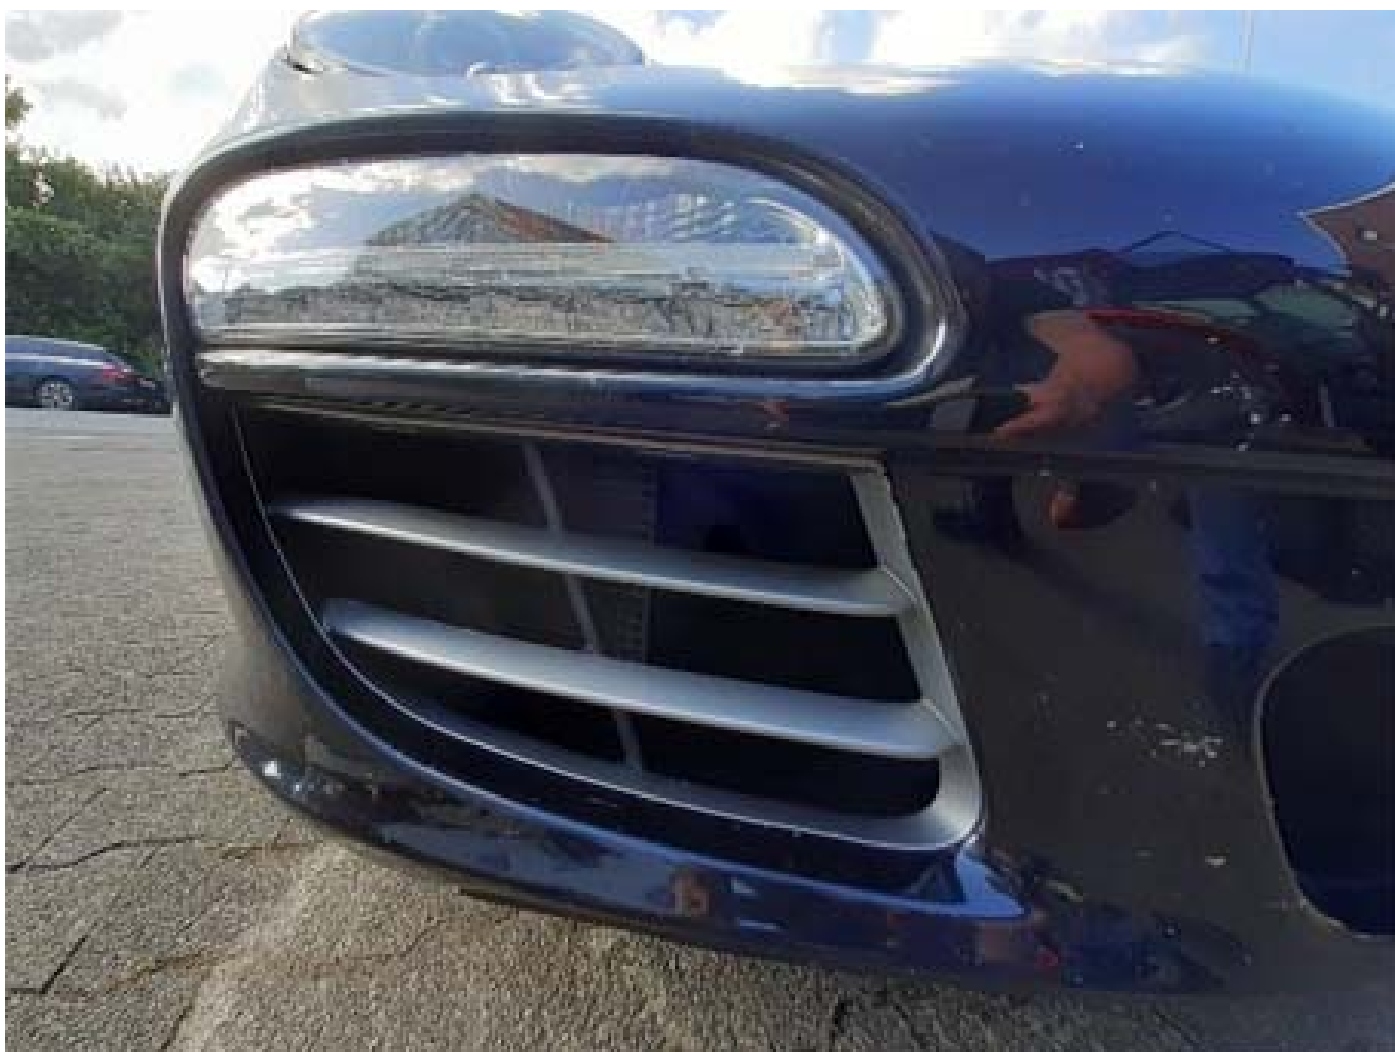
The radiators are located on the left and right behind the air guide grille in the bumper ([Figure 1](#)). The fans themselves can be accessed from the wheel well if the wheel well trim ([Picture 2](#)) is removed first.

Figure 1: The radiators are located on the left and right behind the air guide grille in the bumper.

Check the wiring on both fans as well as the fans themselves for penetrated moisture to resolve the situation. If there is corrosion on the connectors, for example, this is a clear indication of the

cause of the error message. It is then necessary to clean the connections and, if necessary, repair them. The radiator fan may also need to be replaced.

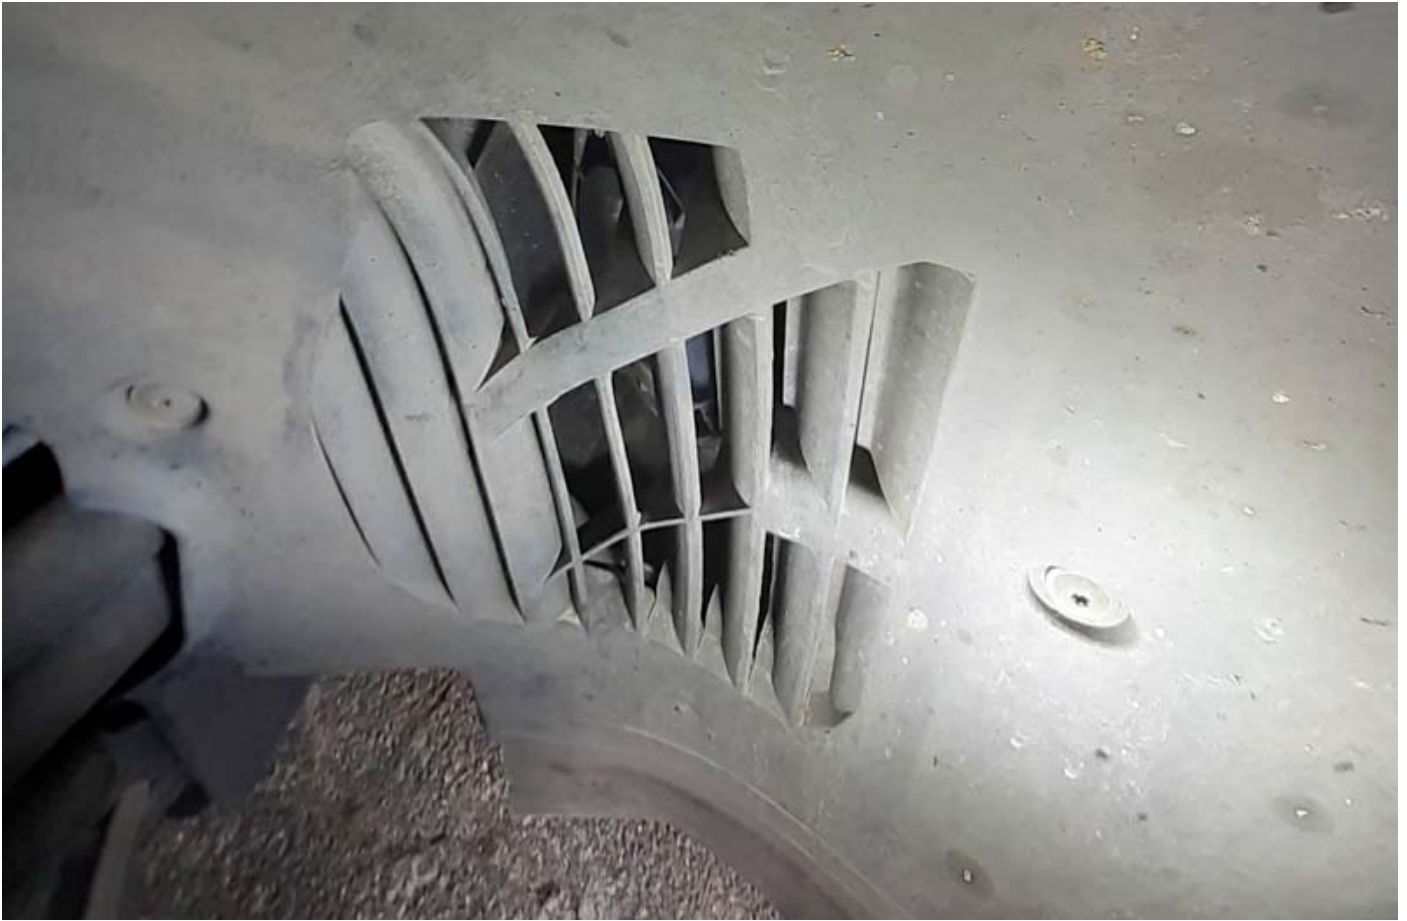
Figure 2: The fans can be accessed from the wheel well if the wheel well trim is removed first.
