# VW Polo 9N - reverse lamps faulty

## Data sheet

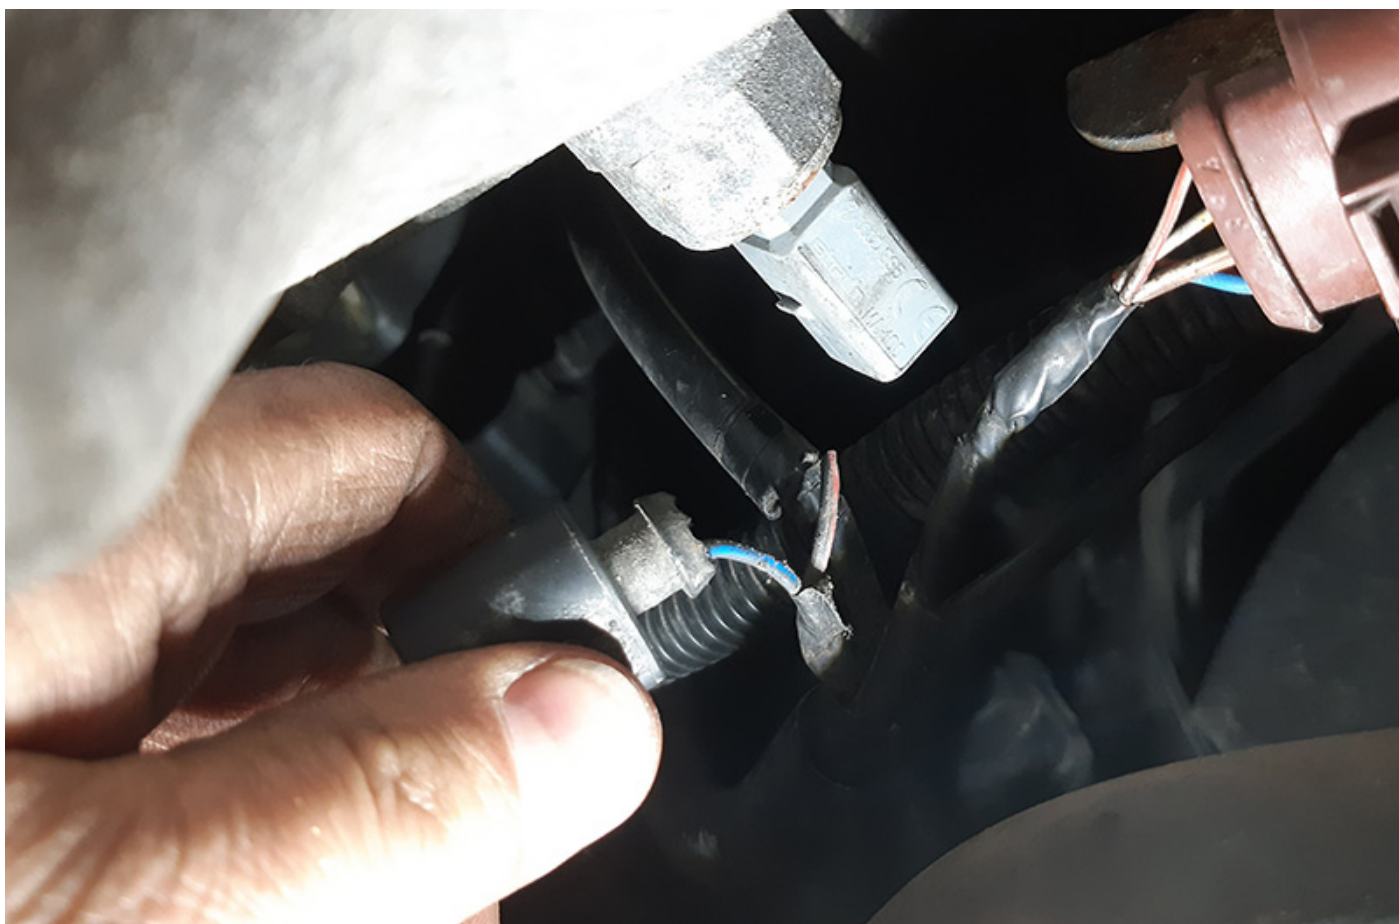
As part of further troubleshooting, the power supply was checked at the pins of the connector on the reversing switch. In this case, there was no voltage. Upon further inspection of the plug, it was established that it was possible to pull out one of the two cables from the connector housing.

Consequently, a cable break inside the connector housing was the cause for the reverse lamp failure. Normal function resumed after having replaced the connector.
