# Verificar a excentricidade lateral do cubo da roda | HELLA

## Testing the wheel hub

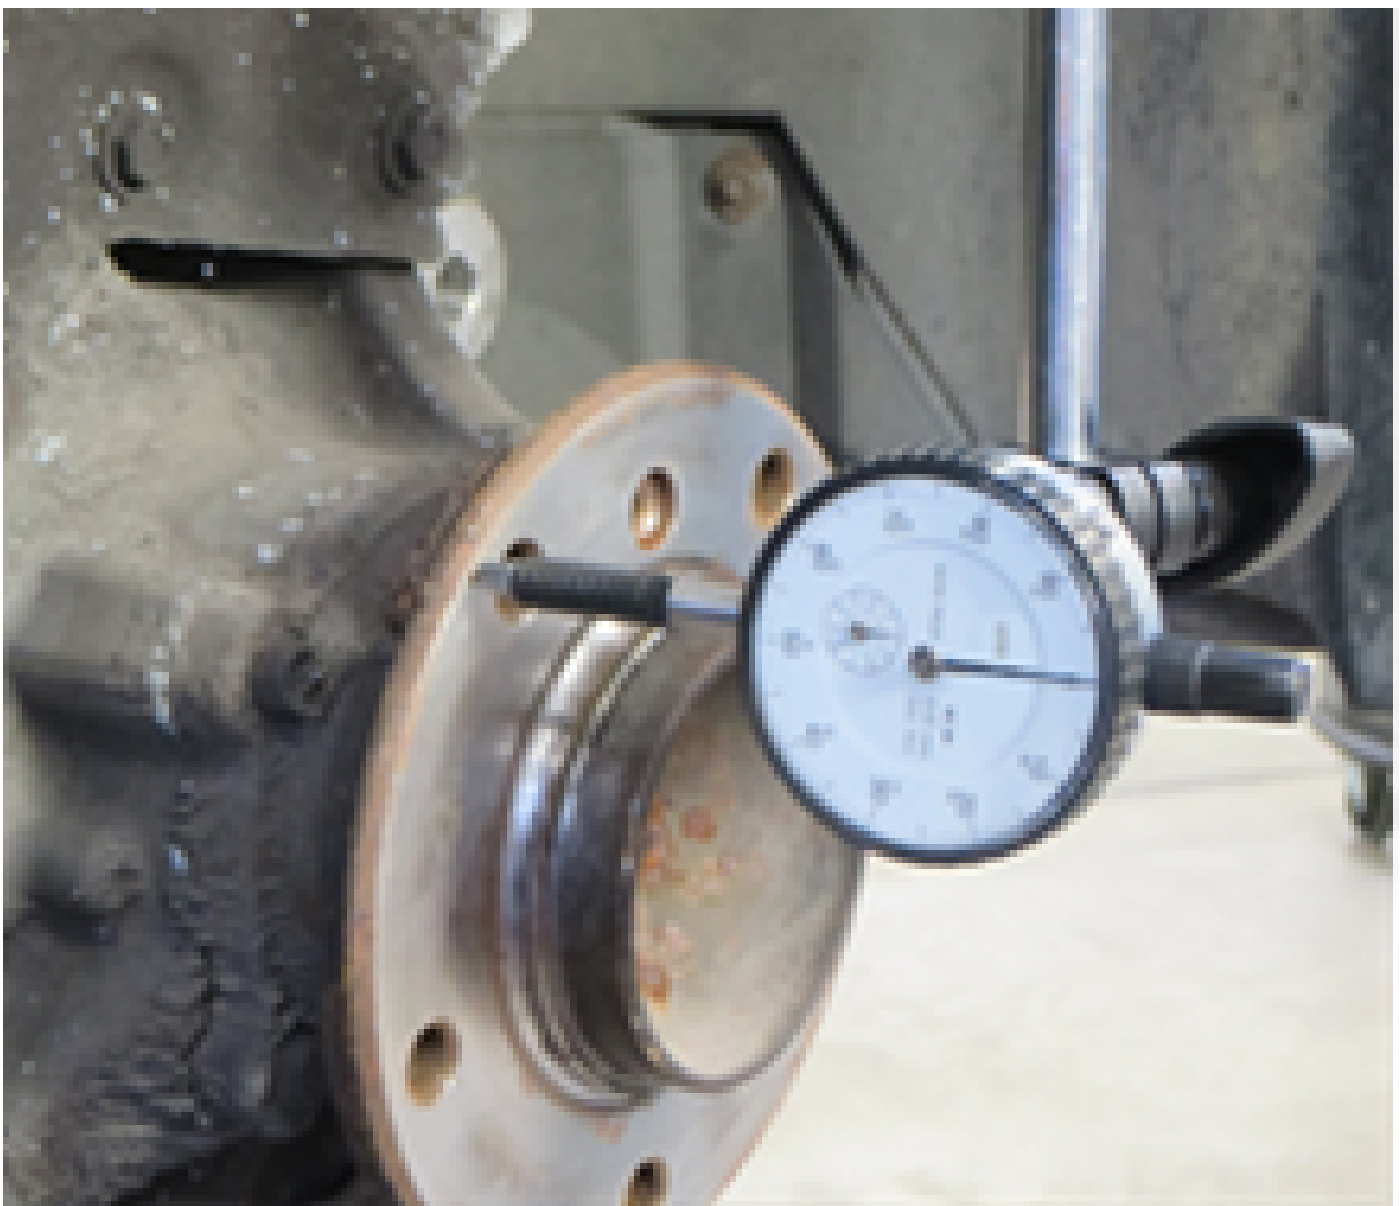
1. Fasten the dial gage with holder to the suspension strut
2. Align the dial gage at the outer edge of the wheel hub
3. Turn the wheel hub slowly and at a constant speed in the direction of travel
4. Read off the measured values

Measured over several wheel revolutions, deviations should not exceed 0.03mm. If the deviations are greater, the hub should be replaced.

- Unevenness on the contact face of the wheel hub can lead to warping of the brake disc and therefore axial runout.
- Any hub runout present will cause twice the disc runout at the outer edge of the brake disc
