# **Fiat Grande Punto - Warning light for electronic stability program (ESP) lights up | HELLA**

**Fiat**

**Grande Punto**

## **Warning light for electronic stability program (ESP) lights up**

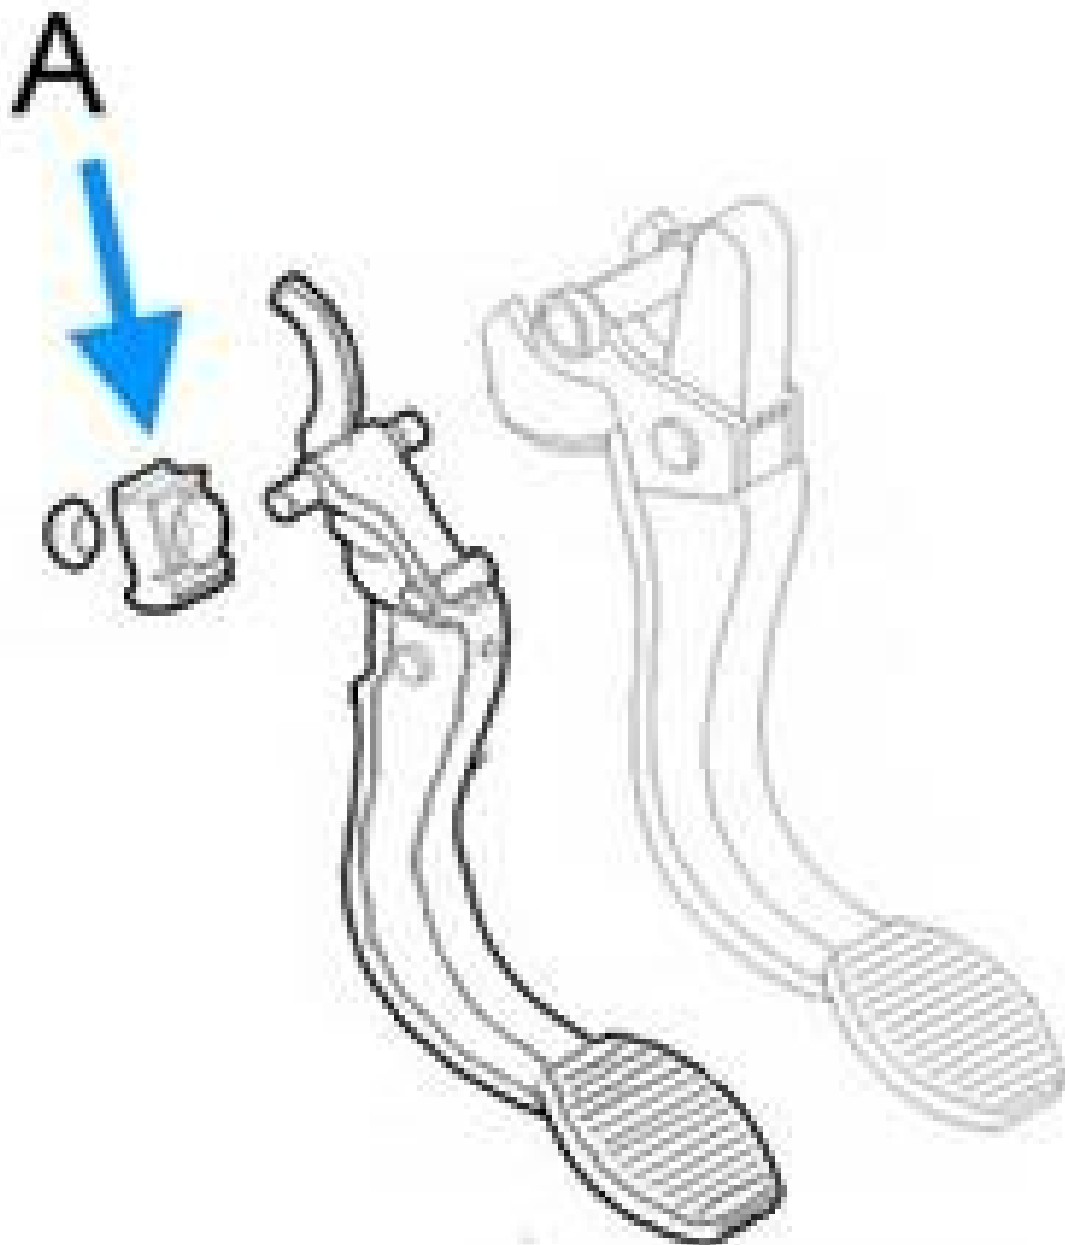
If the above-mentioned defect is discovered in connection with permanently lit-up stop lights, a possible cause responsible for this is a faulty fastening element.

The fastening element fixes the pressure rod for the brake booster on the brake pedal.

Check the fastening element (A) of the pressure rod above the pedals and, if necessary, replace.

Please observe the maintenance and repair notes provided by the vehicle manufacturer in this context.

Fiat - service part number: 46755874
