# Ford All models - With air-conditioning system | HELLA

Spring-lock cable connectors

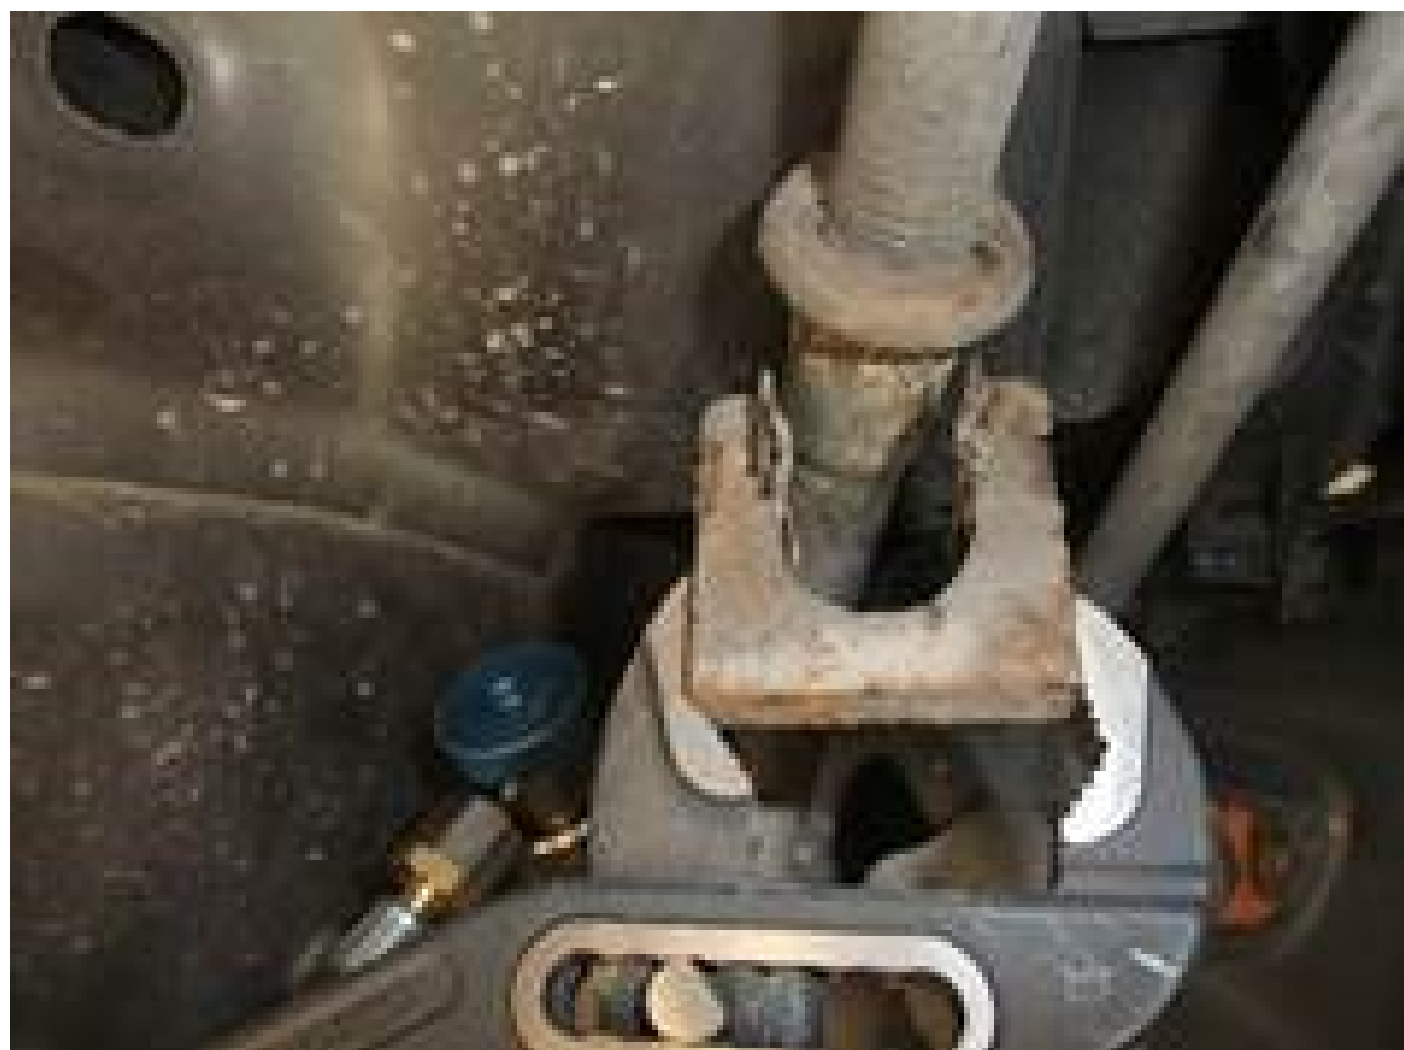
After the retaining clamp has been removed from the spring-lock connector, remove all contamination and corrosion from the line.

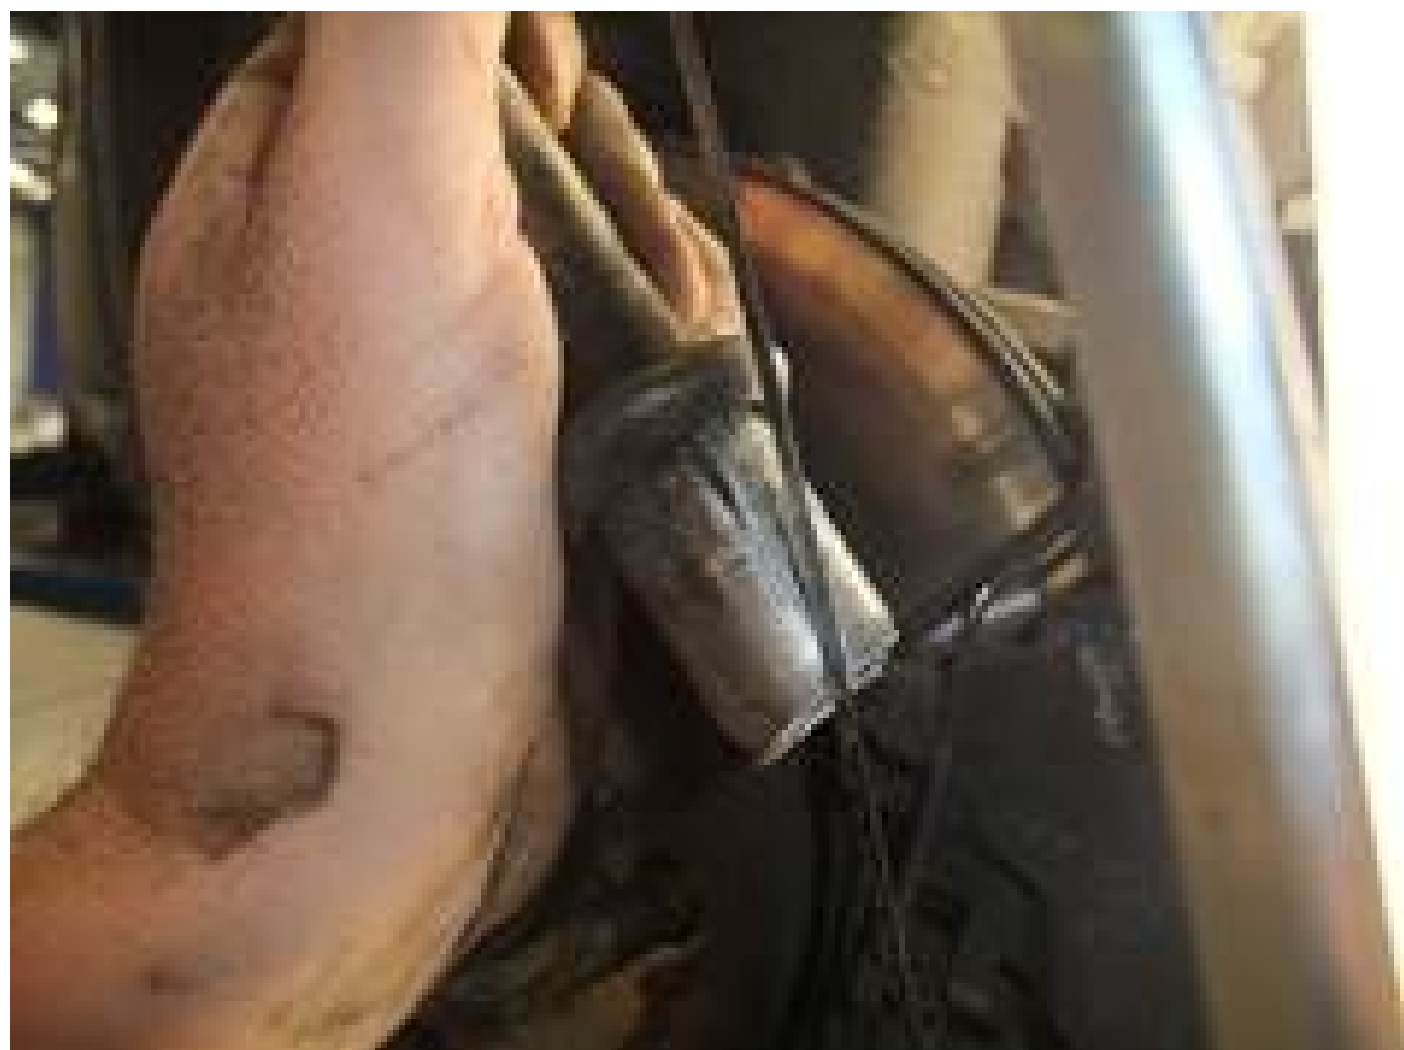
You can now cut off the cleaned line on the accumulator side.

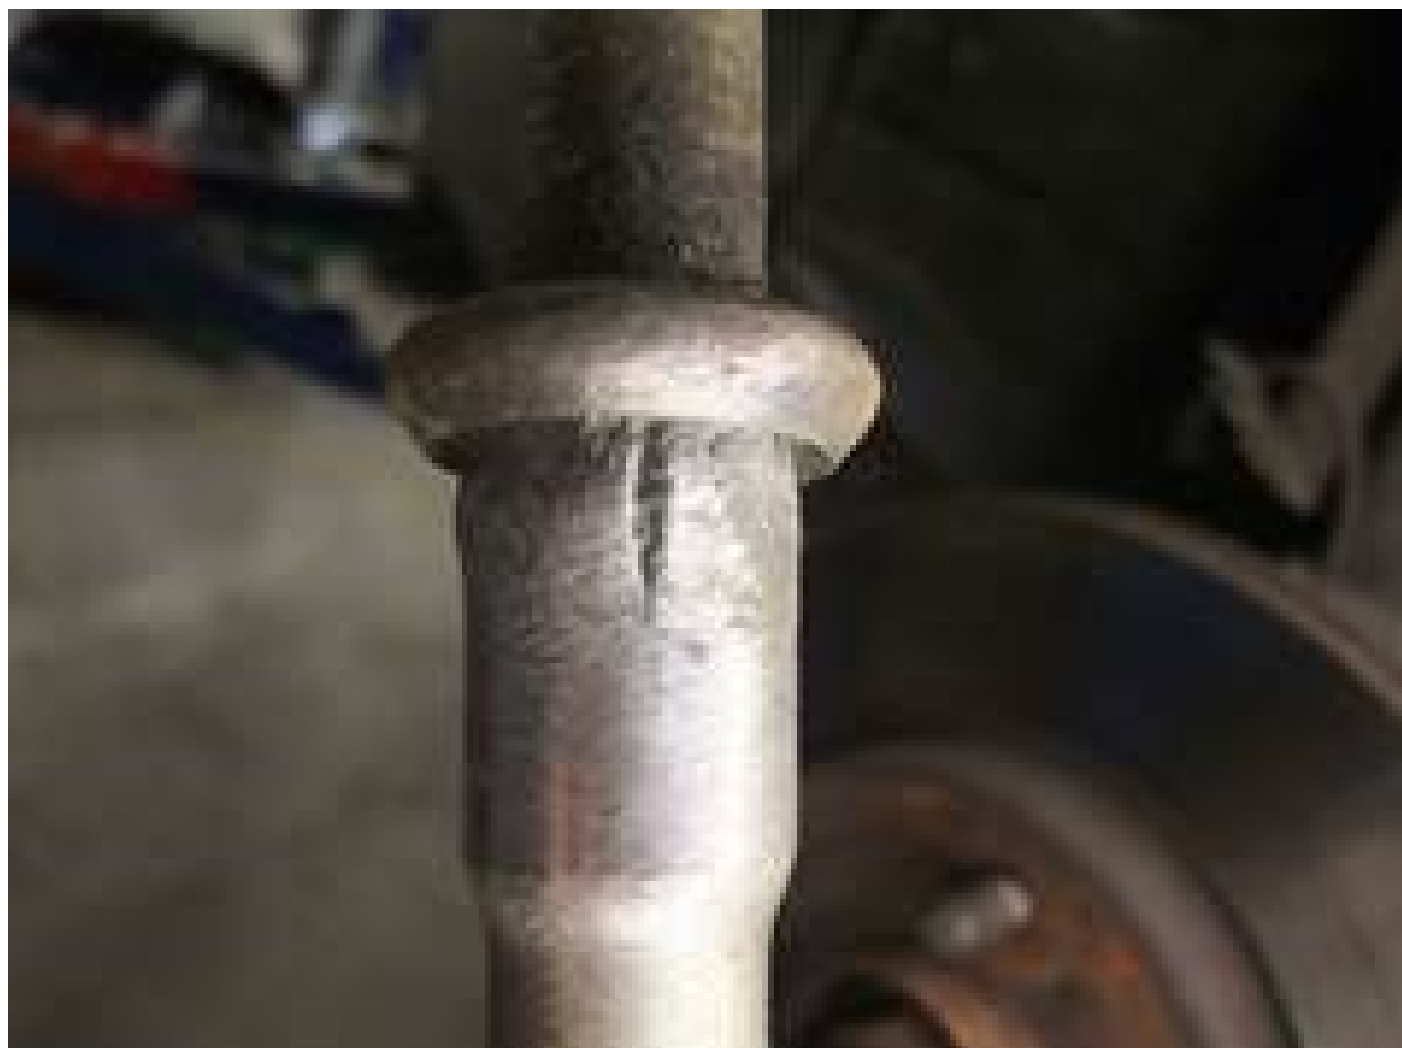
The remaining part of the line is then carefully cut.

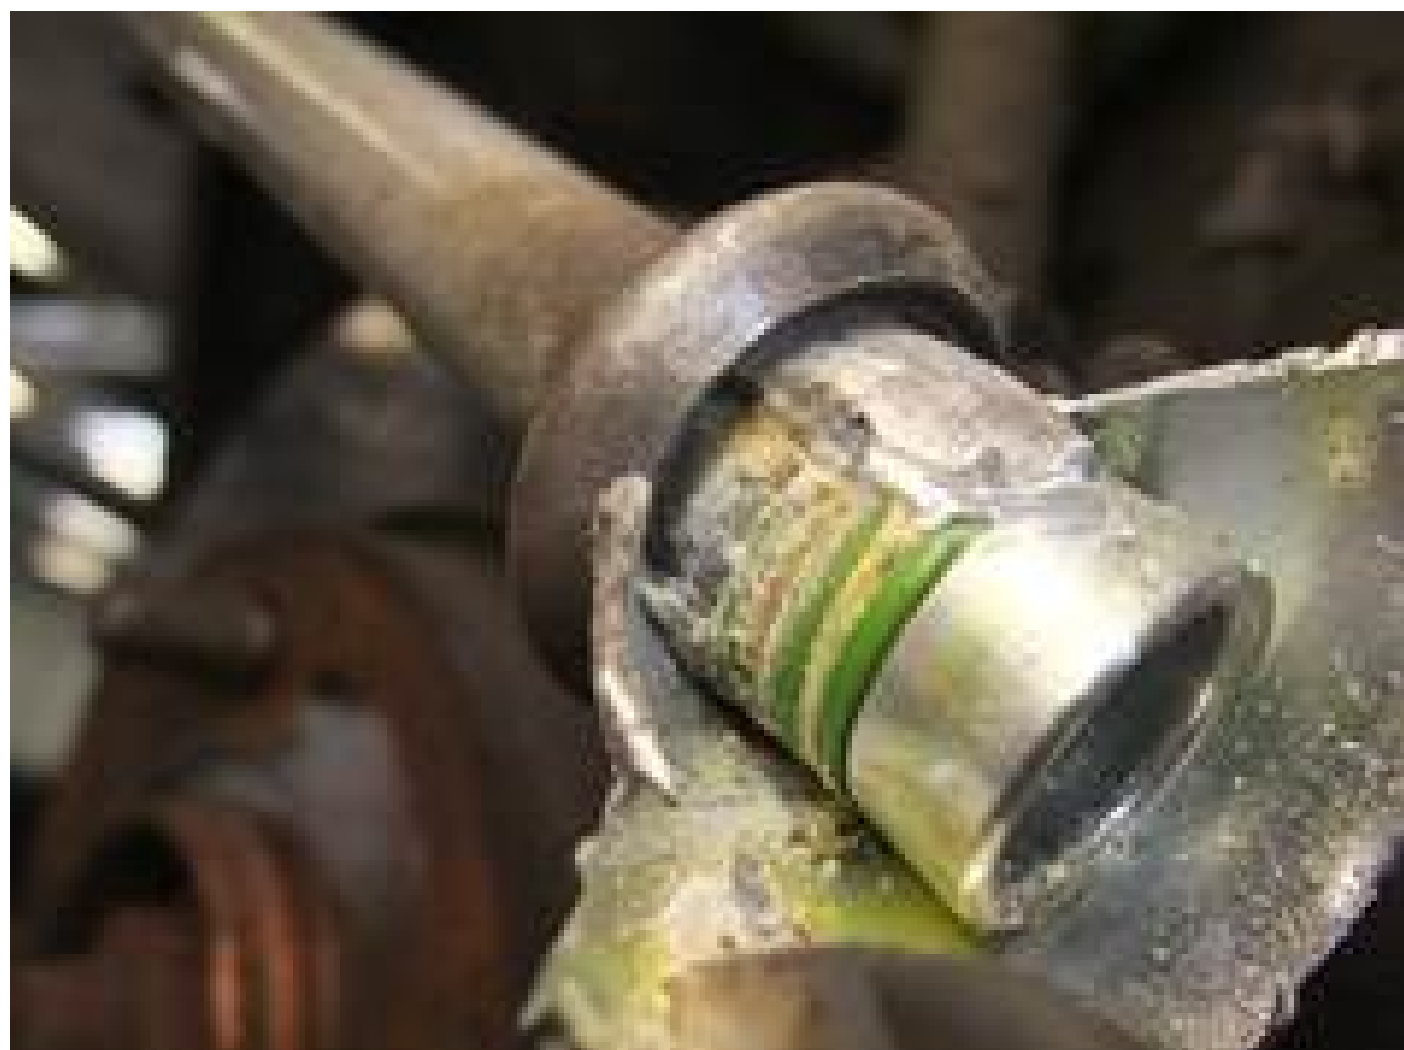
Now slowly bend and remove the remaining part of the line.

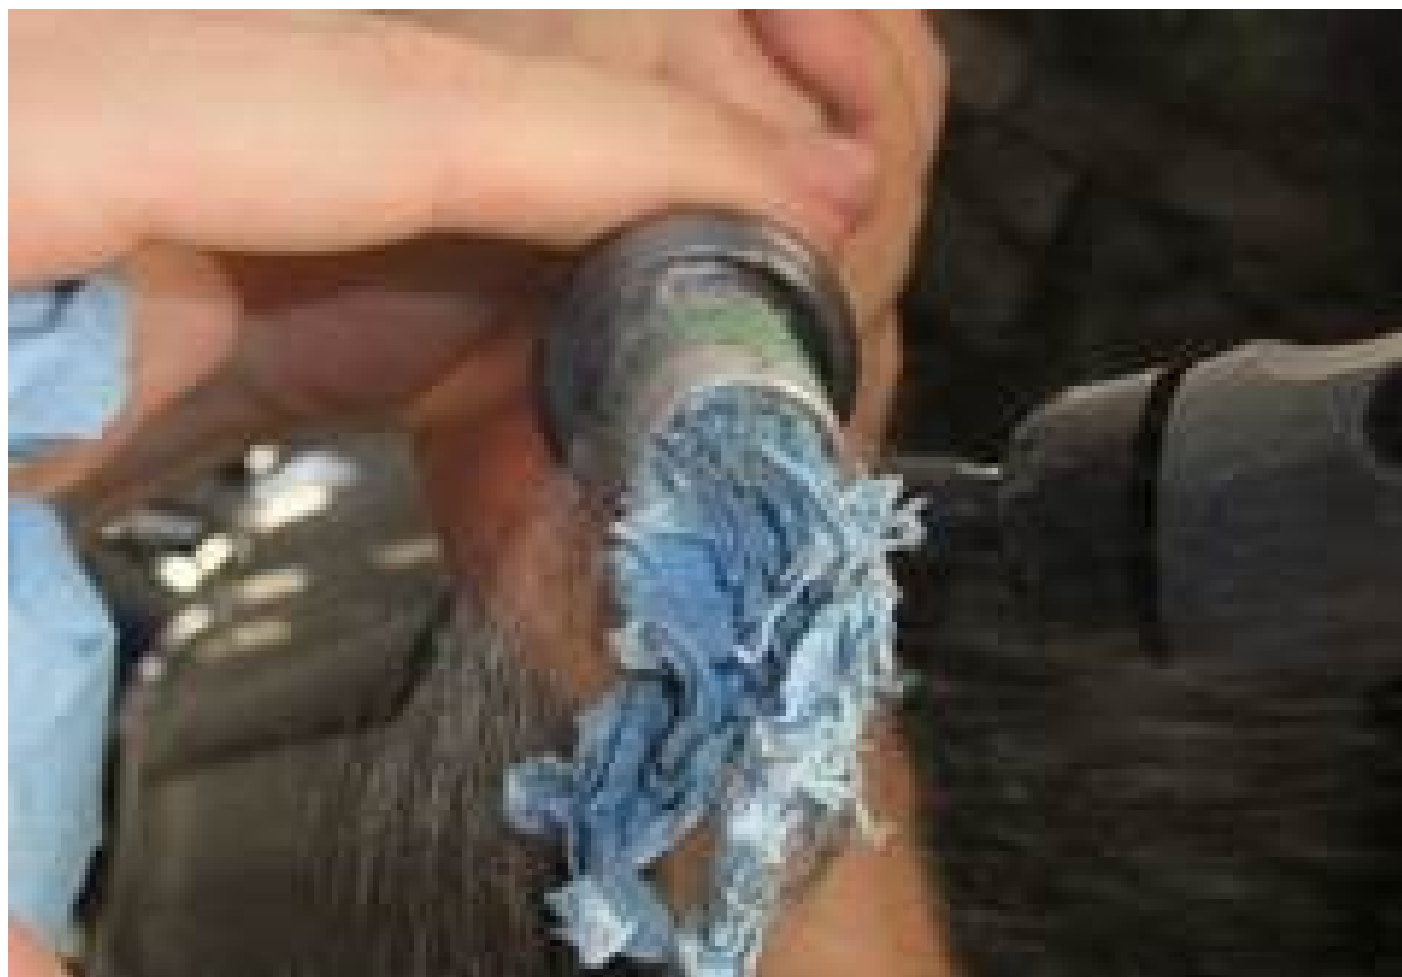
Use a grinder (Dremel) and compressed air to remove the residual contamination. After the spring washer has been replaced and the O-rings have been exchanged and wettened with oil, the new dryer can be fitted. Before you refill the system with refrigerant, a leak test (forming gas/vacuum) must be carried out.
