# Opel Insignia - electronics failure

## Error code U0140 - malfunctions in various electronic systems

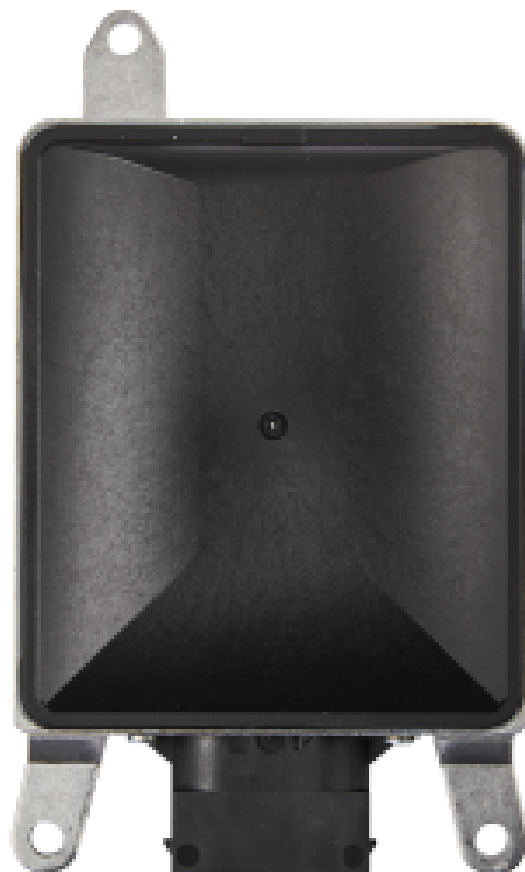
If the above-mentioned fault is present and if no definite faults have been detected in the periphery of the affected systems during the diagnosis, then special attention should be paid to the radar sensor in the bumper to the rear on the left.

As a result of moisture ingress in the radar sensor, interference can be caused on the data bus. This means that error-free communication between the individual control units is no longer possible, resulting in the failure of individual systems.

If the visual inspection reveals signs of corrosion in the plug connection of the radar sensor, then this sensor has to be replaced.

The plug or connector contacts on the vehicle harness must also be checked; if there are also signs of corrosion here, the plug connection has to be repaired and returned to good working order.

After completion of repairs, the system has to be calibrated in accordance with the manufacturer's specifications.
