# Audi TT - Reparation af sideblinklygte | HELLA

## Audi TT

Model year: 2002

### Returning side direction indicator to good working order

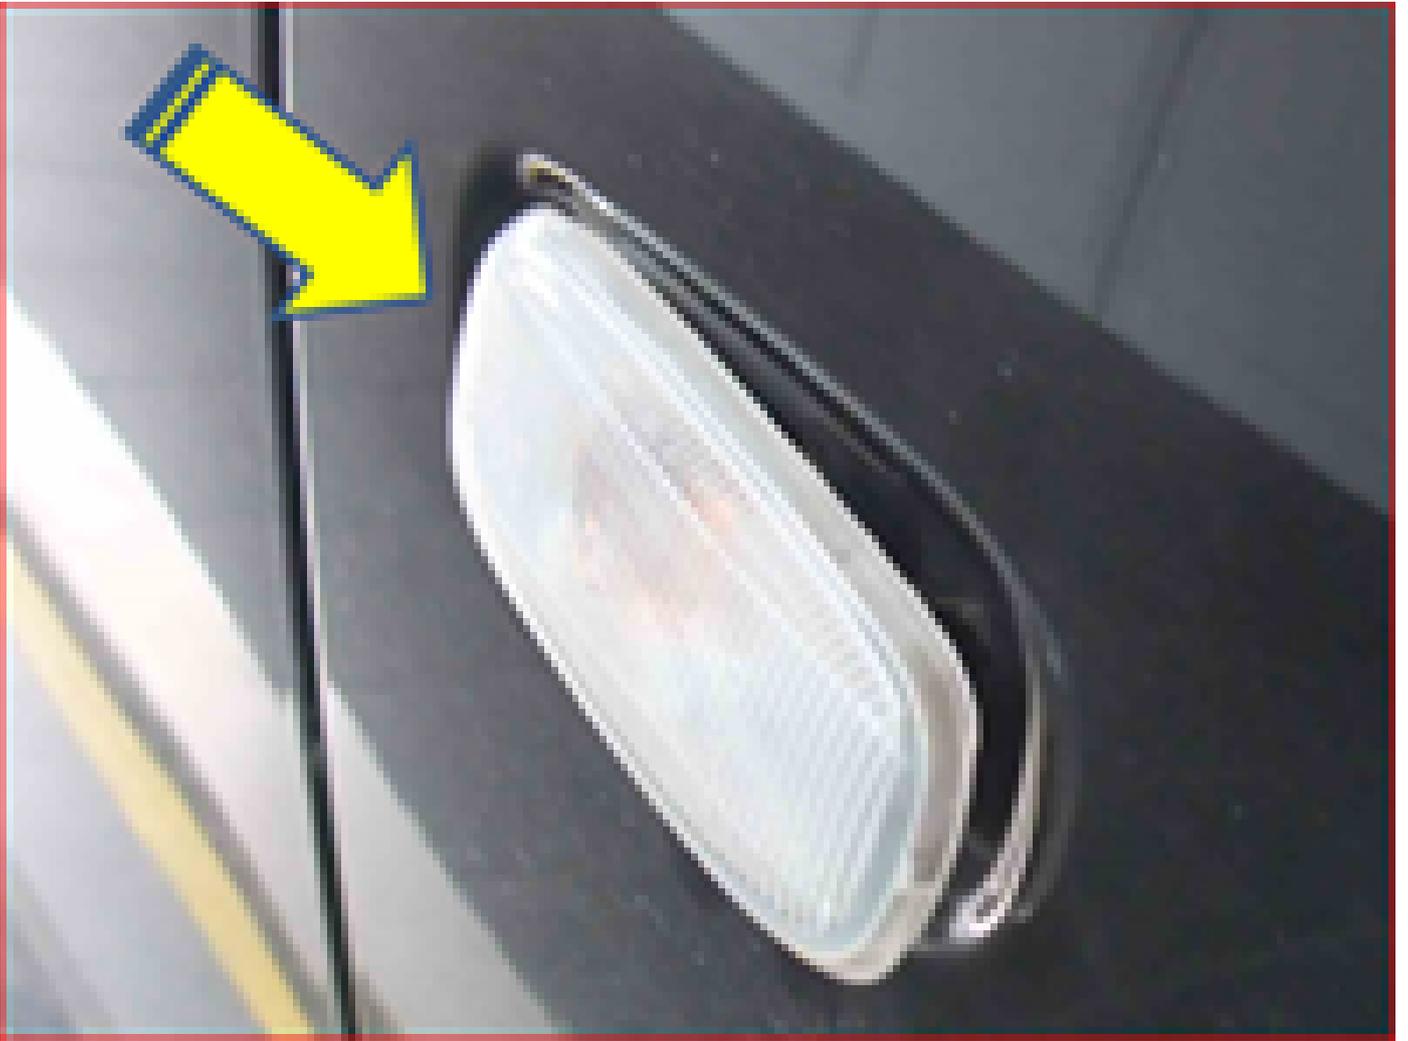
Fig.1

If the above-mentioned vehicle is found to have a defect in the additional side direction indicator (Fig.1) or in the bulb holder, this must be repaired as follows.

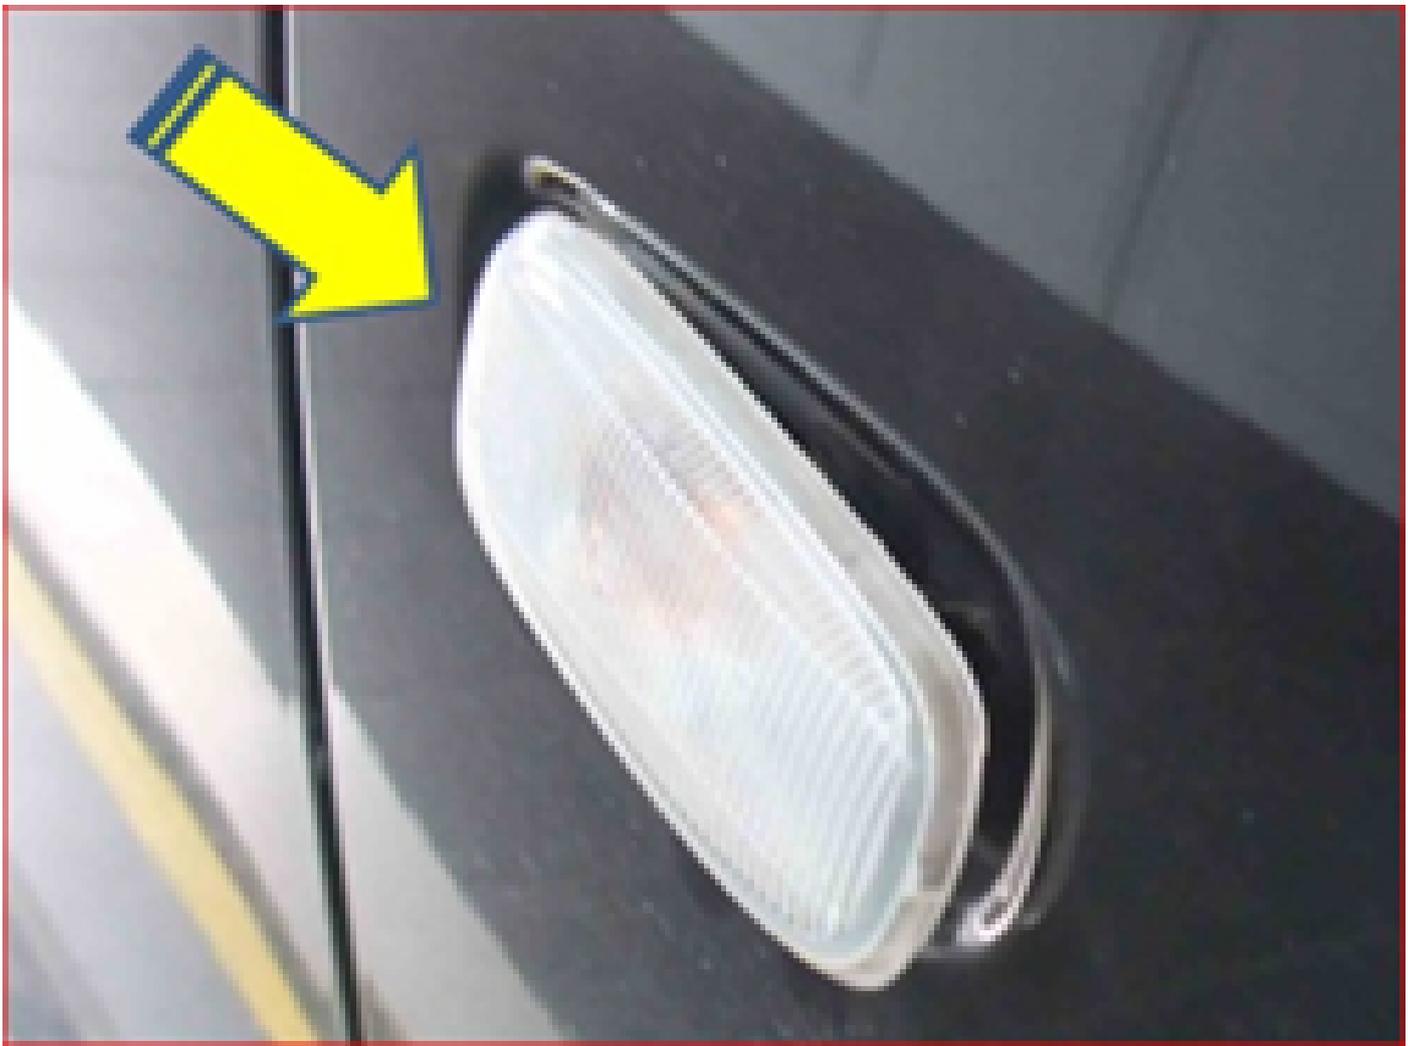
Fig.2

- Switch off the electrical system.
- Press the direction indicator forward against the retaining clip, see arrow direction (Fig.2); and remove it from its opening in the wing.
- Remove the housing from the bulb holder (Fig.3).
- Replace light source if necessary (Fig.3).
- Carry out performance check (Fig.4).
- Then remount the parts in reverse order.

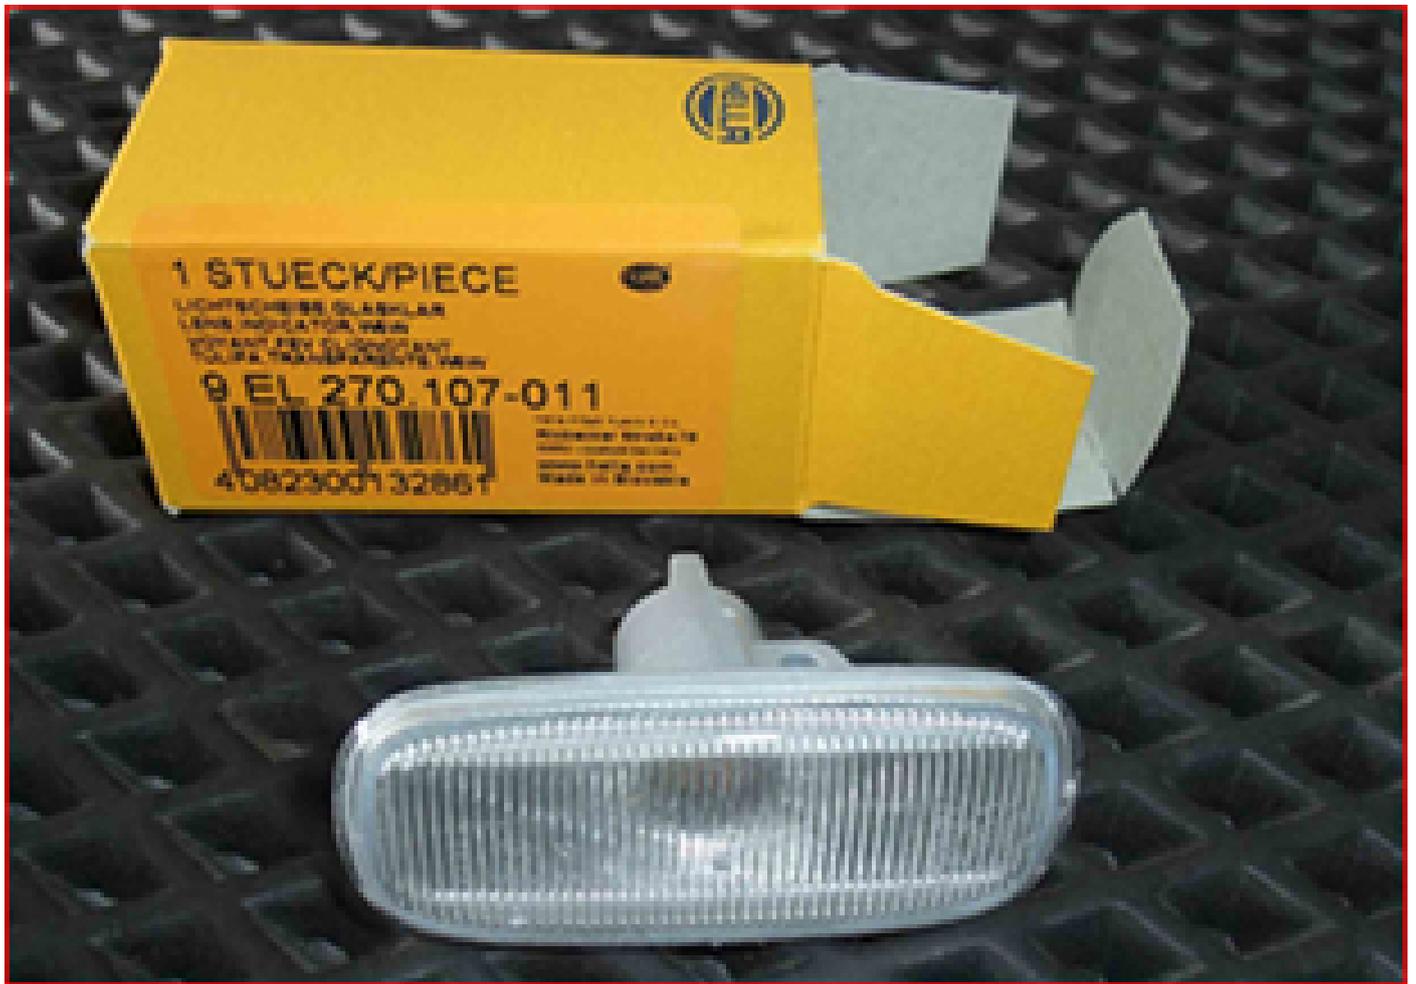
Bulb

WY5W = 8GP 003 594-541

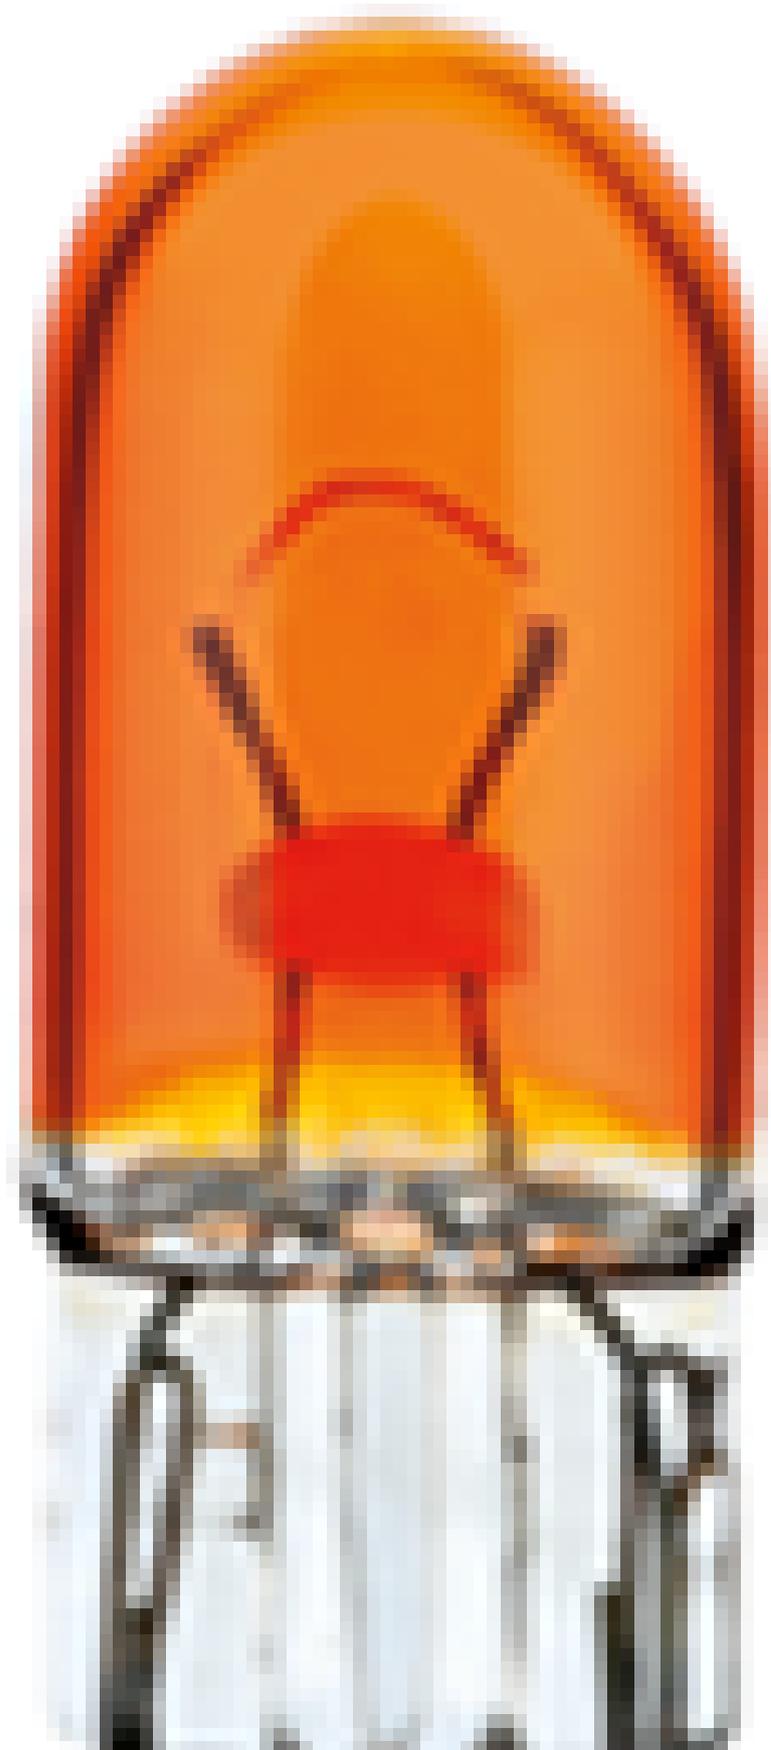
Direction indicator

9EL 270 107-011
