BMW i3 (I01) - Støj fra dørene | HELLA

i3 (I01)

Model year: 2013

Noises in the area of the doors

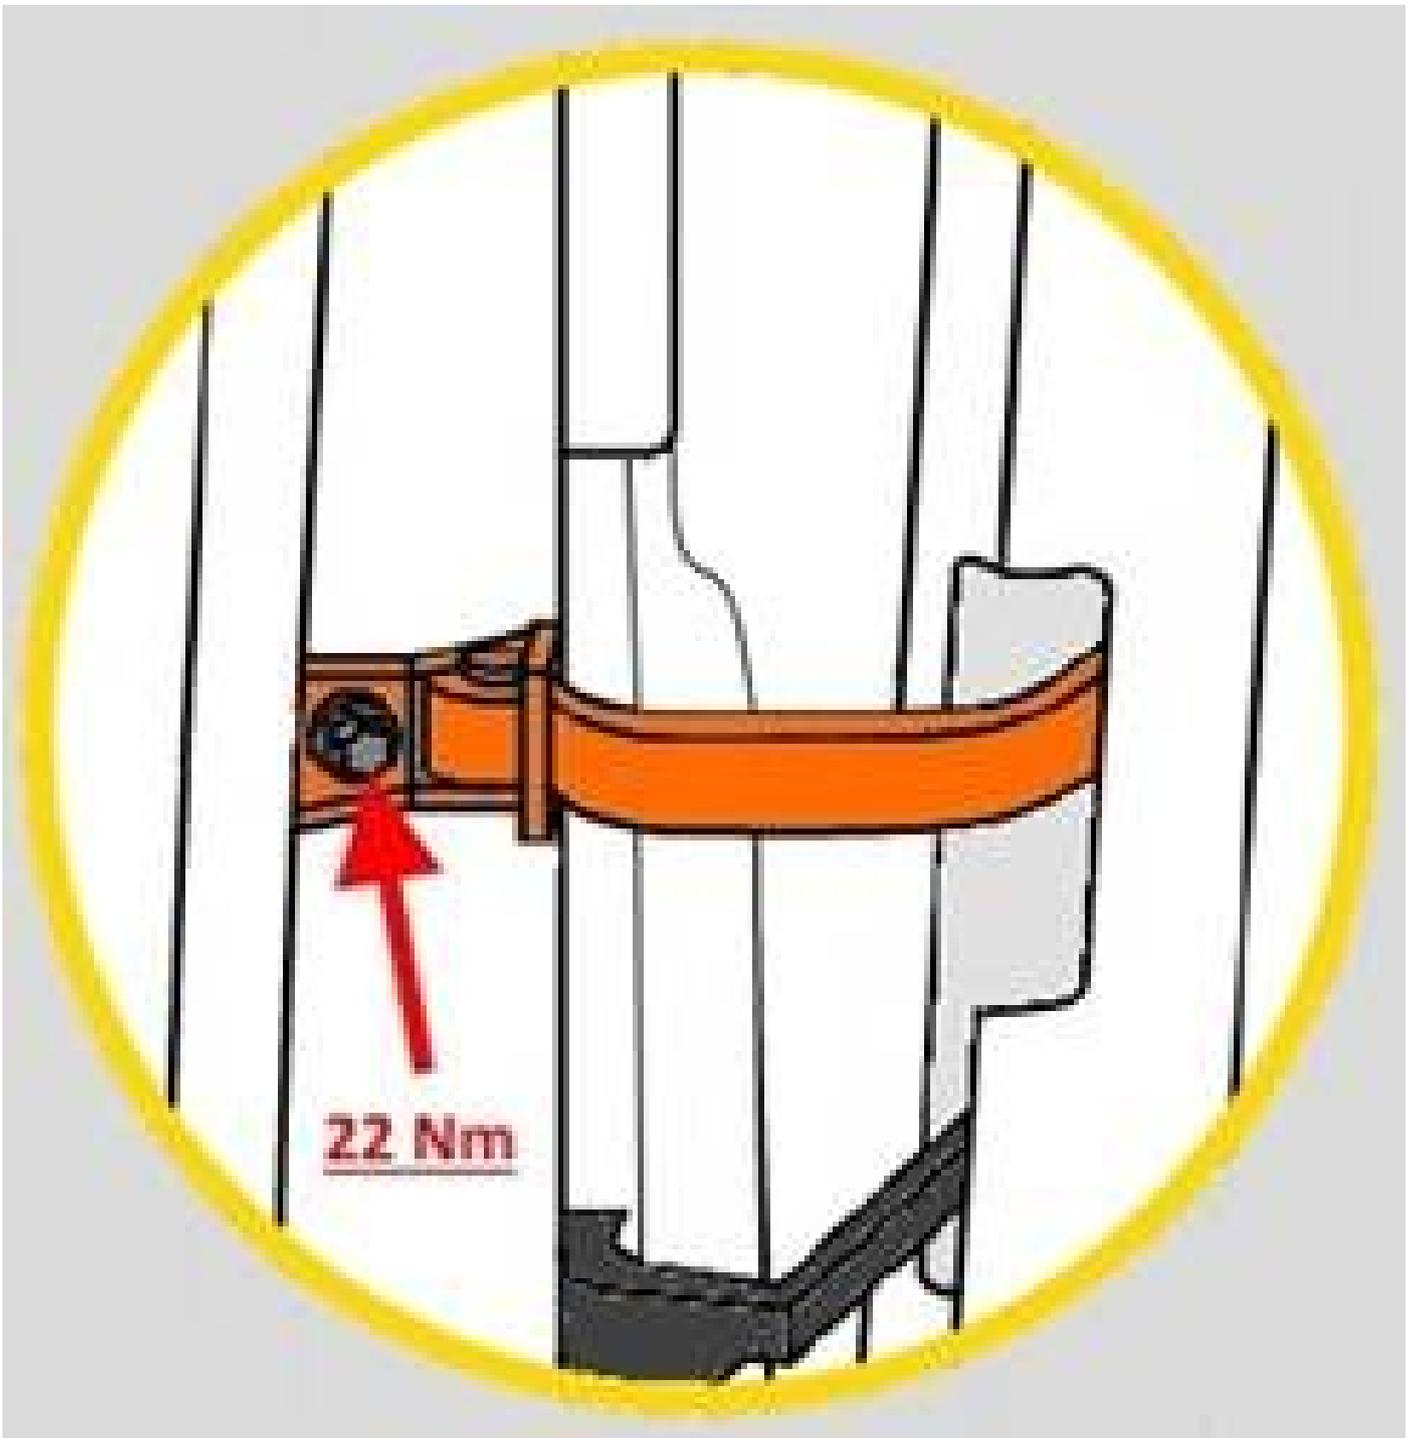
A closer look at the door mechanism revealed that the fastening screw of the door check strap had come loose.

-Fixing screw (ASA M8x22) OE No. 07147248803

- Disassemble the fixing screw
- Check the mounting hole and the screw for damage (thread, etc.) and repair or replace if necessary
- Tighten the fixing screw to torque as specified by the vehicle manufacturer (22Nm) (see picture)
- Repeat this procedure for all doors
