Chevrolet Cruze - Ekspansionsbeholder / Tab af kølevæske | HELLA

Expansion tank/Loss of coolant

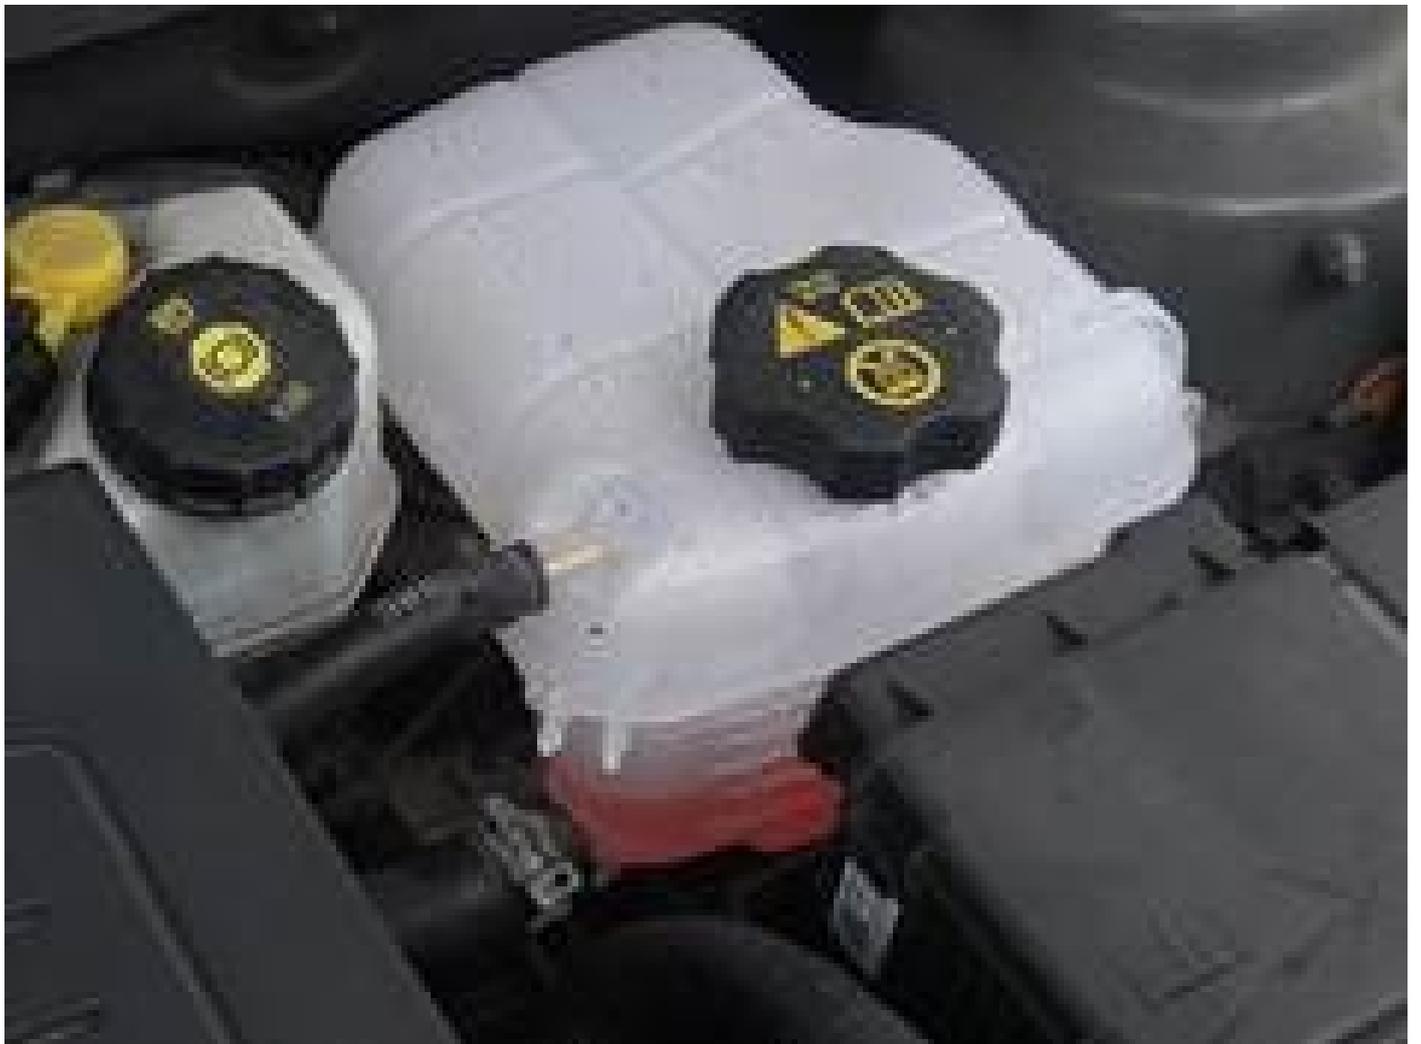
Due to cracks in the expansion tank return nozzle, a loss of coolant may be experienced in the above vehicles.

These cracks are caused by thermal loads and may lead to a loss of coolant. If the engine temperature increases as a result of this, acoustic and visual signals will be issued accordingly by the instrument cluster. If necessary, the engine will switch to "emergency running."

In order to remedy the problem, the expansion tank should be checked and, if necessary, replaced.
