Hyundai IX 35 - Motoren kan ikke starte | HELLA

IX 35

Model year: 03/2011

Engine will not start

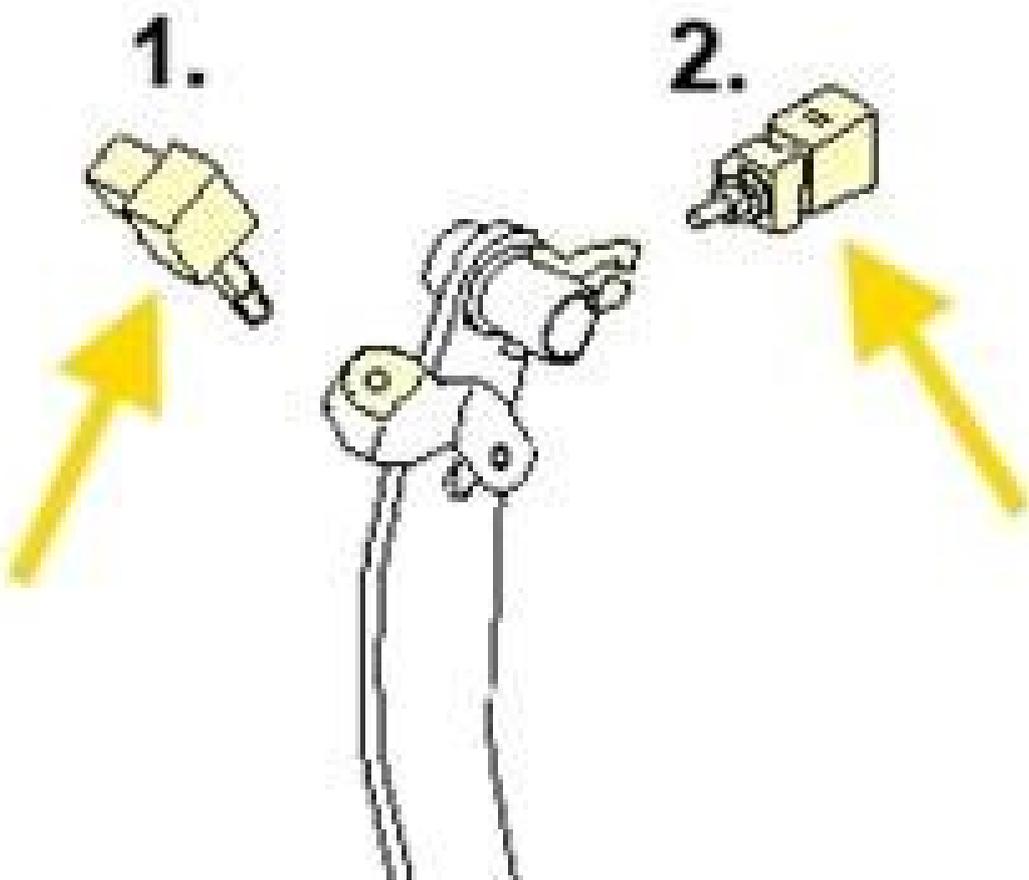
Fig. 3

The switch is located on the clutch pedal (figure 3)

Replace faulty switches.

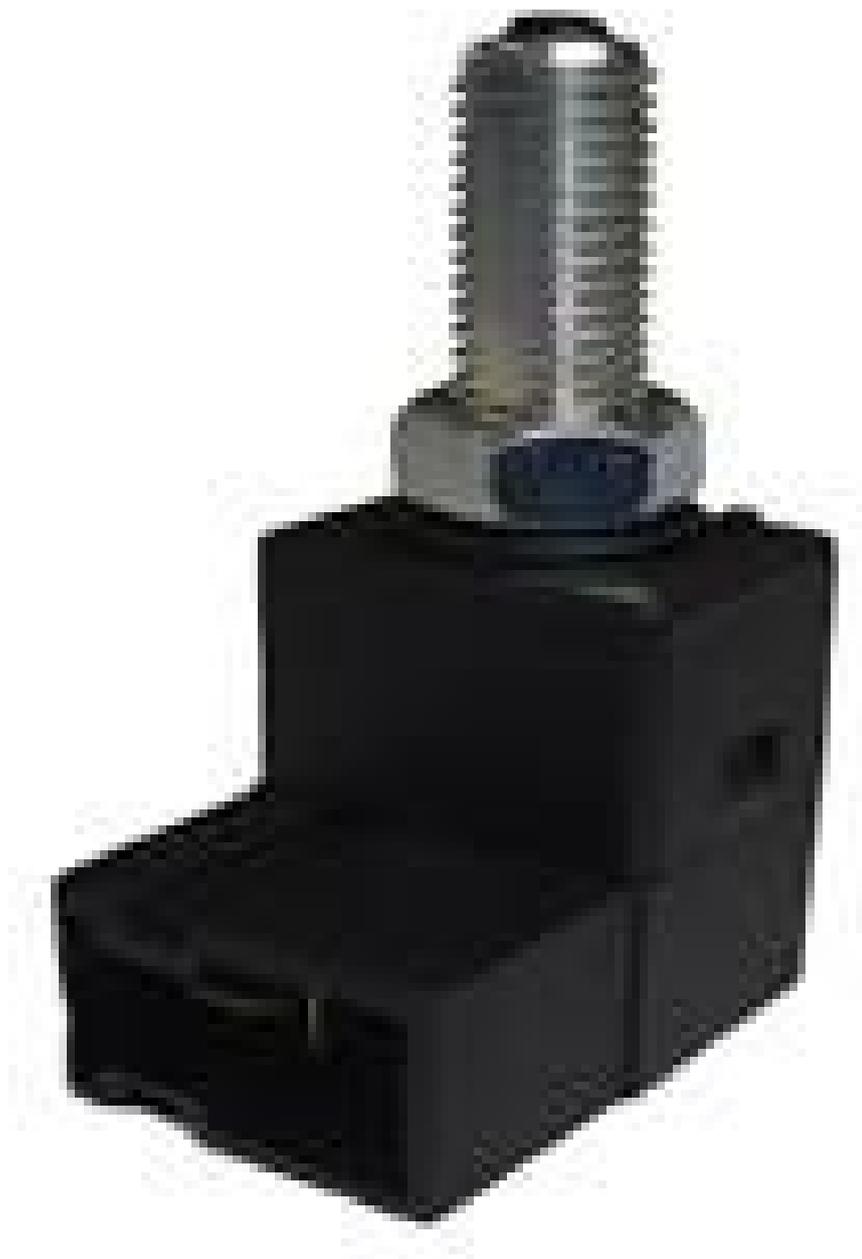
Fig. 1

The switches (Switch Assy-Ignition Lock, figure 1+2) prevent the engine from starting if the clutch pedal is not actuated or is partially actuated.
