Opel Ampera - Batteriladeklappen kan ikke åbnes | HELLA

Ampera

Model year: 2012 - 2013

Battery charger door cannot be opened

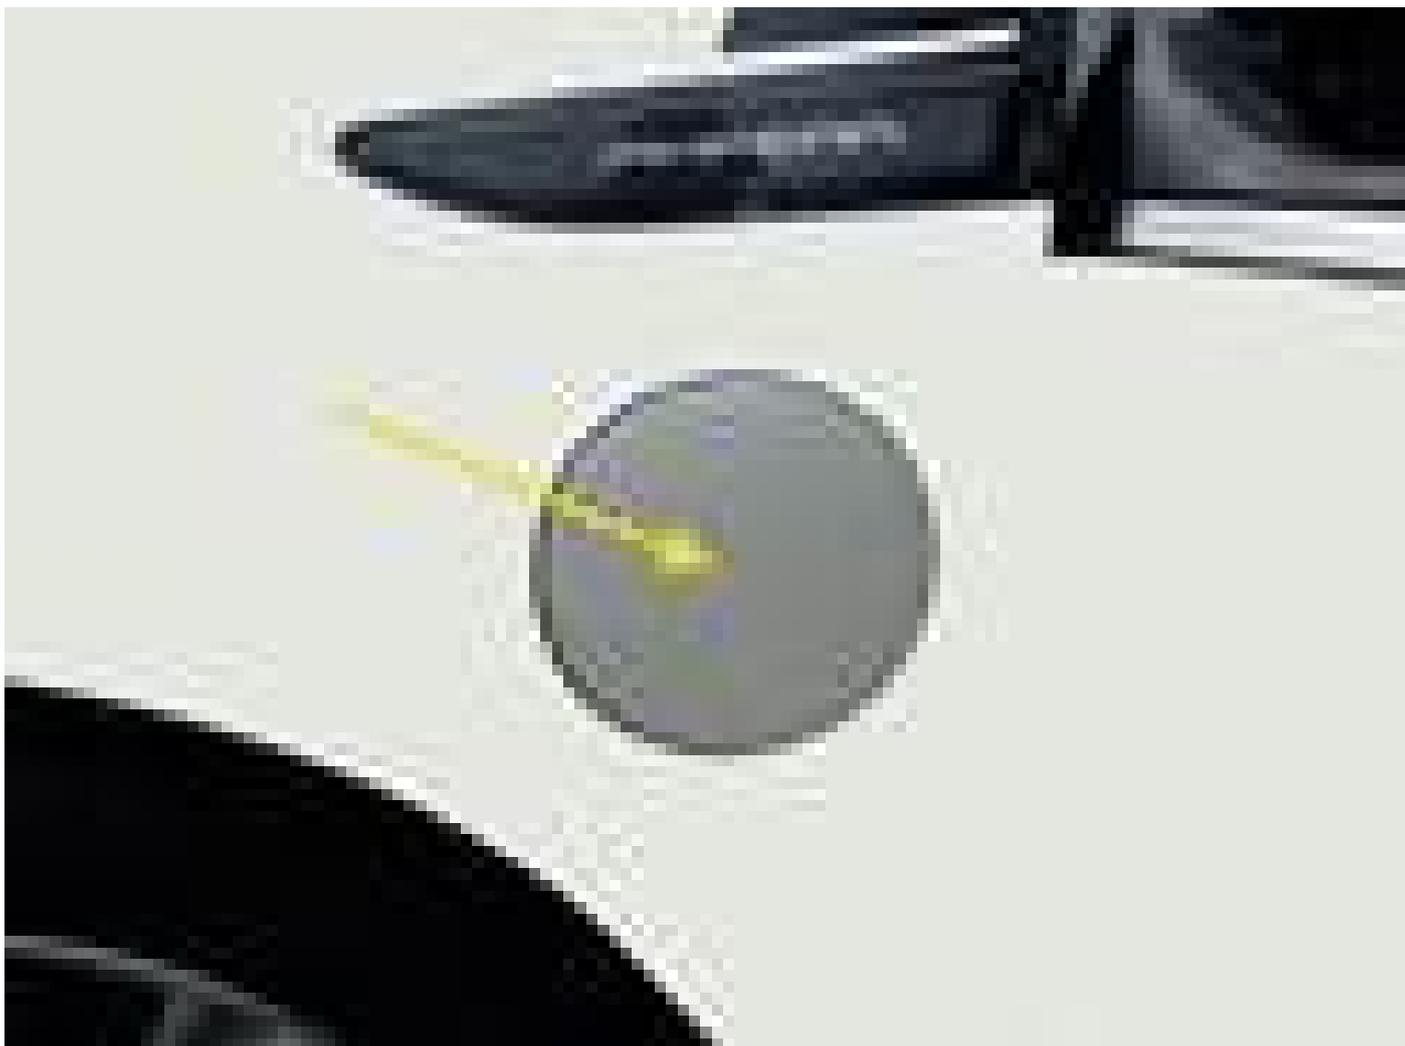
Figure 1

There have been complaints that the battery charger door (figure 1) of the vehicles specified above cannot be opened.

The malfunction indicator lamp may light up and the error code DTC P0CD2 (battery charger door not open) may be set in the electronic control unit.

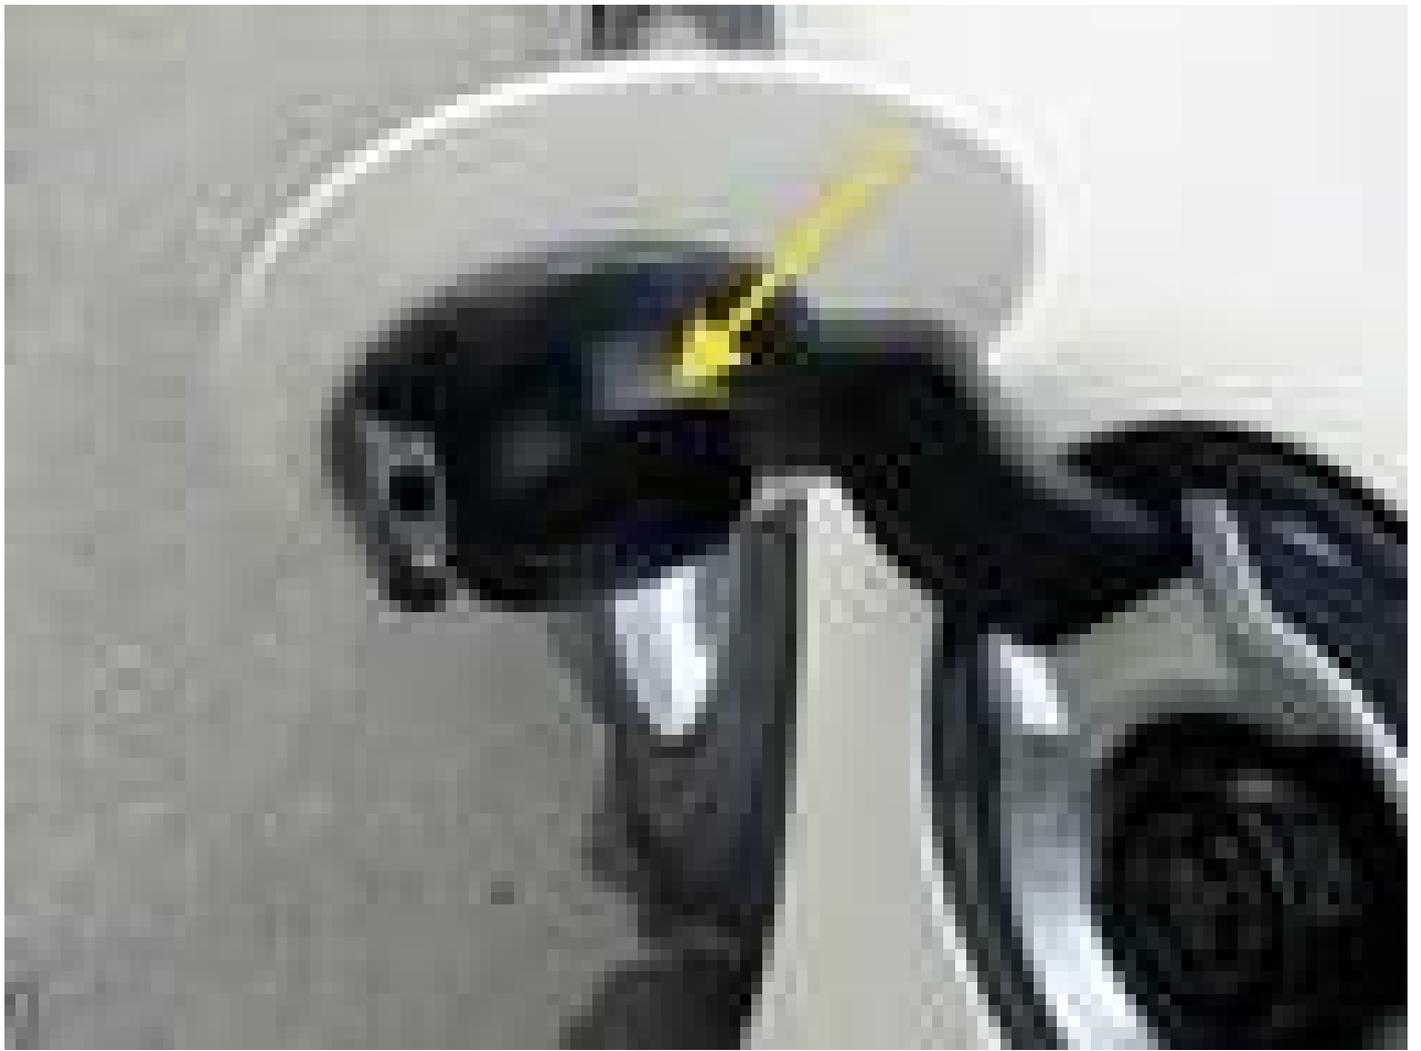
Figure 2

The cause for the issue mentioned above may be the rubber seal (figure 2) of the battery charger door.

The rubber seal (figure 2) may jam in the opening (figure 3) or freeze at low temperatures.

- Carefully open the door with a plastic wedge (figure 4).
- Apply special oil (vehicle manufacturer article number 93165293) to the outside and inside (as indicated, figure 5) of the rubber seal.
