Opel Meriva B - Fejlkode P0128 - Termostat | HELLA

Meriva B

Error code P0128 - Thermostat

Air-conditioning system switches off automatically

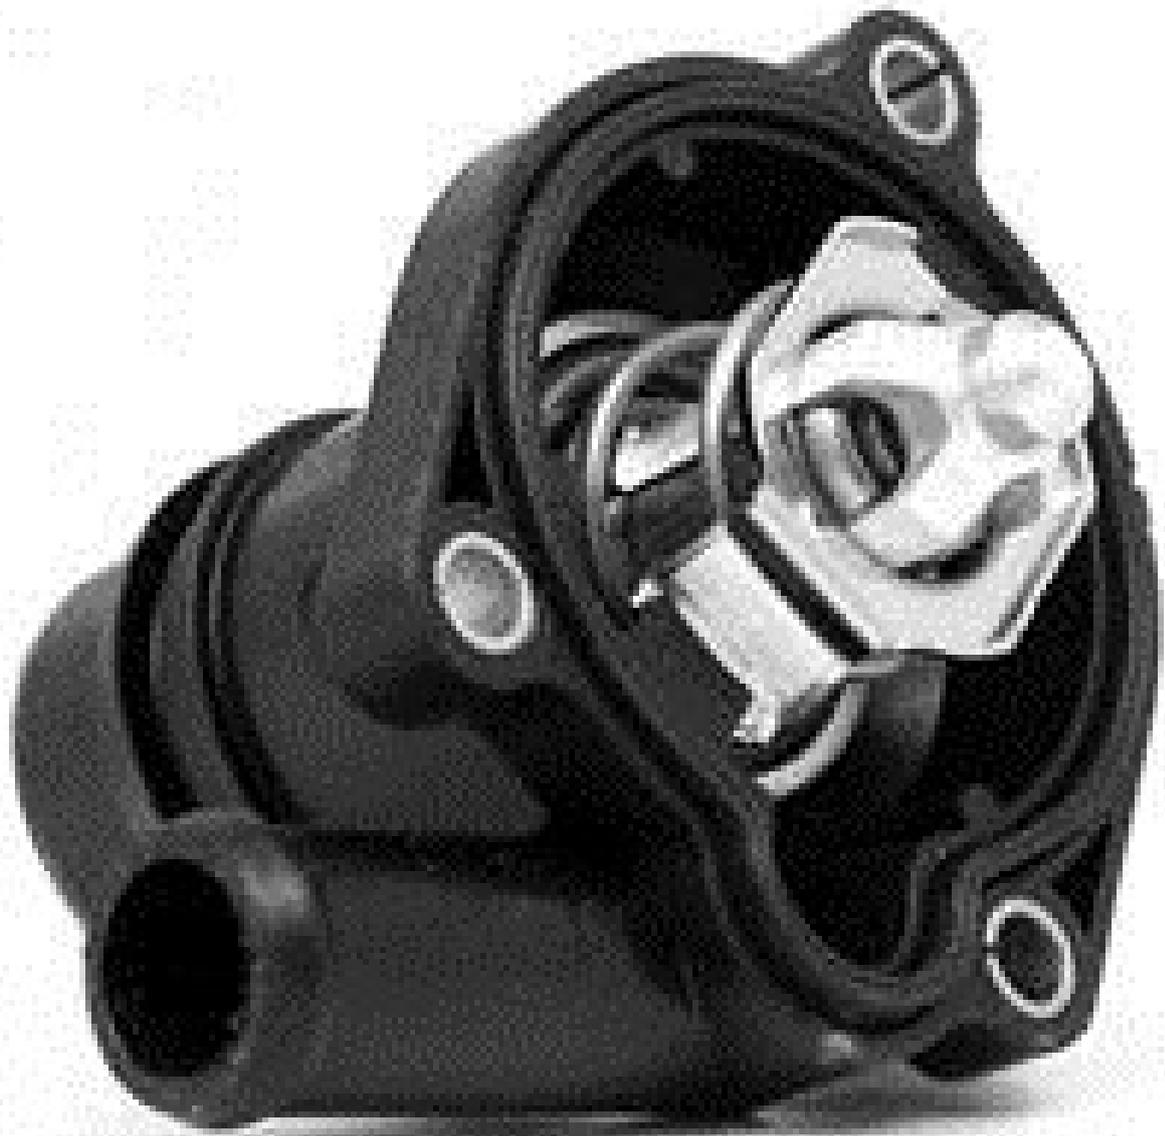
The vehicles mentioned above may experience a failure of the air-conditioning system due to a defective coolant thermostat.

When the motor is switched off and is still warm from operation, the coolant temperature increases (to 130°C).

As a result, the thermostat opens "up to the limit stop" and can get stuck in this position. The on-board electronics system interprets this as an error and switches off the air-conditioning system. The error code P0128 (coolant thermostat) is then stored in the error memory.

In order to remedy this situation, the thermostat (see figure) should be replaced and the error memory cleared.
