Volvo V60 (155/157) - Servicetilslutning til klimaanlæg | HELLA

V60 (155/157)

Service connection of the air conditioning system

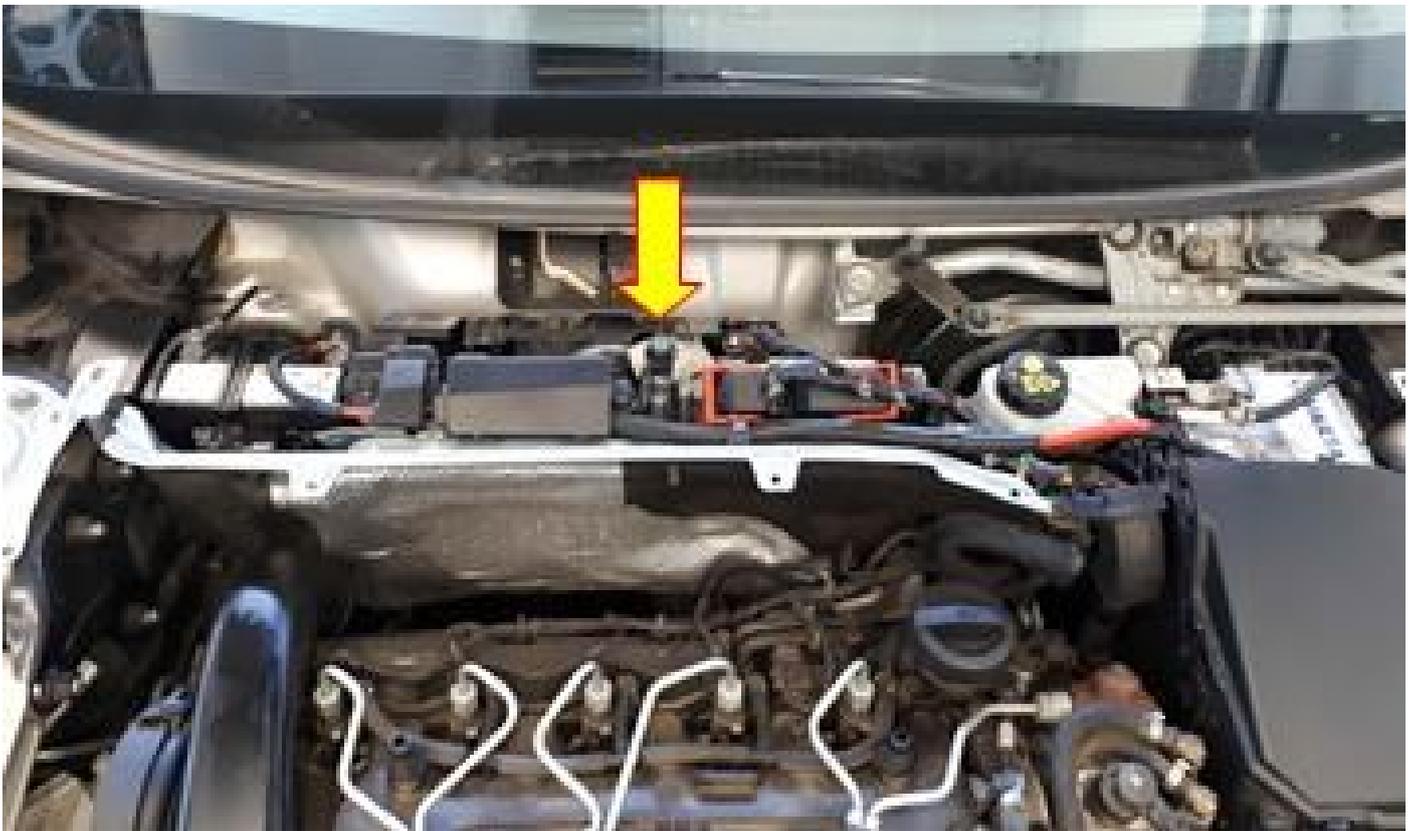
The service connection is now visible in the middle of the water tank (Fig.1+2).

If the low-pressure service connection of the air-conditioning system in the engine compartment is not immediately visible on the above-mentioned vehicle, it can be found located below the water tank cover (cowl cover).

- Dismantle wiper arms
- Remove fastening plug of the cowl cover
- Remove cover
