VW Up - Kølerventilatoren kører konstant | HELLA

Up

Radiator fan permanently in operation

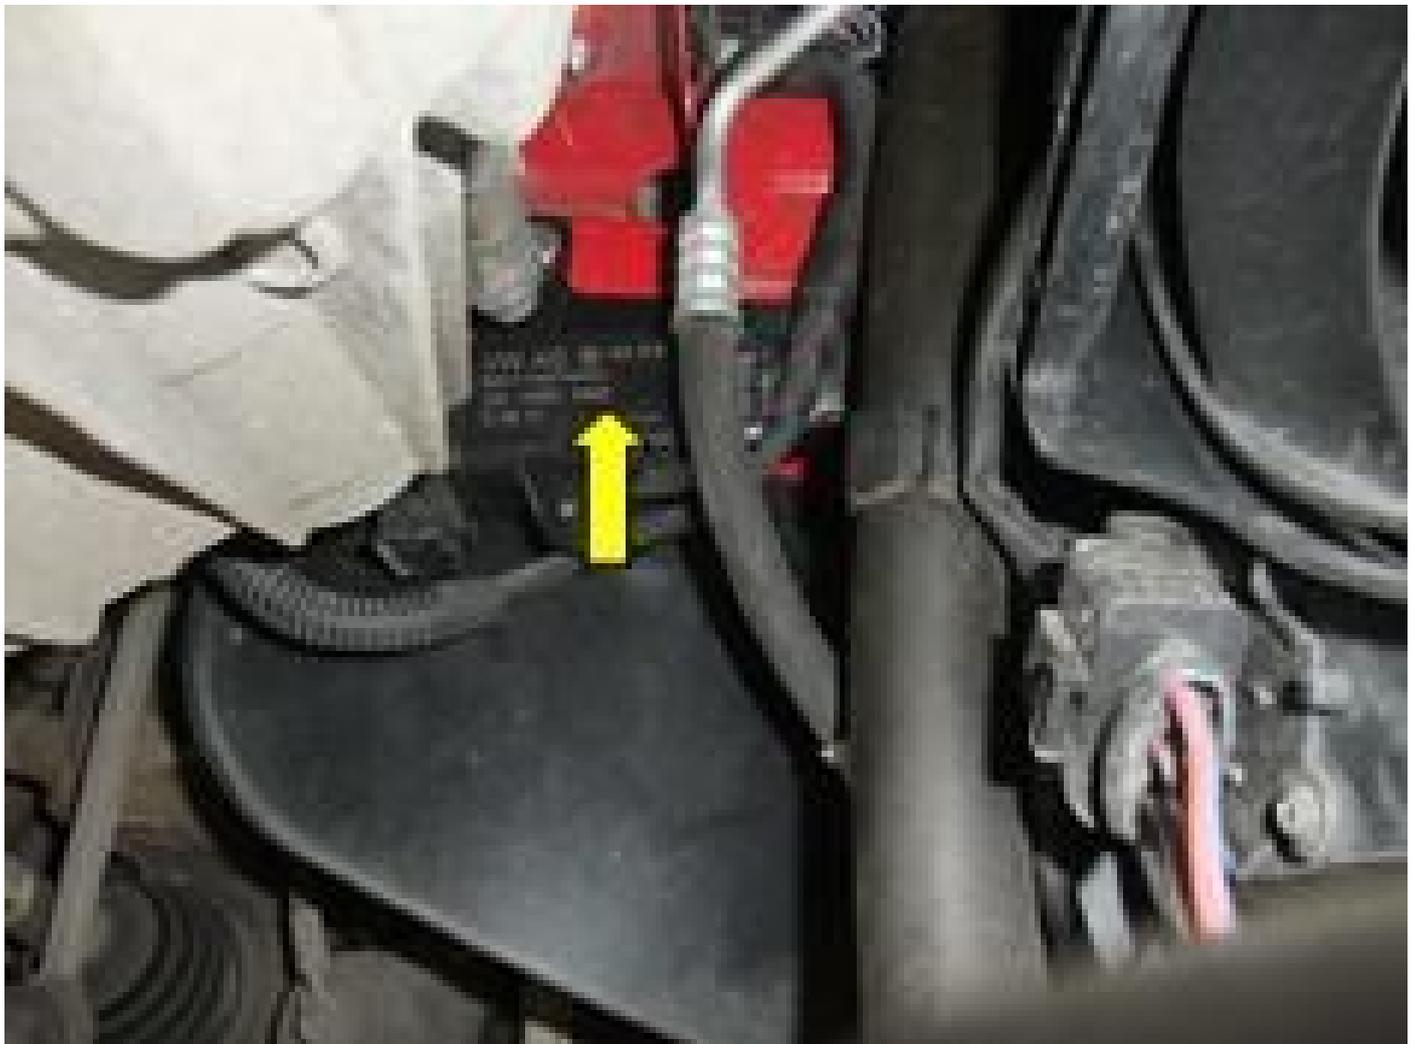
The ECU is located between the transmission and

the wheel arch liner (see figure).

To remedy this, the engine control unit is updated and, if necessary, the radiator fan control unit replaced.
