Kontrol af tykkelsesvariation på en bremseskive | HELLA

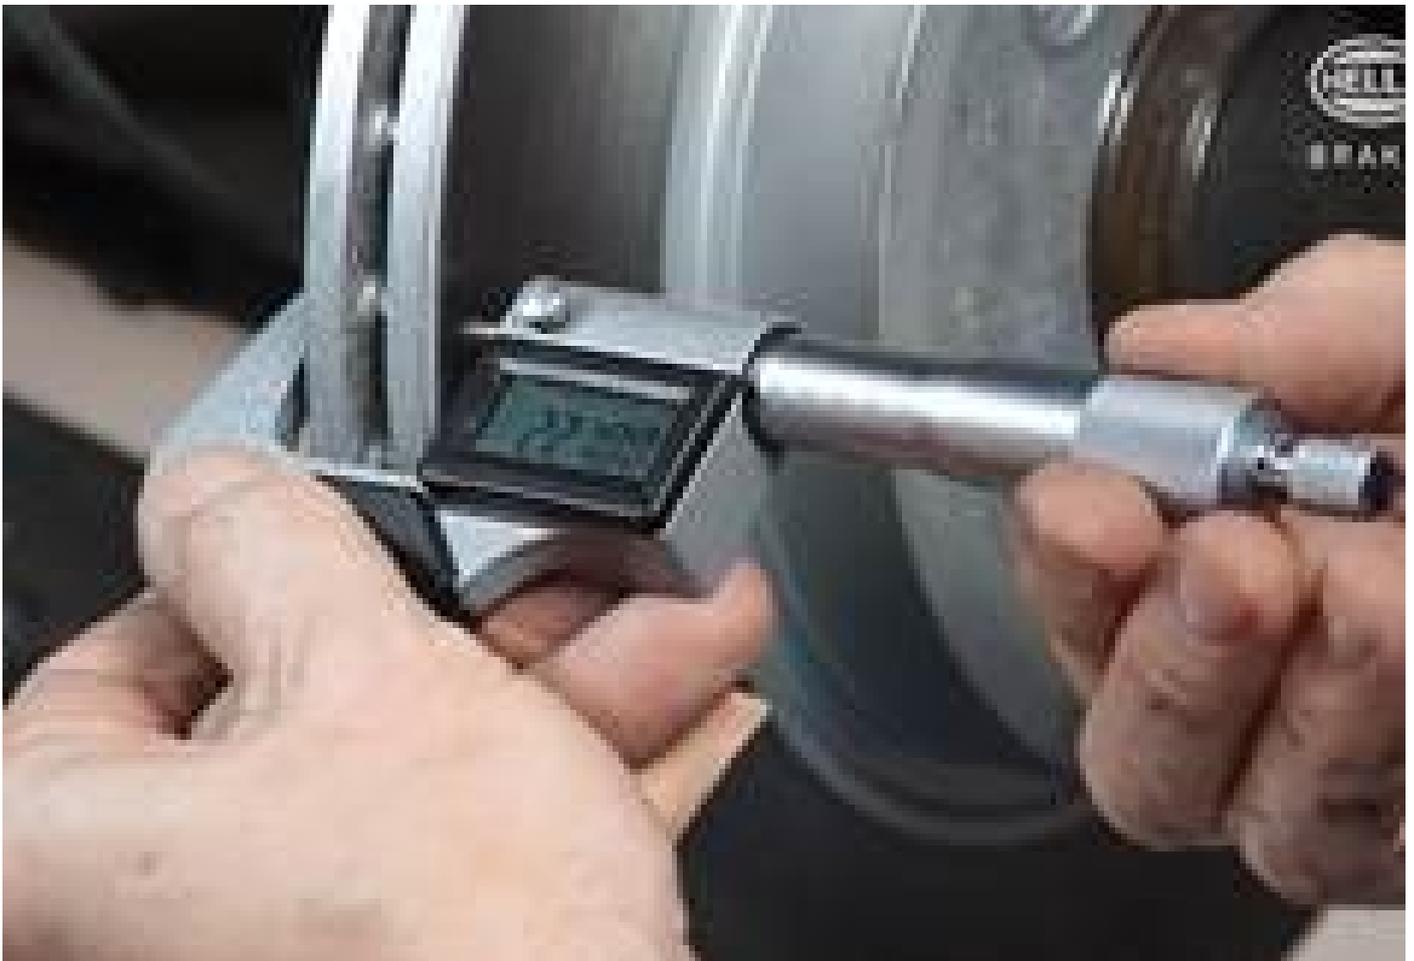
A micrometer screw provides sufficient measuring accuracy of ± 0.001 mm.

This test should only be carried out on brake discs that have been normally worn or are like new.

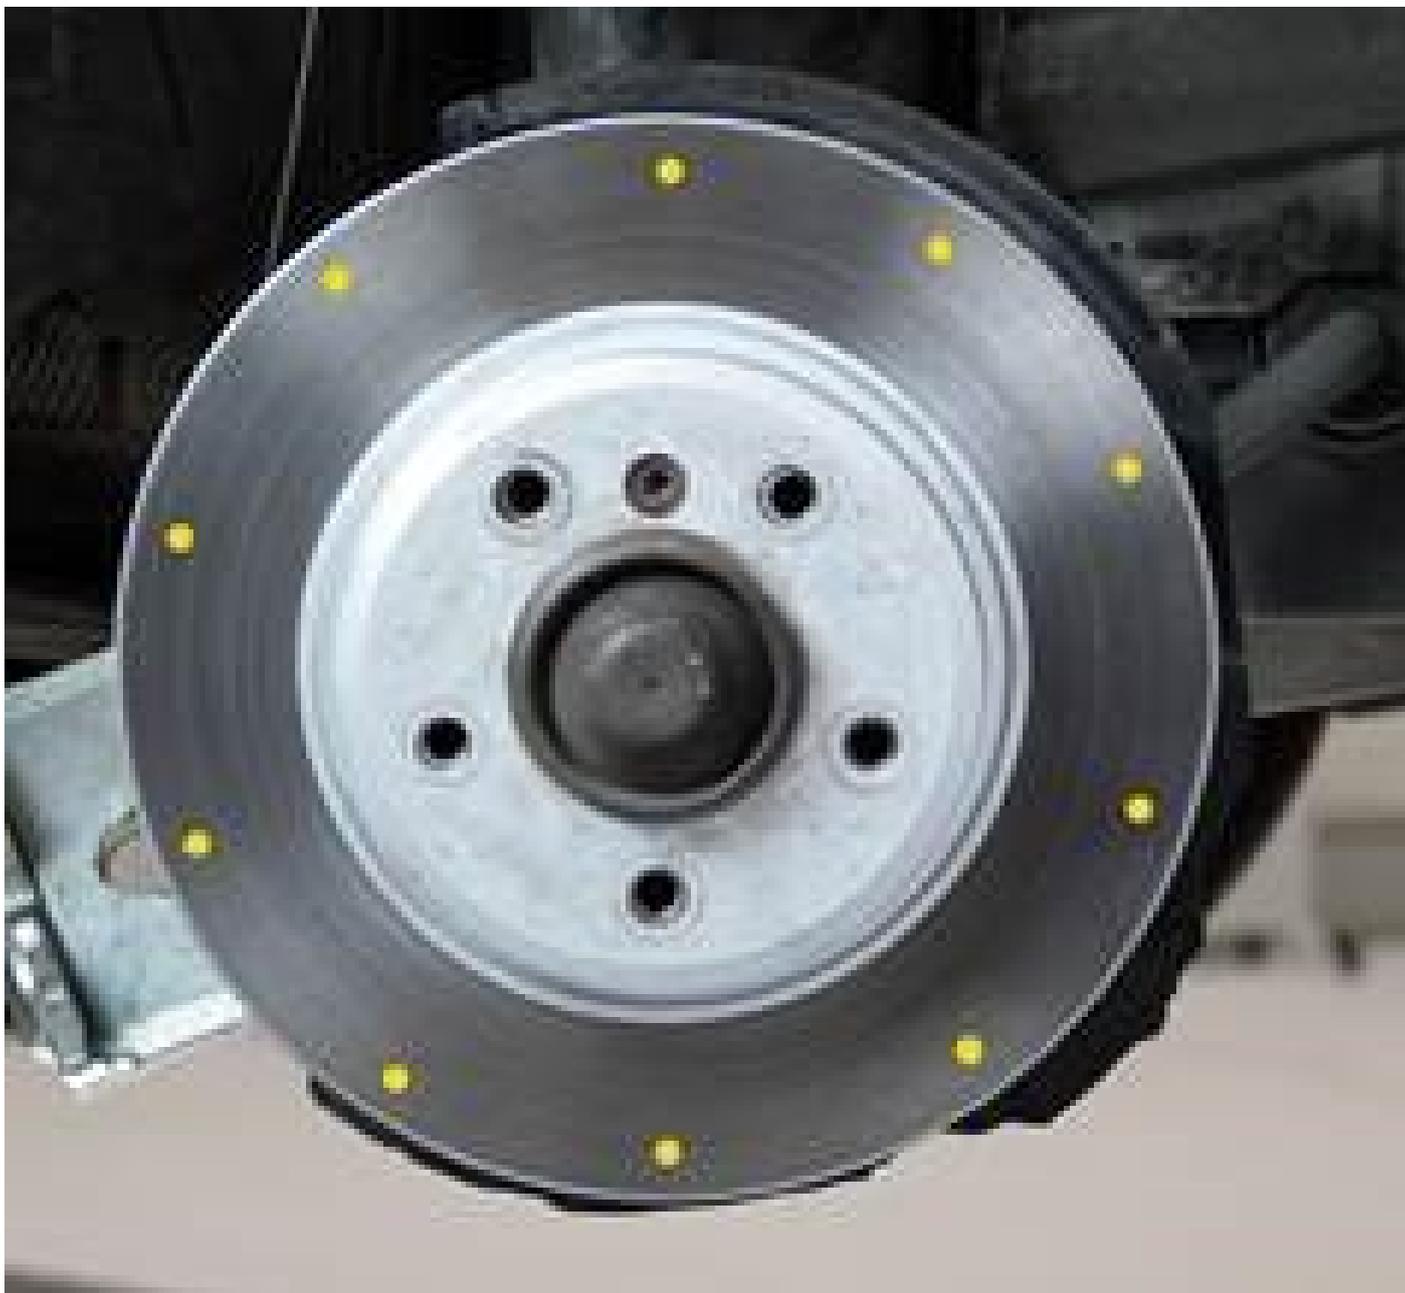
1. Prepare the brake disc for testing. If necessary, disassemble the brake caliper and brake caliper carrier for this
2. Clean the friction surfaces of the brake disc
3. Determine the thickness of the brake disc at various measuring points around the brake disc, approx. 10 – 15 mm beneath the external friction radius
4. Note the measured values and compare

The difference between the smallest and greatest measured value is the thickness difference.
