# Kia Niro - noises coming from engine compartment

## Noises from the engine compartment + error code P2600

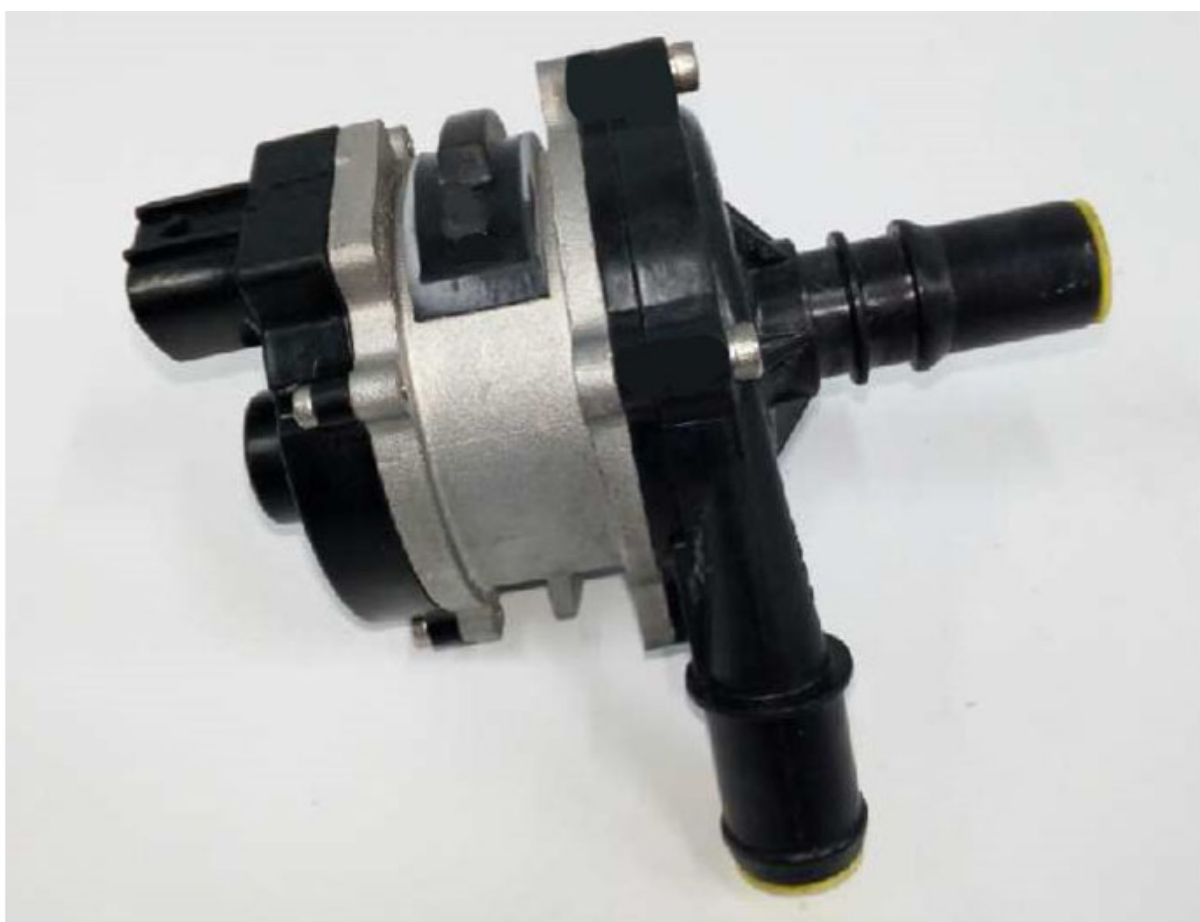
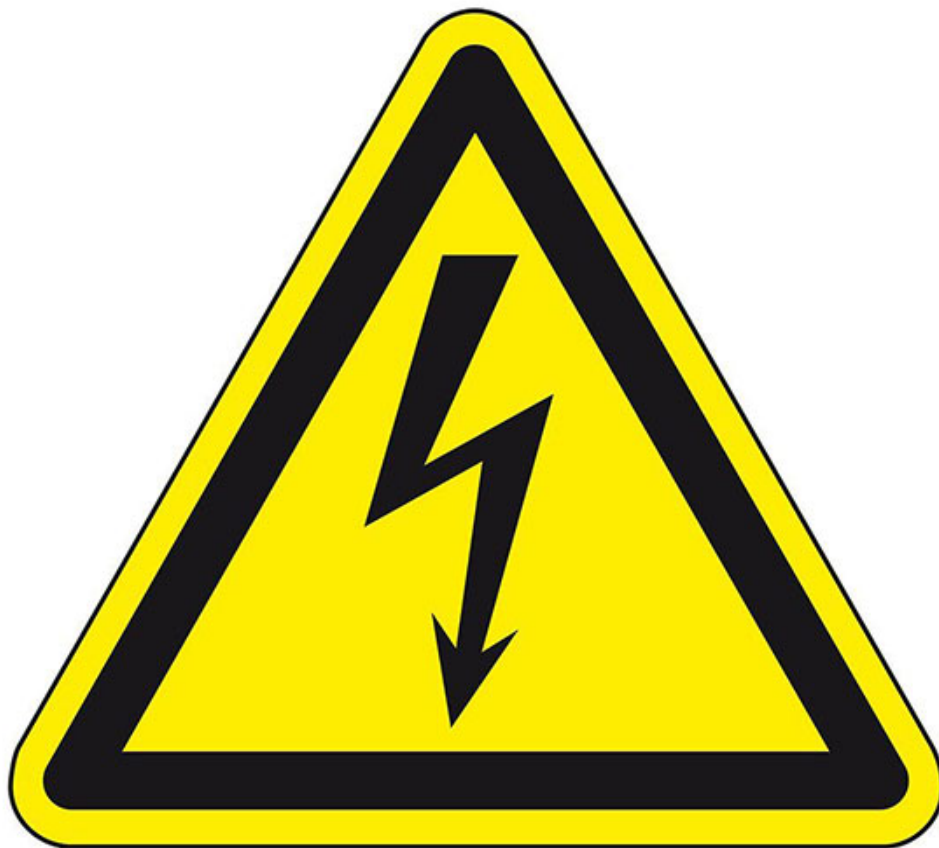
If unusual noises are heard from the engine compartment of the above-mentioned vehicle, the cause could be a faulty electric coolant pump. Often the error code P2600 (coolant pump) is also stored in the control unit.

The cause of this could be internal corrosion brought about by water entering the pump motor. The following steps can be taken to remedy the situation:

- remove and disassemble the coolant pump
- If there are no traces of corrosion: repair pump with repair kit (251000-3HZ0FFF)
- If corrosion is visible, replace the pump

- Check the multi-connector of the coolant pump for corrosion and clean/repair where necessary
- Fill/vent cooling system and check for leaks
- Clear error memory
- Carry out a test drive
