# Lancia Ypsilon 843 - Malfunction "Third stop light" | HELLA

**Ypsilon 843**

**Model years: 2003 – 2011**

**Malfunction "Third stop light"**

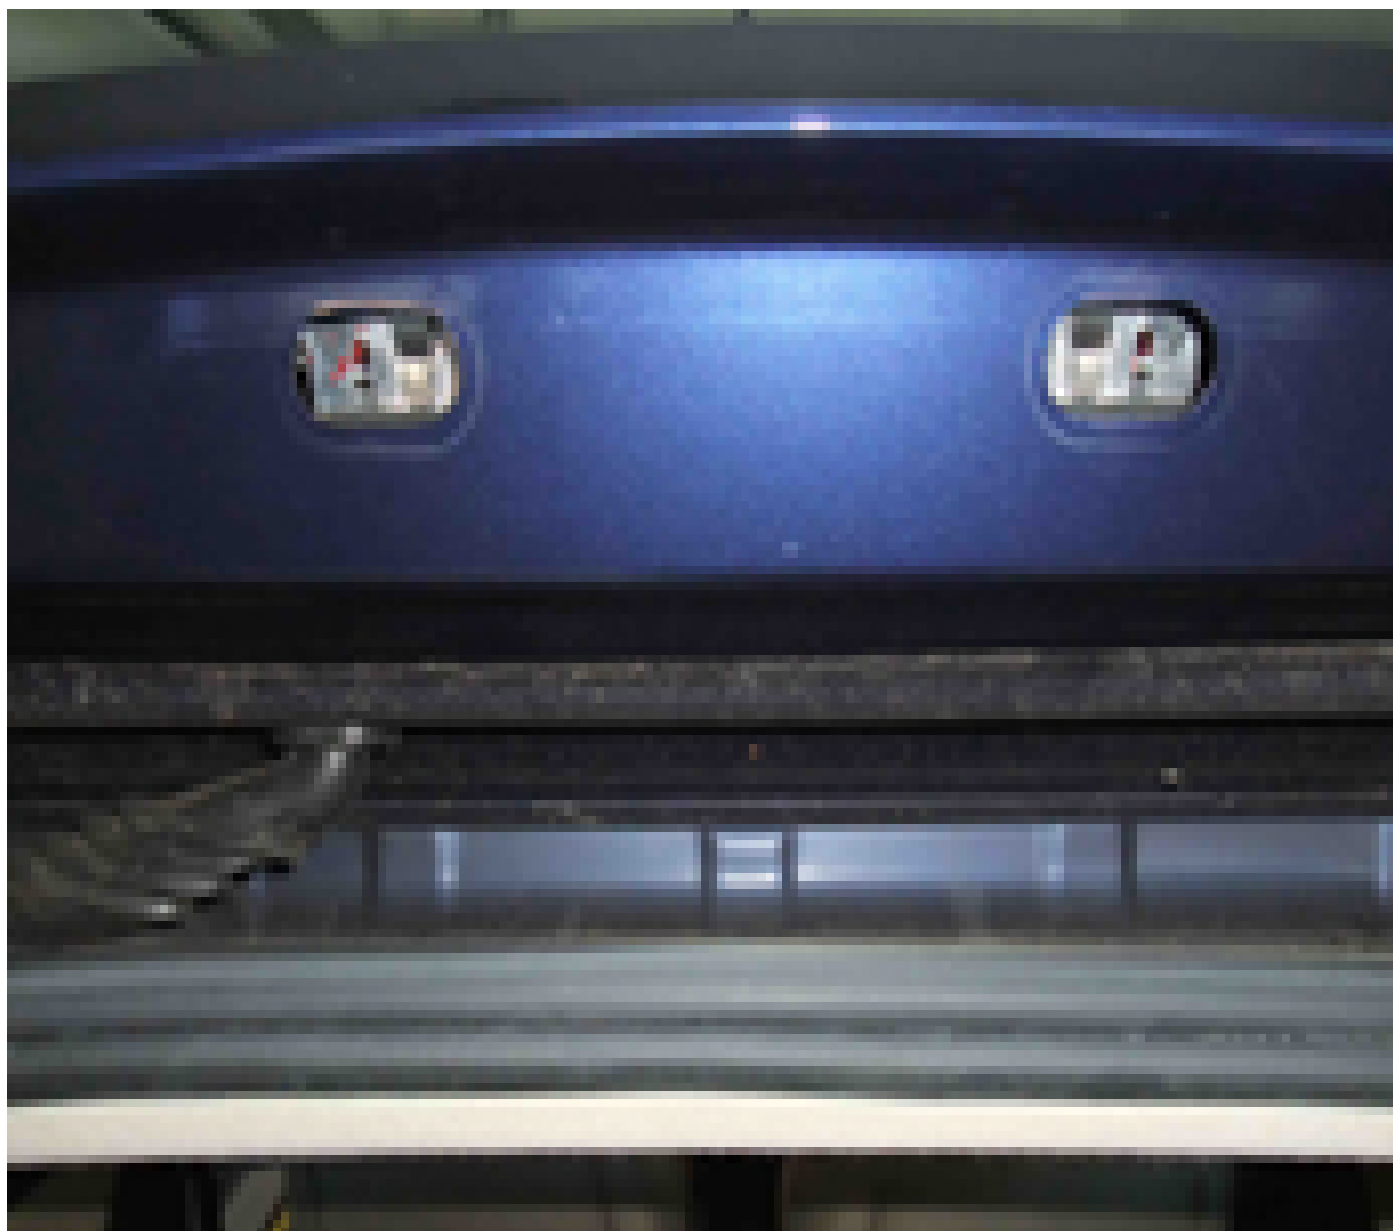
Fig.3

- Completely switch off the electrical system.
- Remove the faulty stop light. To do so, remove the covers (Fig.3) and unlock the clips (Fig.4).
- Then remove the light unit (Fig.5) and unplug the connector.
