# **Opel Astra-G, Opel Zafira, Vectra-B - Irregular engine running | HELLA**

**Opel Astra-G, Vectra-B**

**Opel Zafira**

**All models with X18XE1 engine**

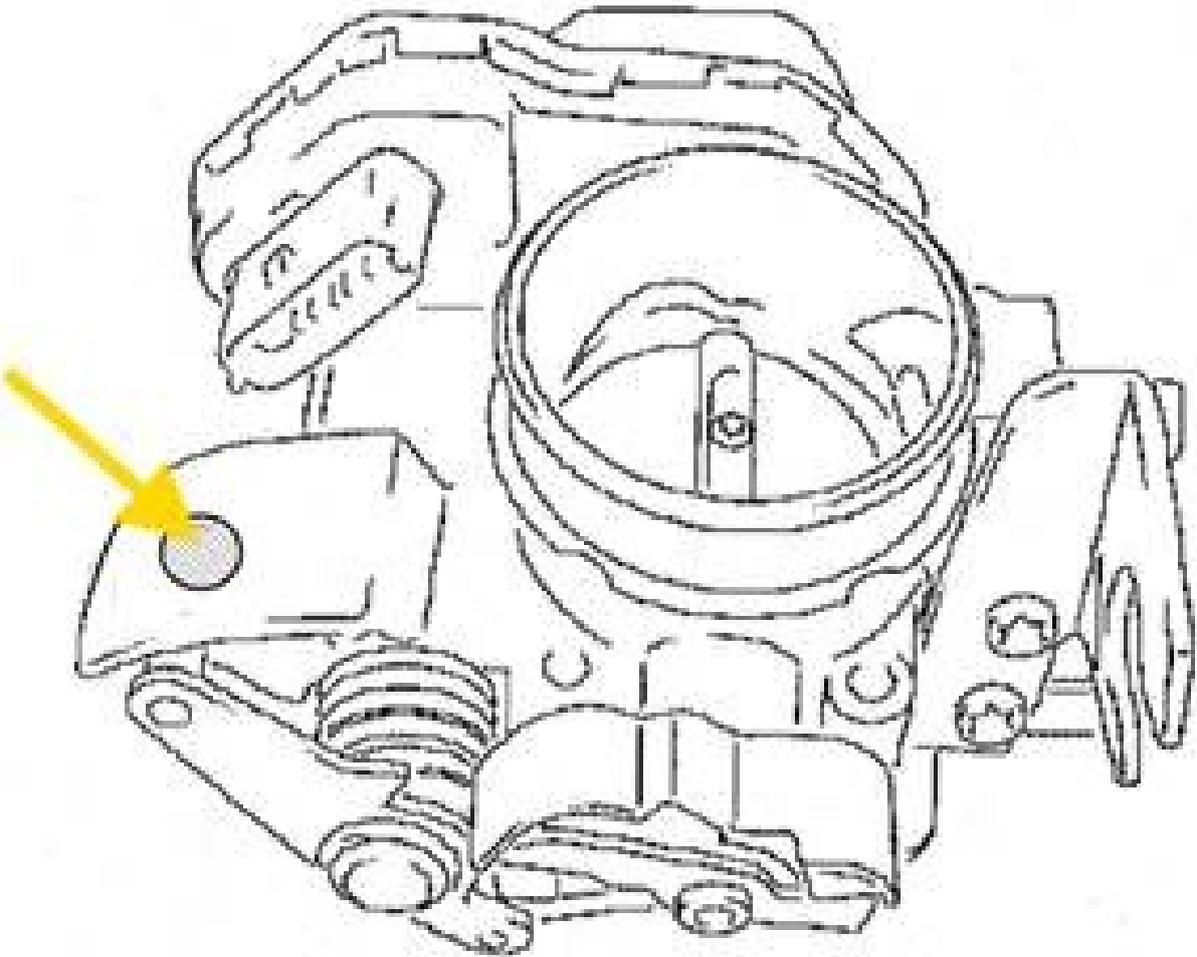
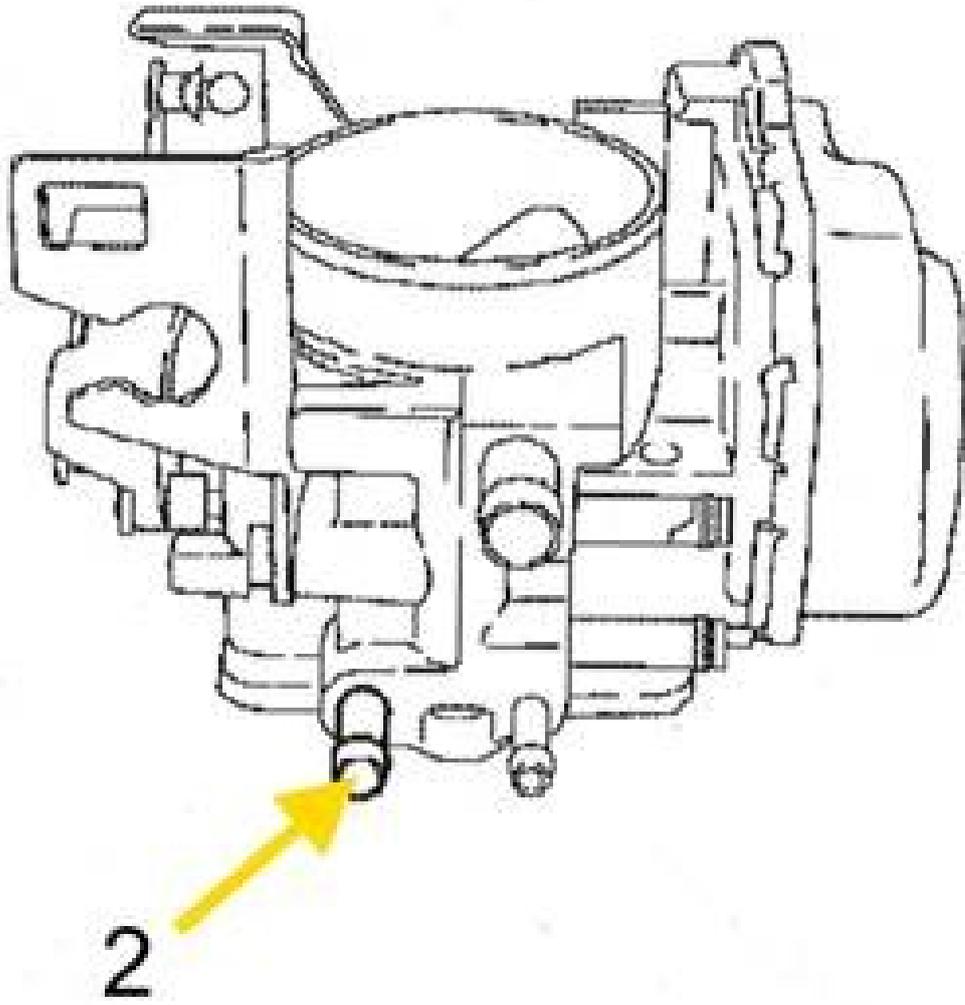
1

If the above-mentioned symptoms occur on these vehicles, this may be caused by a dirty throttle valve. In this case, check the blow-by hole and, if necessary, drill open to 2mm. Afterwards, the ECU must be reprogrammed with a software modified for this purpose. The ECU software can only be updated by an authorised dealer.
