# Opel Meriva A - Starter does not turn

| Manufacturer | Opel |
| Engine code | Y17DT (1.7 DTi) |
| Symptoms | Starter does not turn over Renewing the starter |

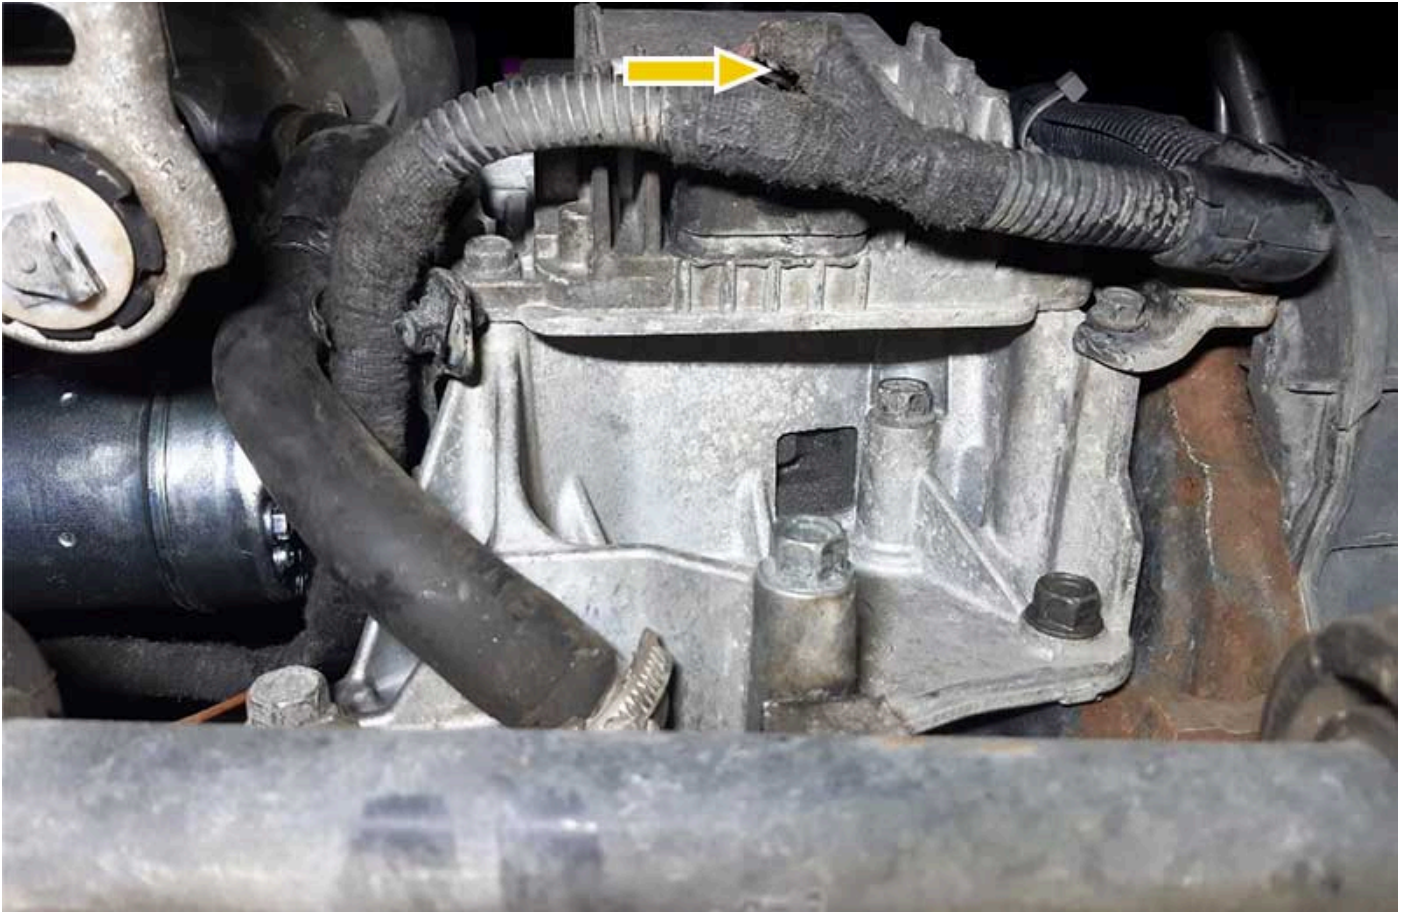
Starting from the underbody, steering control unit

- Remove ground connection of the battery (note the radio code if necessary)
- Raise vehicle on a lifting platform
- Starting from the underbody, remove the steering control unit <span class="gallery-mode--link" data-order="1">(Fig. 1)</span> from the metal carrier
- Unscrew and remove the carrier <span class="gallery-mode--link" data-order="2">(Fig. 2)</span>
- Disconnect electrical connections on the starter
- Loosen / remove the screw from the starter <span class="gallery-mode--link" data-order="3">(Fig. 3)</span>
- Remove left wheel well trim
- Loosen / remove screw of the starter from the wheel well or from the engine compartment <span class="gallery-mode--link" data-order="4">(Fig. 4)</span>
- Remove starter

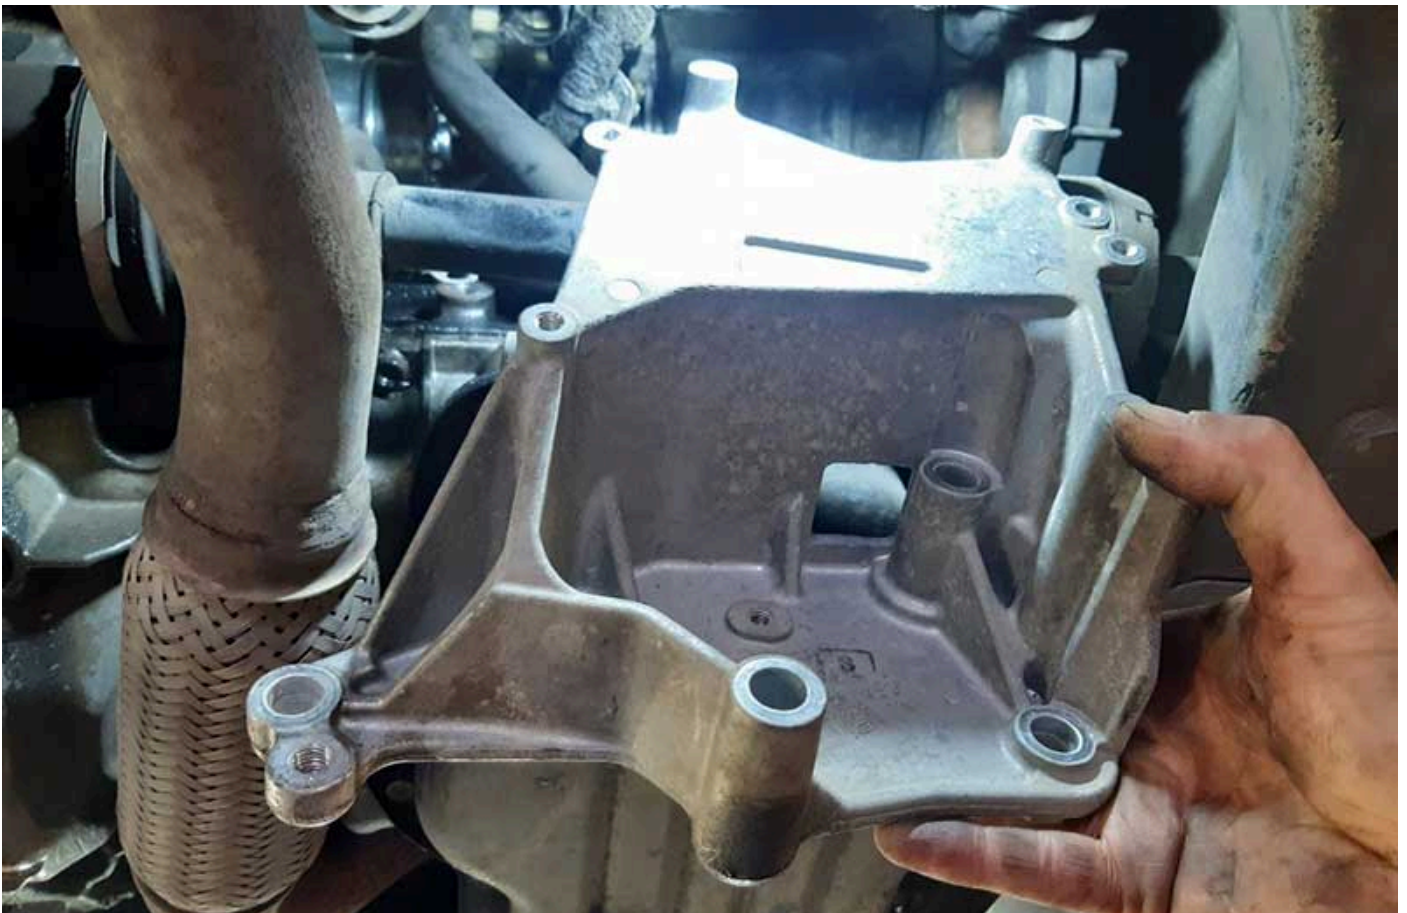
Carrier is to be unscrewed and removed
