# Renault, Citroen, Peugeot - Poor braking with the driving brake | HELLA

Renault, Citroen, Peugeot

All models with drum brakes

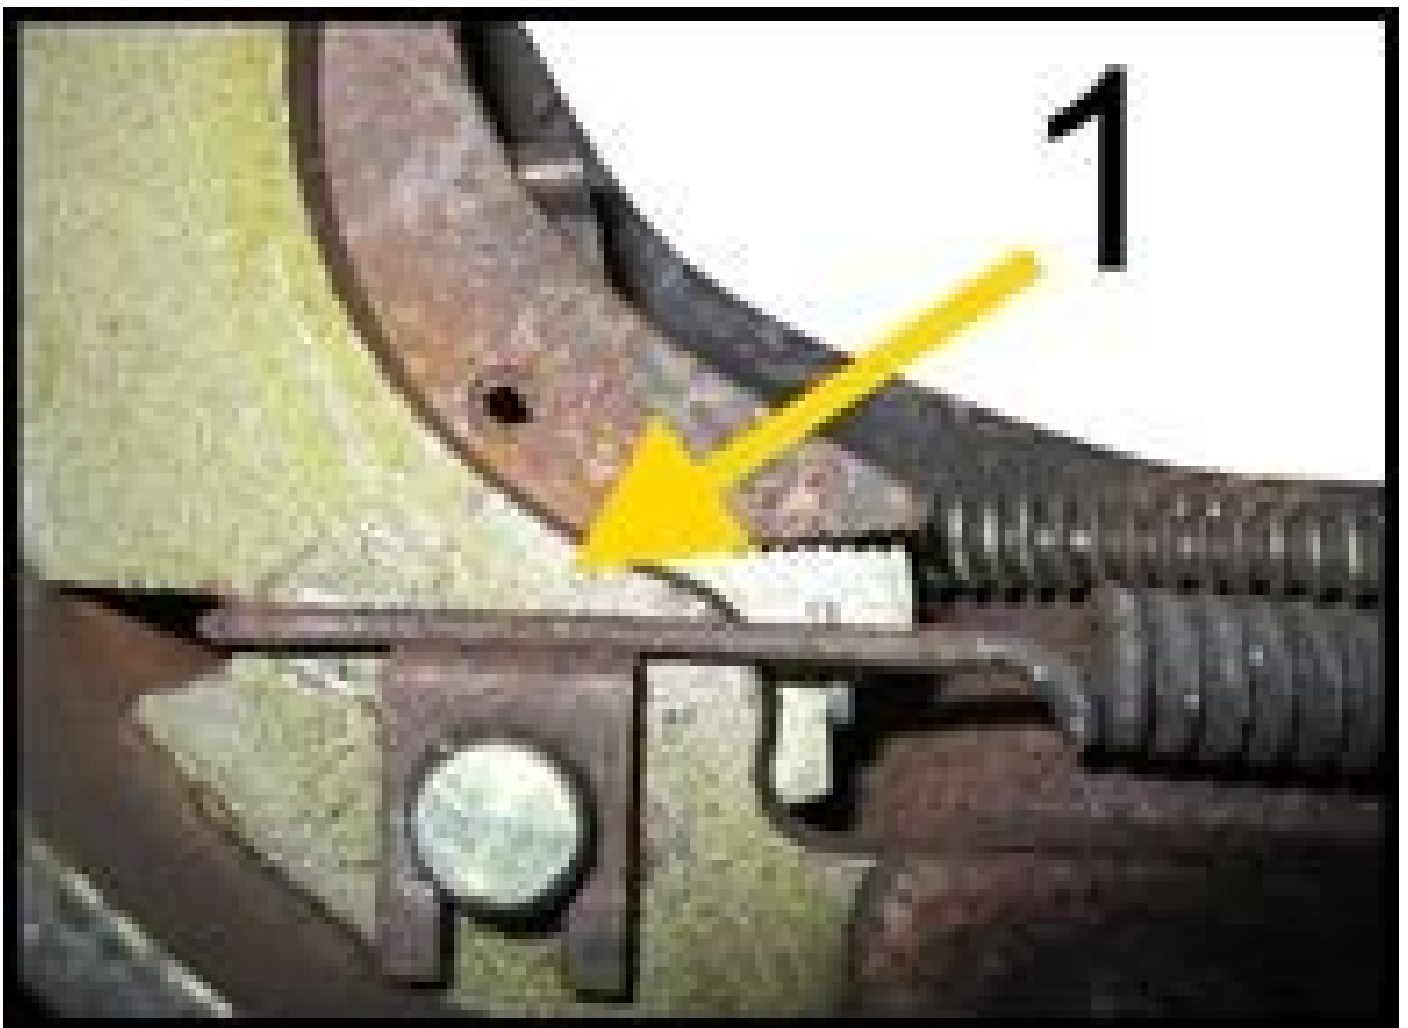
Poor braking with the driving brake and parking brake.

**Malfunction of the automatic adjusting device on the rear axle drum brake system.**

If one of the errors listed above occurs on these vehicle models, the cause may stem from a vertically mounted safety clip on the brake shoe.(Fig.1)

Please remember to always follow the general assembly instructions for installing and removing drum brakes and other special installation instructions from the brake pad or vehicle manufacturer in this regard.
