# **Seat Ibiza (6J) - Engine warning light comes on | HELLA**

**Seat**

**Ibiza (6J)**

**Engine: 1.6 TDI**

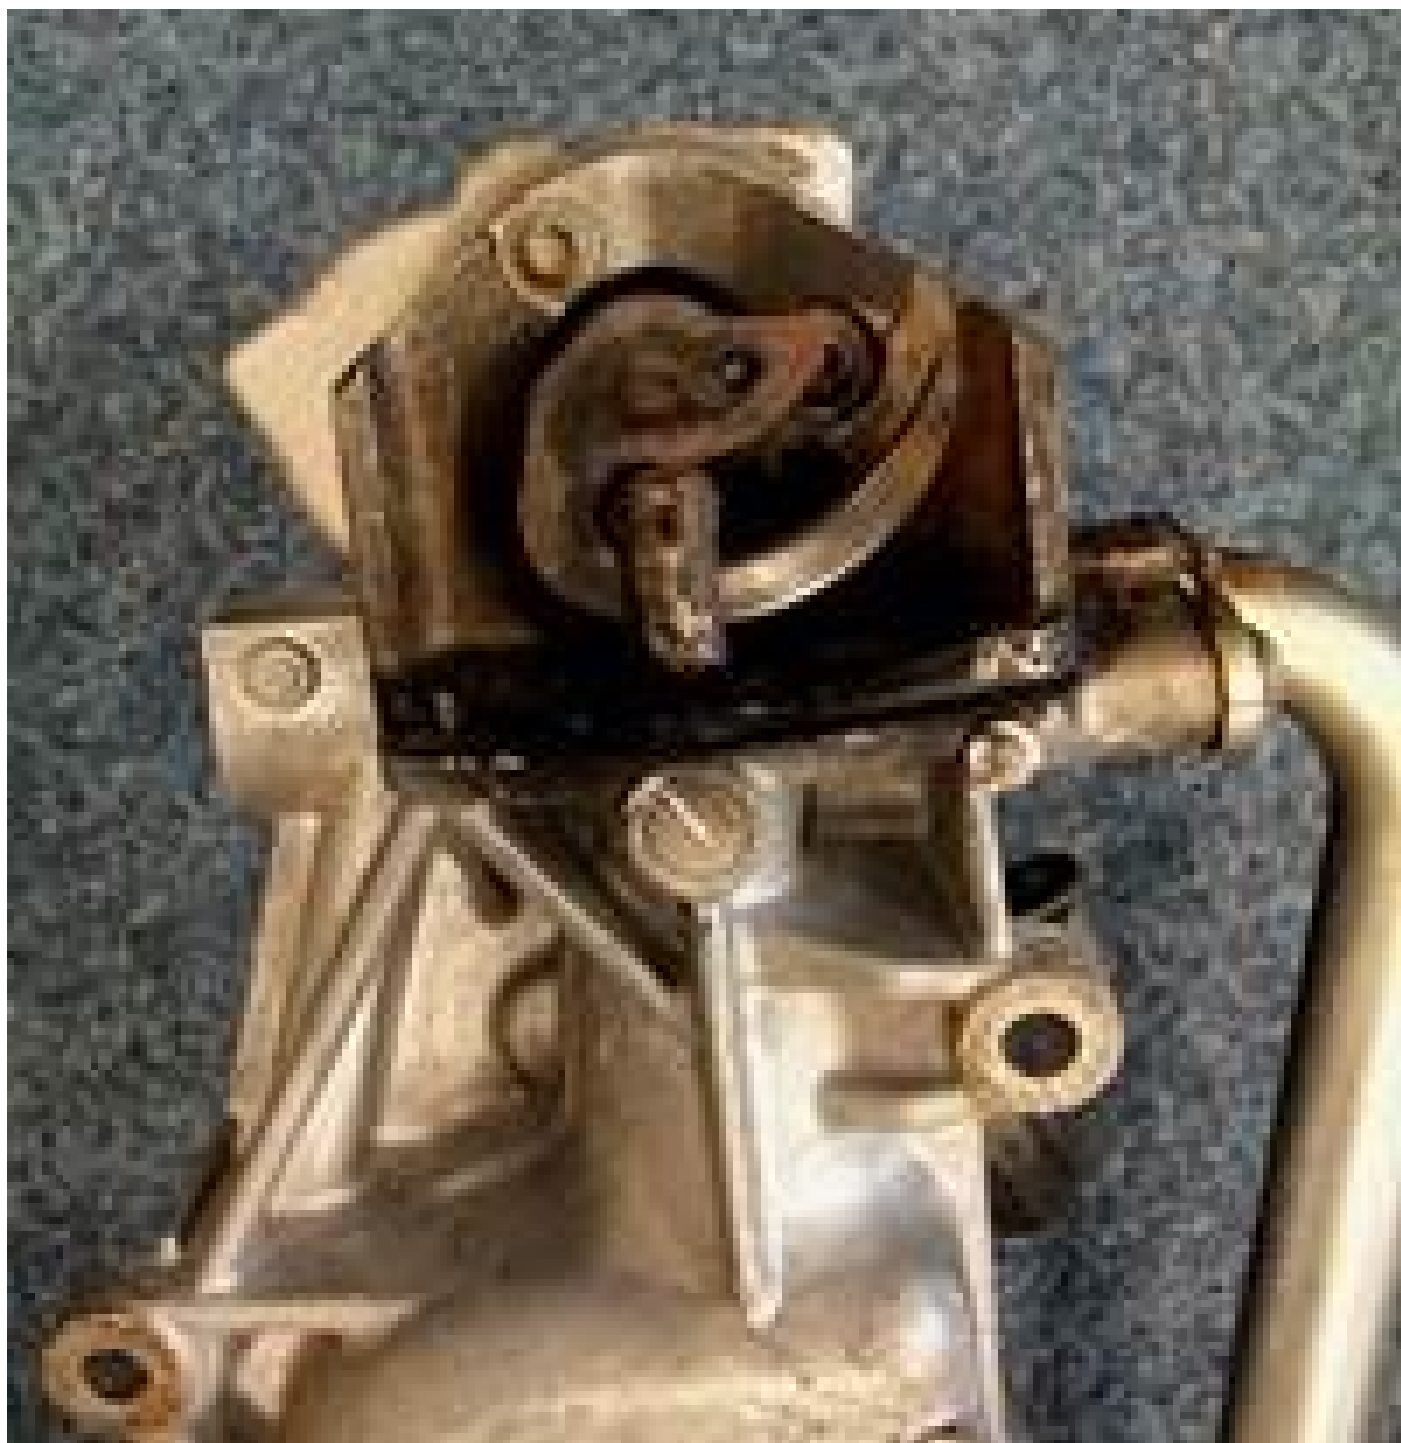
Figure 1

The exhaust gas recirculation radiator unit (EGR radiator) is fitted with a vacuum cell and an electric actuator motor (Figure 1). The EGR radiator should be examined according to the following criteria:

- Internal coking
- Functionality of vacuum cell
- Functionality and control of electric actuator motor
- External and internal leaks

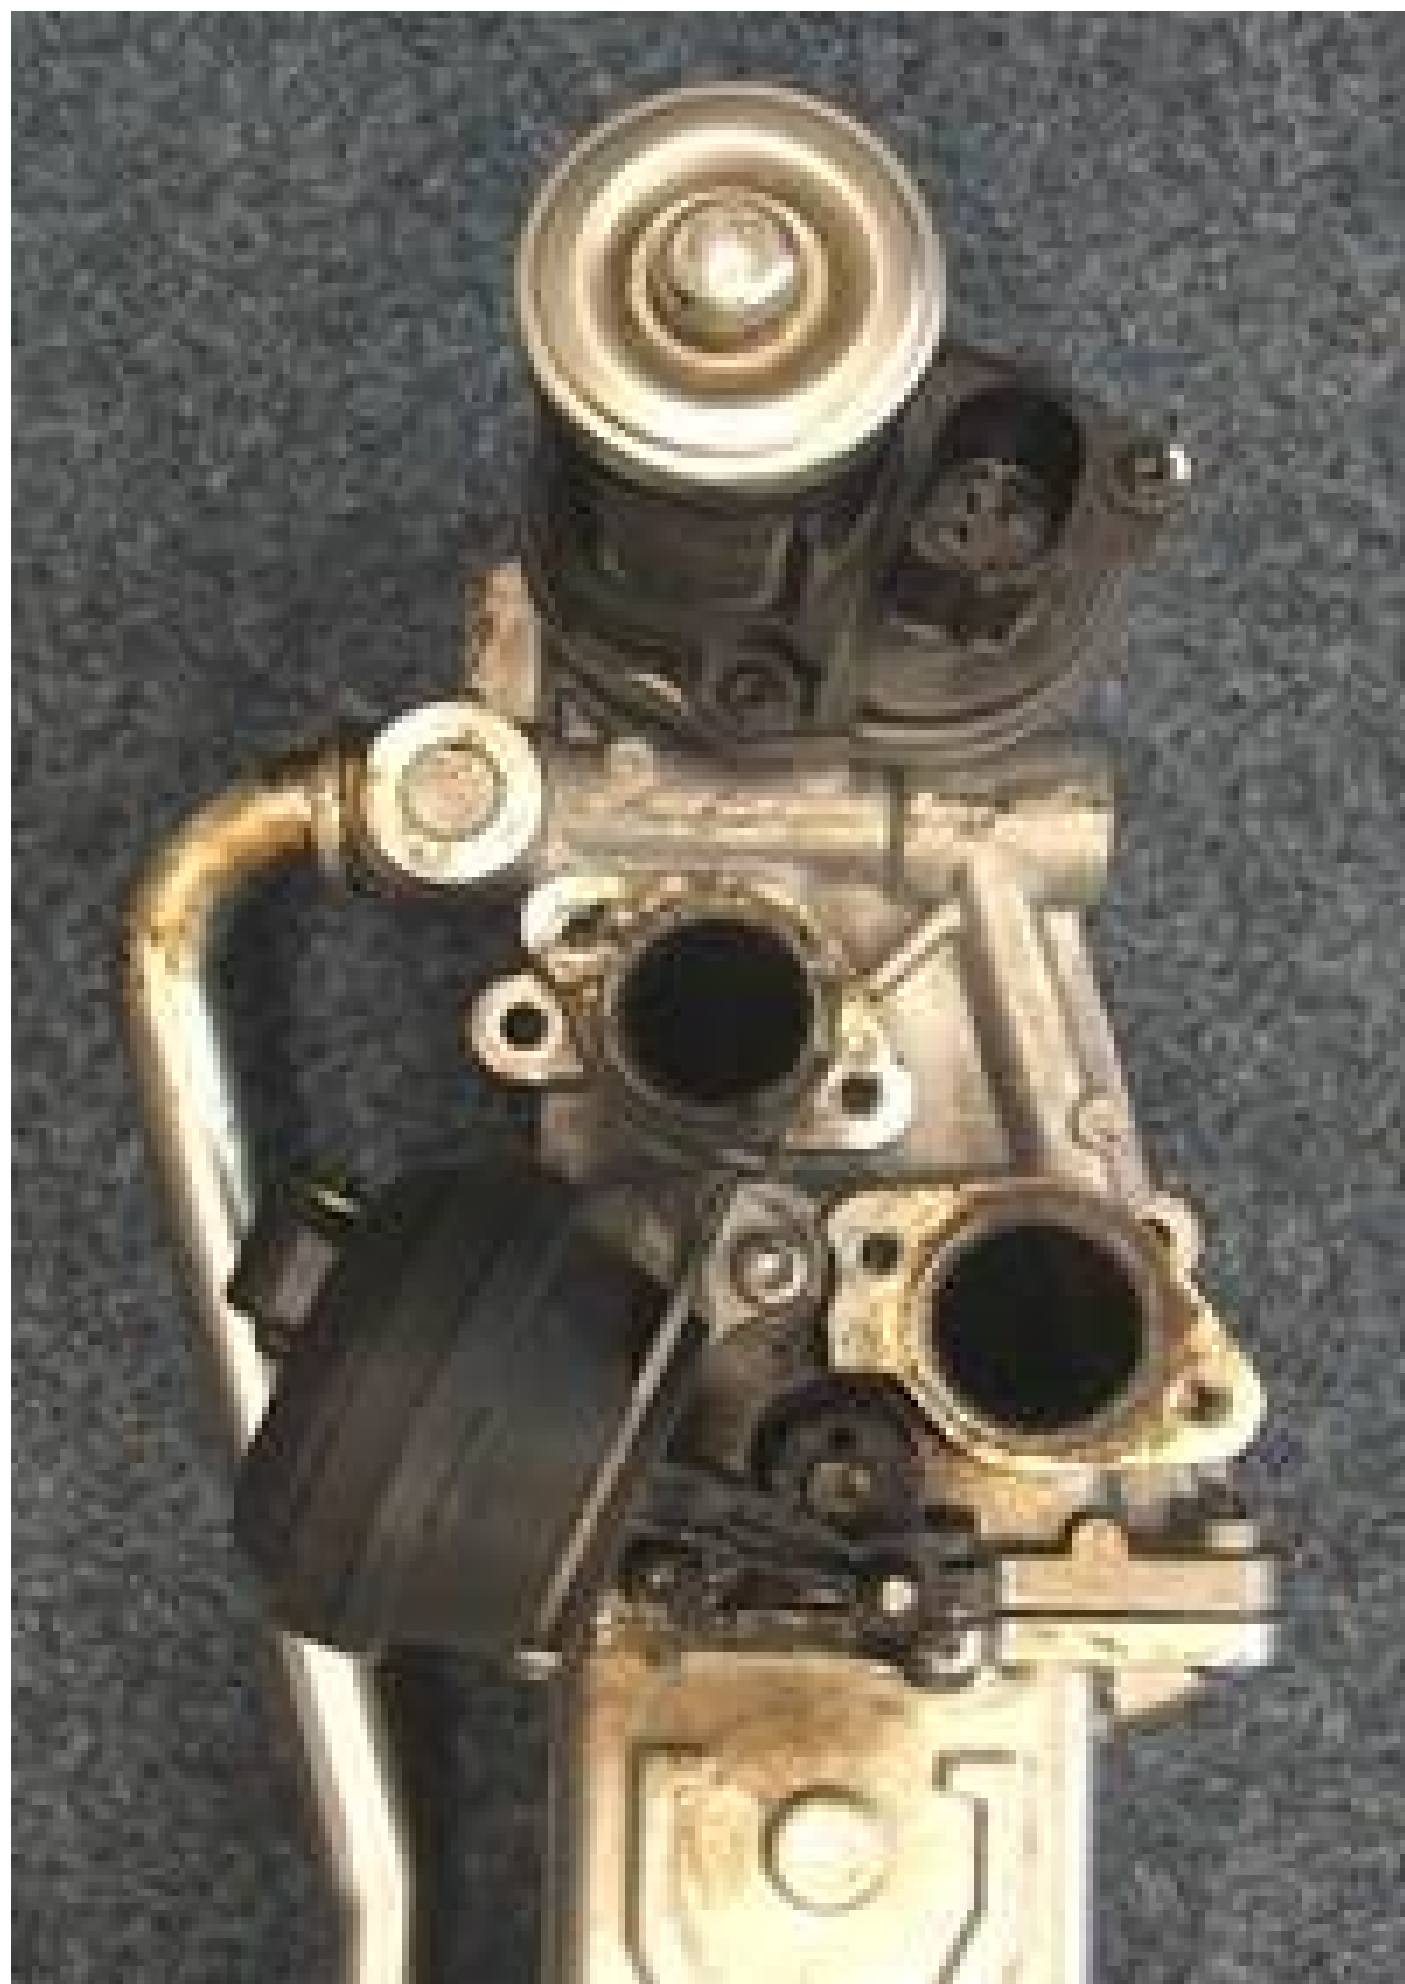
Figure 2

Furthermore, the mechanics of the actuator motor (Figure 2) and the vacuum cell must be checked to ensure that they run smoothly. They may often jam or fail to run smoothly, leading to faults.
