# **BMW Serie 5 (G30/G31) / Serie 7 (G11/G12) - La luz de freno se queda encendida | HELLA**

**Serie 5 (G30/G31) / Serie 7 (G11/G12)**

**La luz de freno se queda encendida**

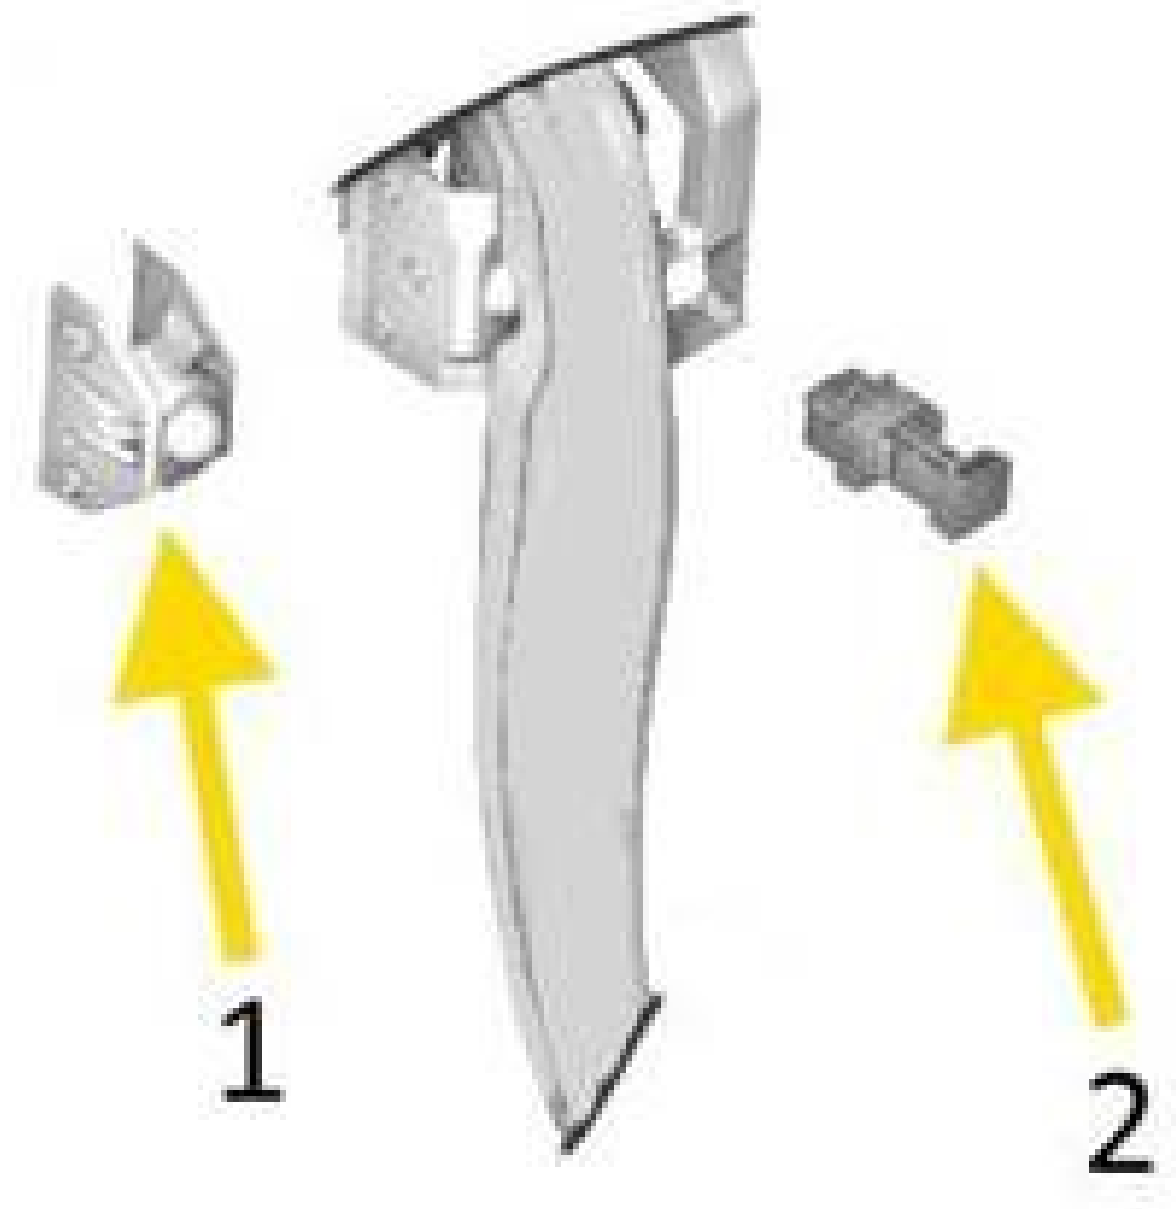
Si se detecta la problemática arriba mencionada, puede deberse a un defecto en la cabeza esférica del pedal de freno.
