# OPEL Astra H - Pérdida de refrigerante | HELLA

Astra H

Año de fabricación: 2002 - 2009

**Fugas y daños en el condensador**

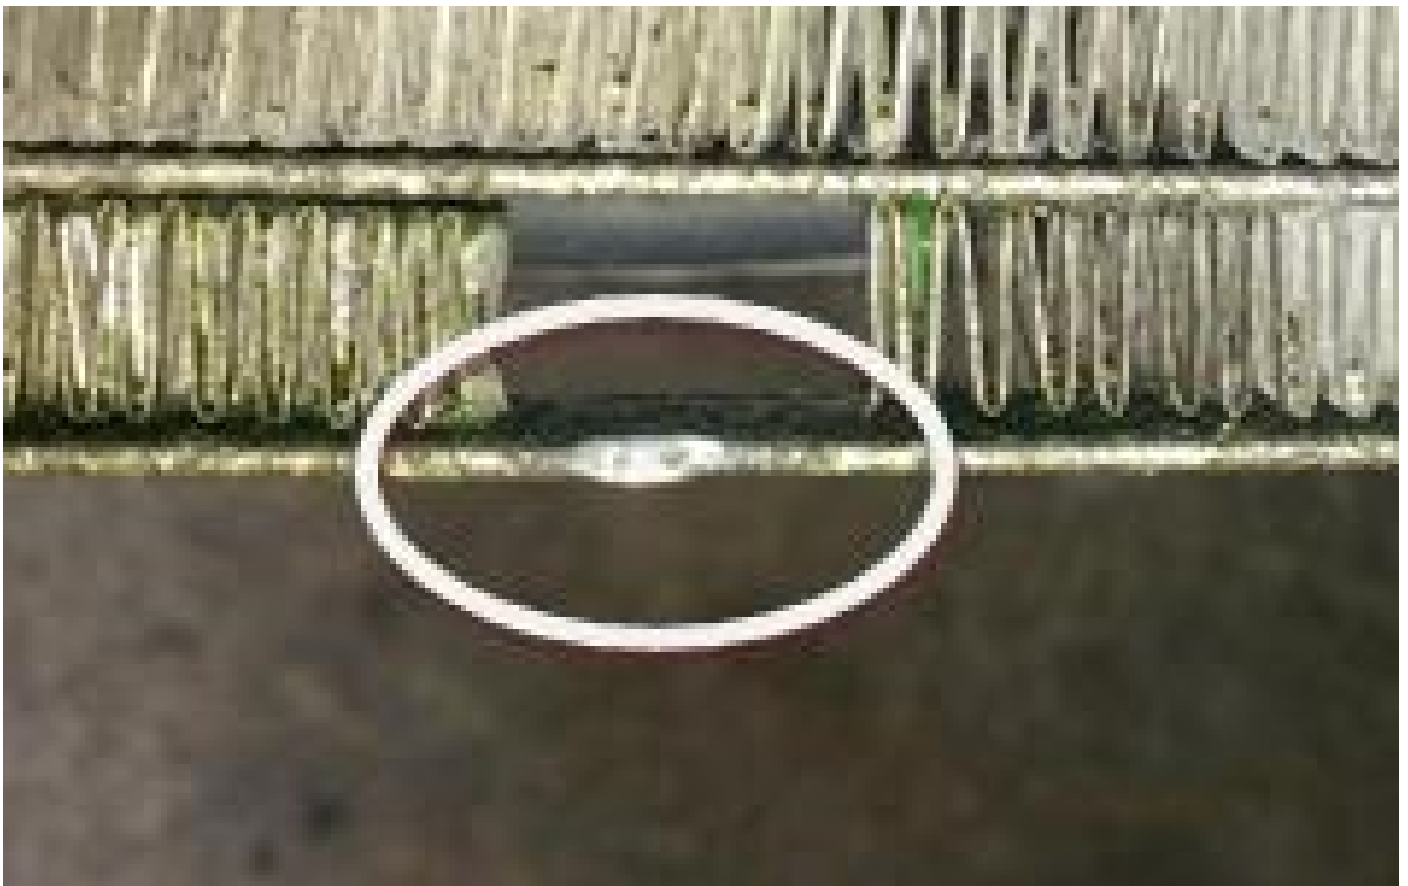
Puede haberse producido cierta inestabilidad en la red del condensador provocada por la pérdida de algunas laminillas. Las vibraciones pueden producir contacto con otros componentes. Debido a ello se daña el condensador (imagen 1), perdiendo así su estanqueidad.

Si se comprueba que los vehículos arriba mencionados pierden refrigerante, deberá prestarse especial atención al condensador.

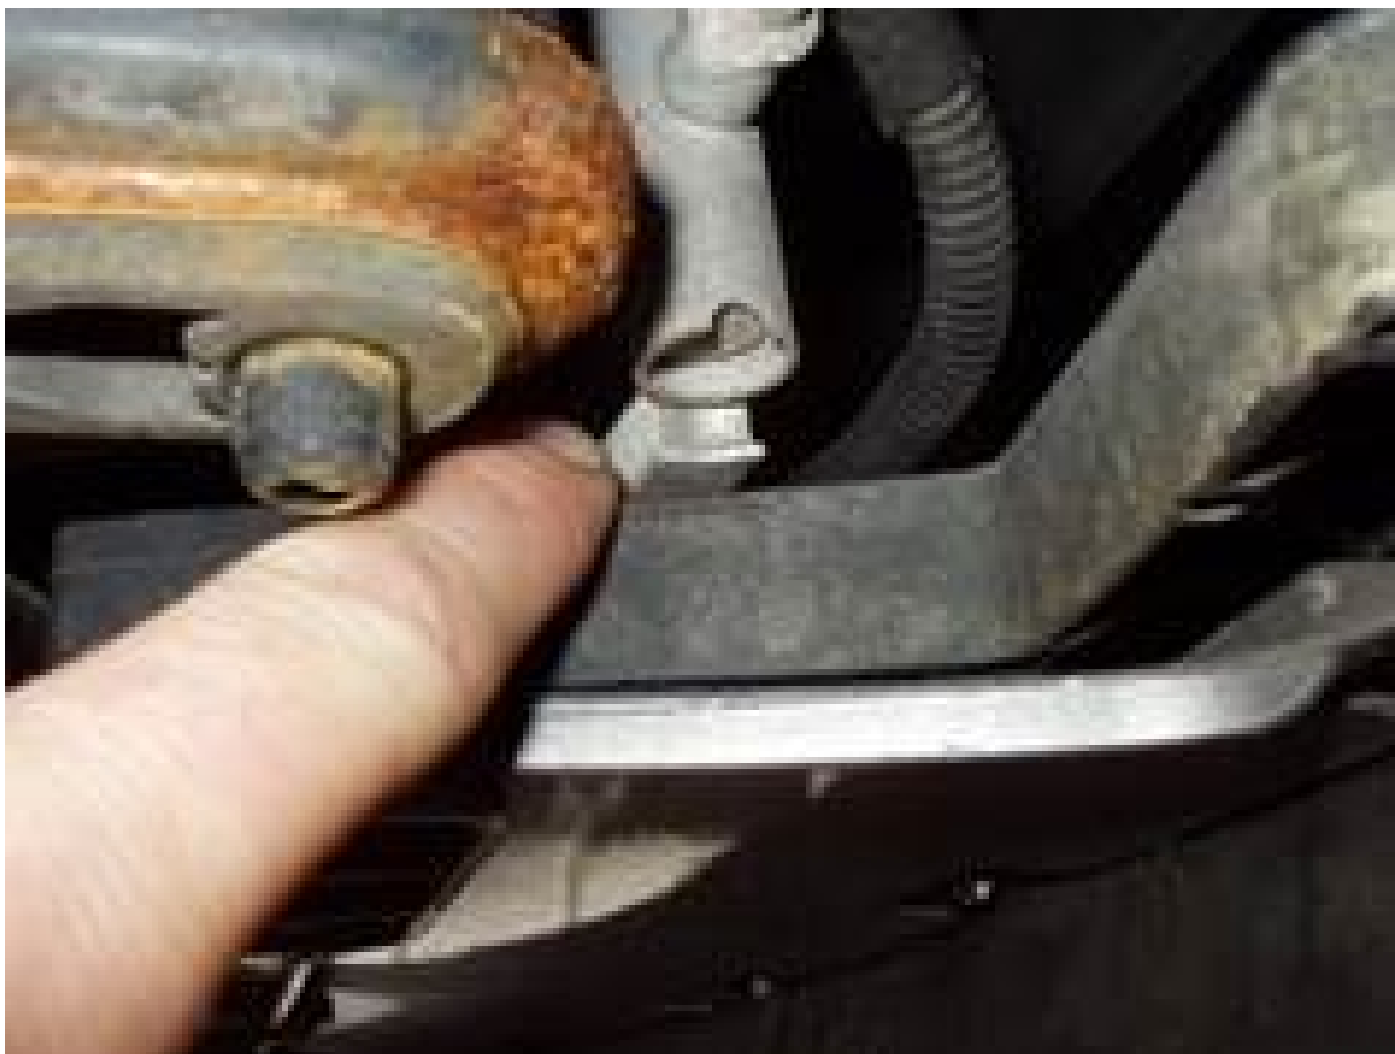
Figure 2

Además, es posible que el condensador se haya soltado de su soporte y que se apoye en el bastidor (imagen 2). Este hecho también podría provocar la falta de estanqueidad mencionada.
