# VW Golf IV - Fonction de recirculation d'air | HELLA

## Fonction de recirculation d'air

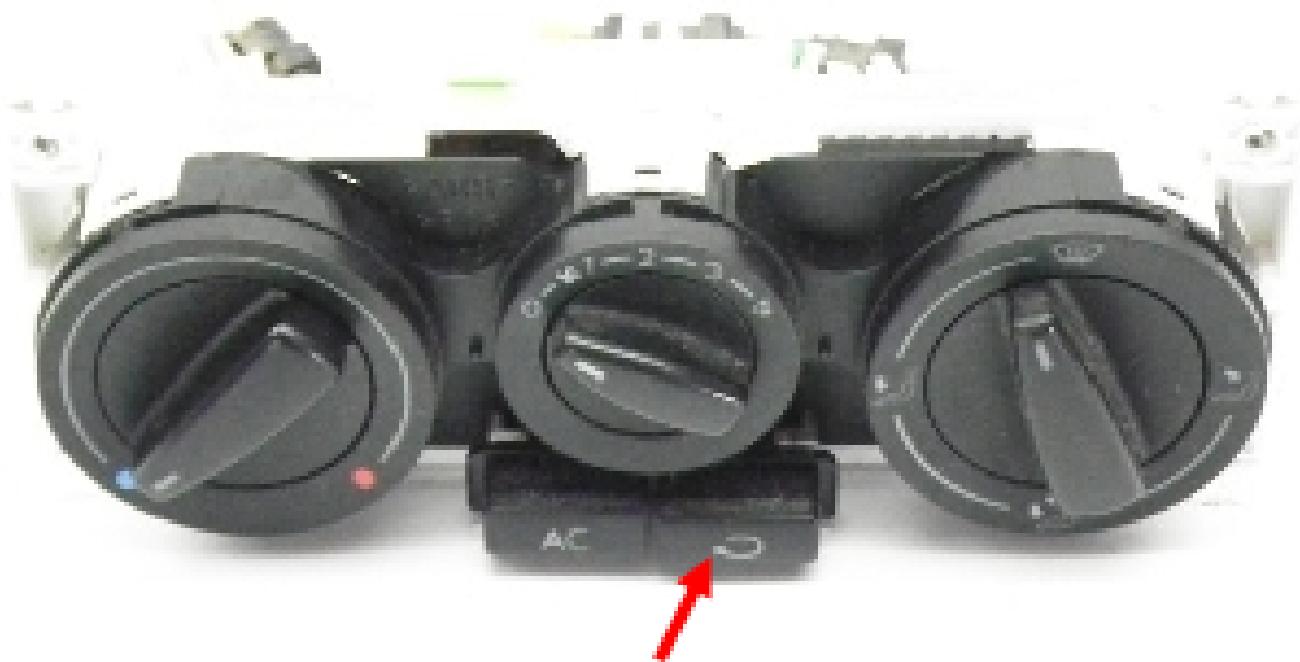
Sur les véhicules mentionnés ci-dessus, on peut éventuellement observer une prétendue défaillance de la fonction de recirculation d'air.

Le voyant du bouton de recirculation d'air (figure) peut, sur ces véhicules, tomber en panne prématurément. Cela amène à supposer qu'il existe un défaut électrique sur le bouton.

Avant de remplacer le bouton ou de procéder à une recherche complète des défauts, la lampe à incandescence doit faire l'objet d'un contrôle de fonctionnement et/ou être remplacée.
