# Fiat Panda - Low beam not functioning | HELLA

Fiat Panda

Model year: 2003 up to 2013

## Low beam not functioning

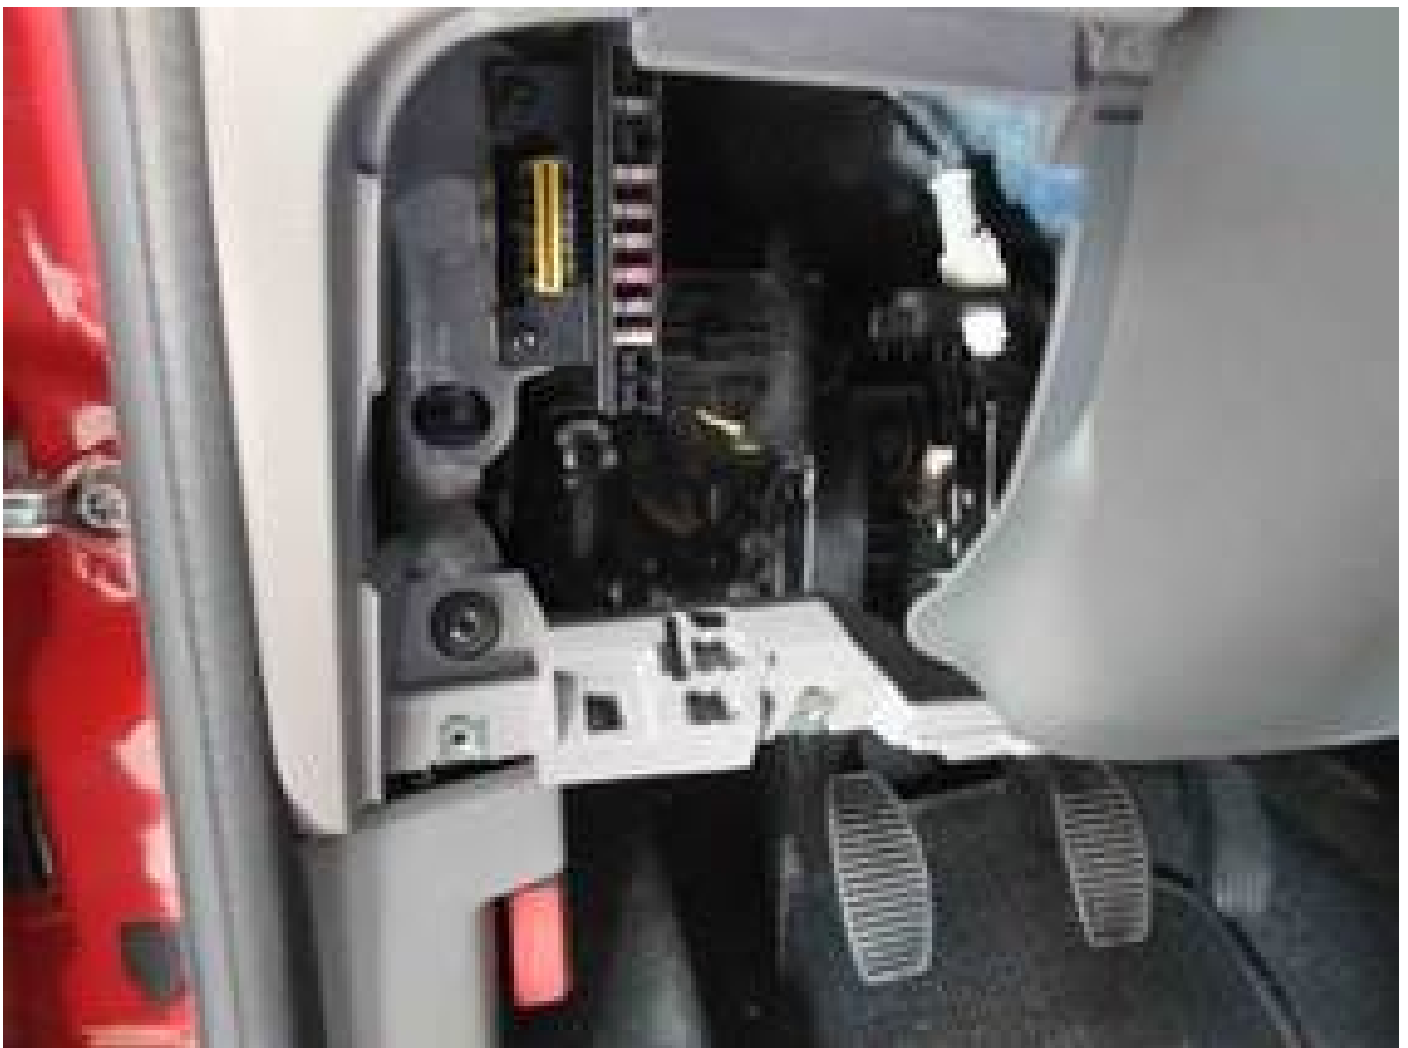
Fig.1

If the above-mentioned problem is detected, it may be caused by a poor contact between the connection socket and the fuse box (Fig.1).

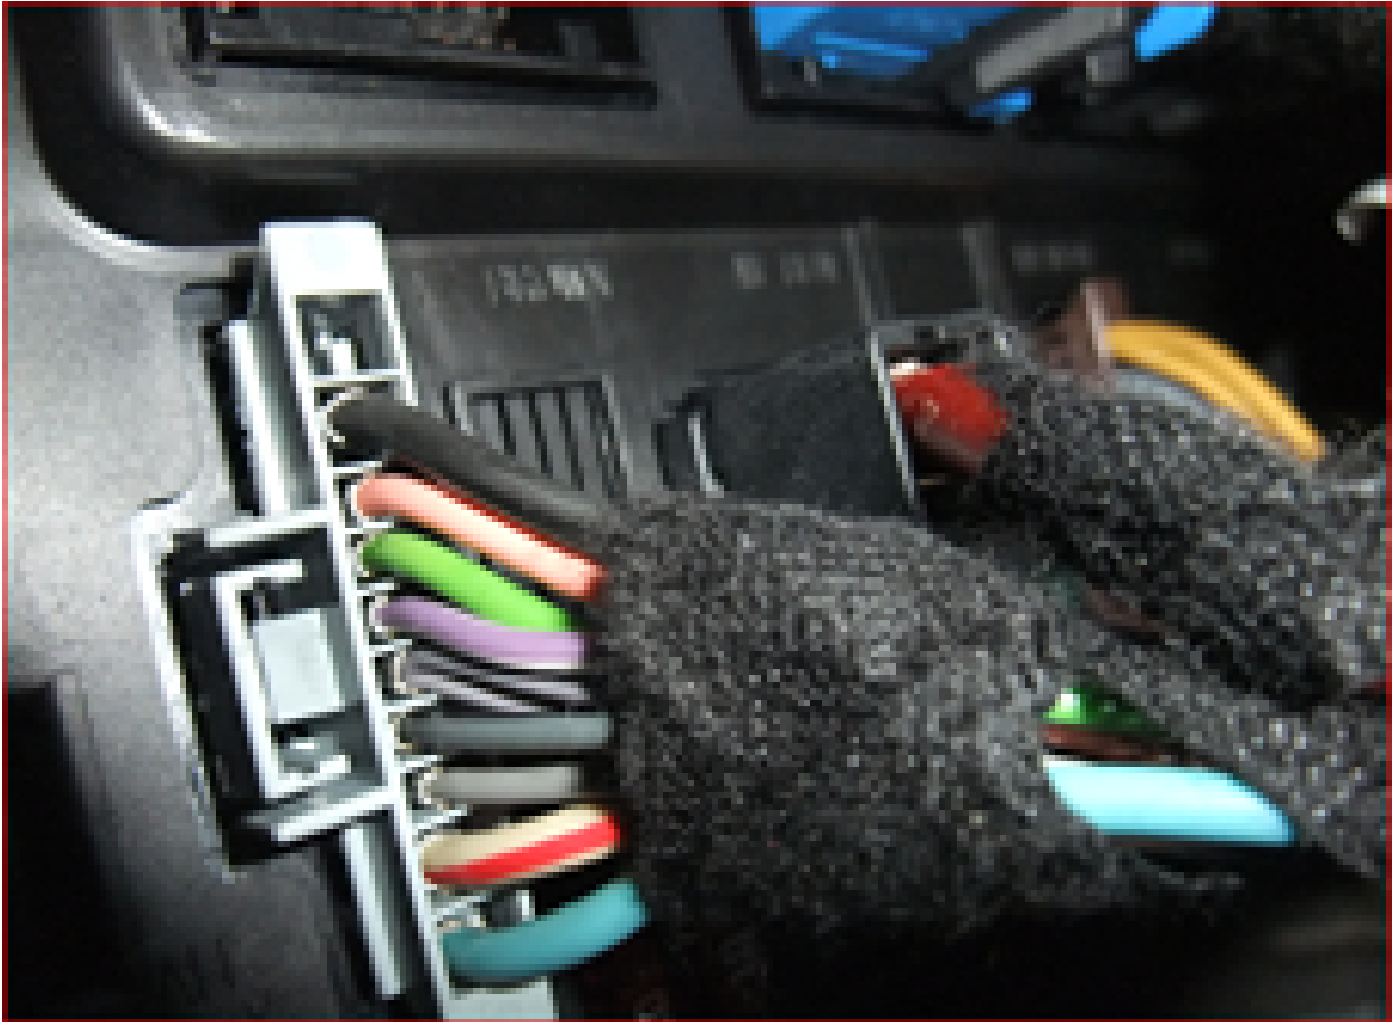
Fig.2

When troubleshooting, first check the contact of the 10-pin multiple connector (Fig.2) to the rear panel of the fuse box / relay plate 2. Here the contact of the plug pins of the low beam can be negatively influenced as a result of excessive heat output.

In order to carry out repairs, the vehicle manufacturer has on offer a repair kit for the wiring harness (Art. No.: 71745167).

Check fuses:

F12= Low beam, right 10A

F13= Low beam, left 10A

Please follow the repair instructions specified by the vehicle manufacturer for the carrying out of such work.
