# **Fiat Punto - Rumori provenienti dai freni delle ruote posteriori dopo fasi di frenatura prolungate | HELLA**

**Fiat Punto**

**Modello/Tipo: 199**

**Anni di costruzione: 2005-2010**

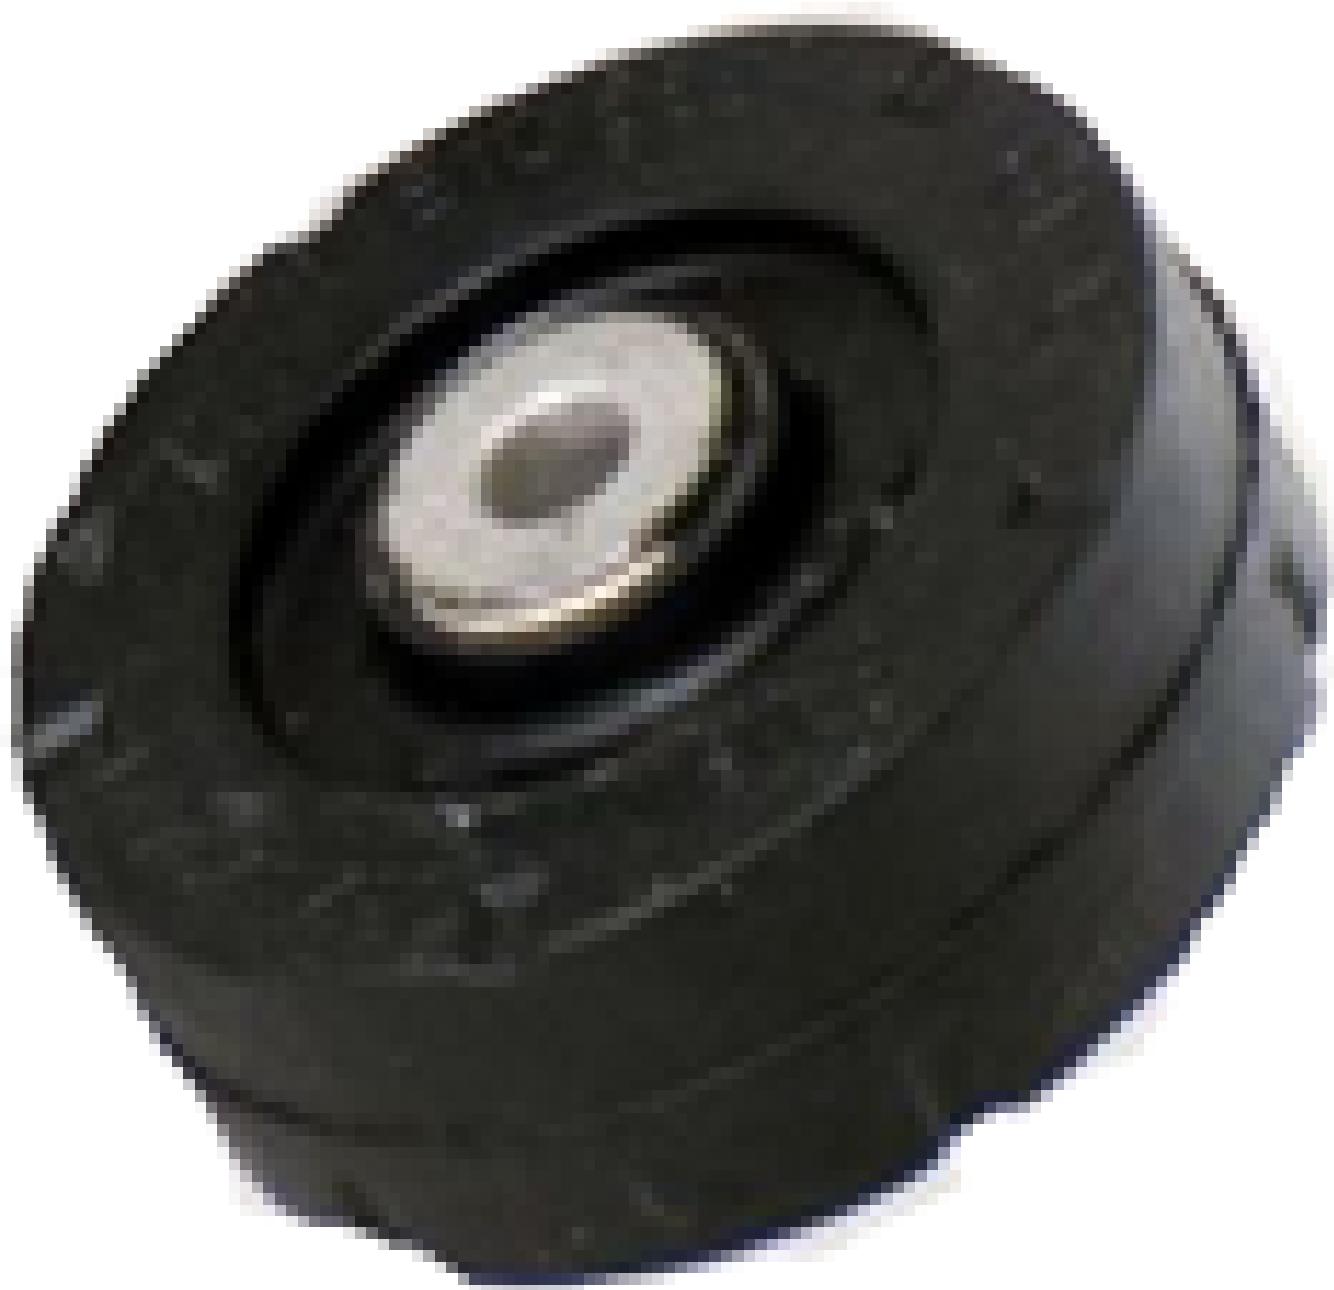
Dopo fasi di frenatura prolungate nei modelli del veicolo succitato è possibile avvertire dei rumori dovuti alla vibrazione dell'asse posteriore.

L'oscillazione della pinza dei freni provoca la vibrazione delle pastiglie.

Per risolvere questo problema il costruttore del veicolo consiglia di adottare degli ammortizzatori di vibrazioni. L'ammortizzatore viene applicato direttamente sulla pinza dei freni allo scopo di eliminare le oscillazioni indesiderate.
