Kia Rio - Accensione della spia motore | HELLA

Kia

Rio

Tutti i modelli, 2000 - 2004

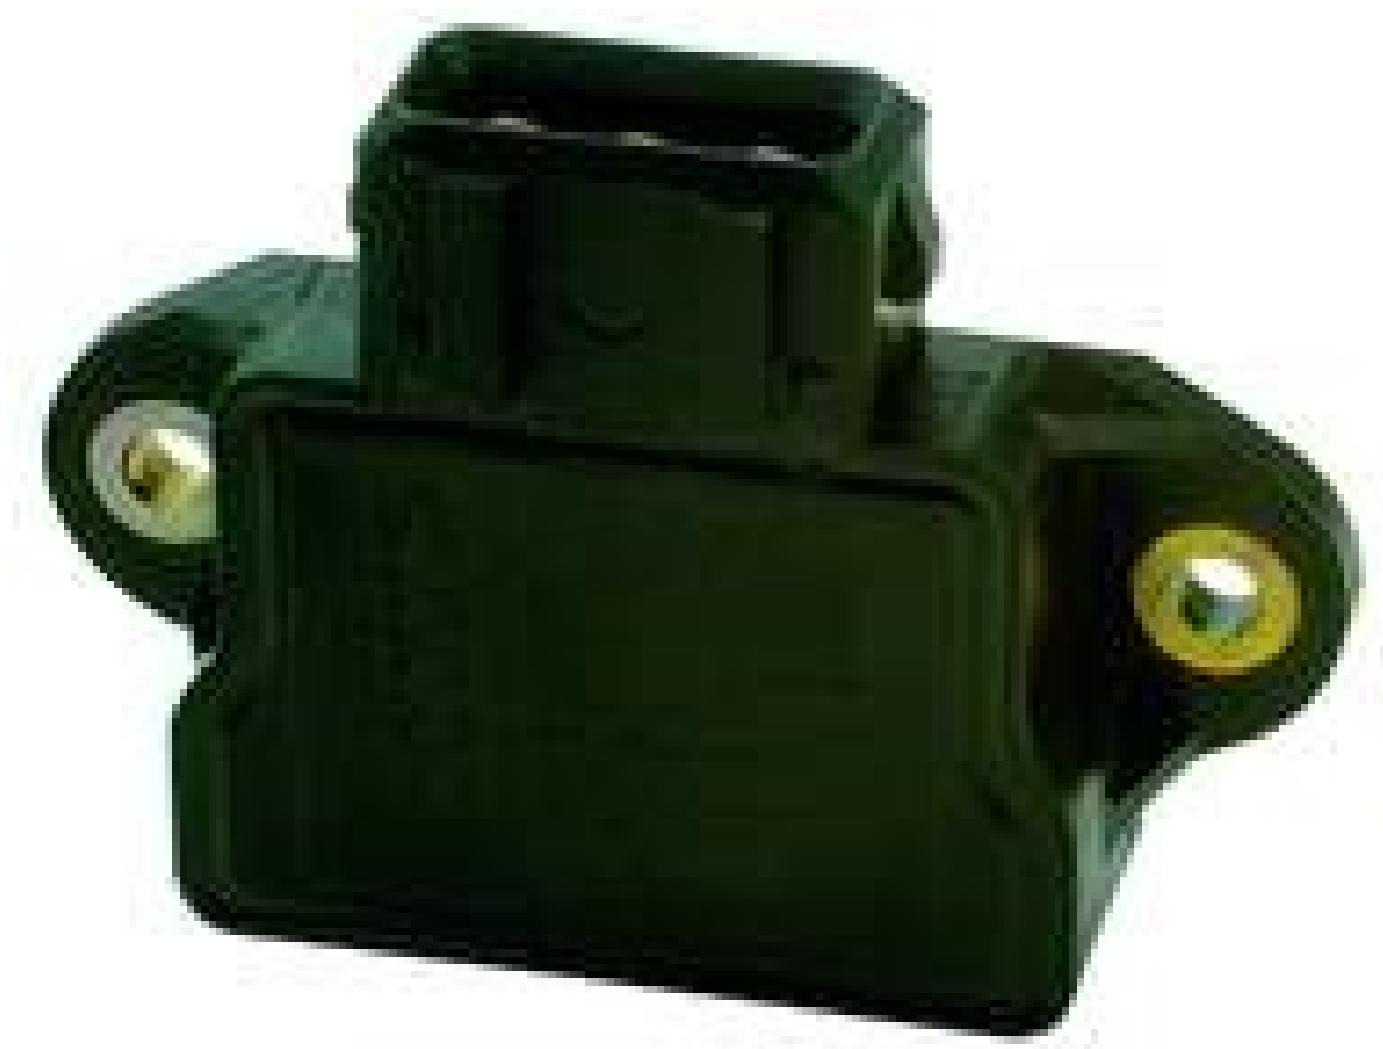
Controllare le tensioni sui morsetti del potenziometro della valvola a farfalla nel seguente modo:

- Potenziometro sul morsetto (massa) circa 0V.
- Potenziometro sull'alimentazione elettrica circa 5V
- Morsetto del potenziometro (segnale) una tensione variabile in base alla posizione della valvola a farfalla.

Se su questi veicoli viene indicato un guasto tramite la spia motore e il cliente segnala anche un regime oscillante del motore, una possibile causa è un contatto incerto sul potenziometro della valvola a farfalla.

Per rimediare a questo inconveniente, per prima cosa si devono controllare visivamente e pulire i pin del connettore sul potenziometro della valvola a farfalla e nel connettore multipolare del fascio cavi.
