# Citroen C4 Picasso - Motor start niet | HELLA

## Citroen C4 Picasso en Grand Picasso

Vanaf bouwjaar 2006

Motor start niet

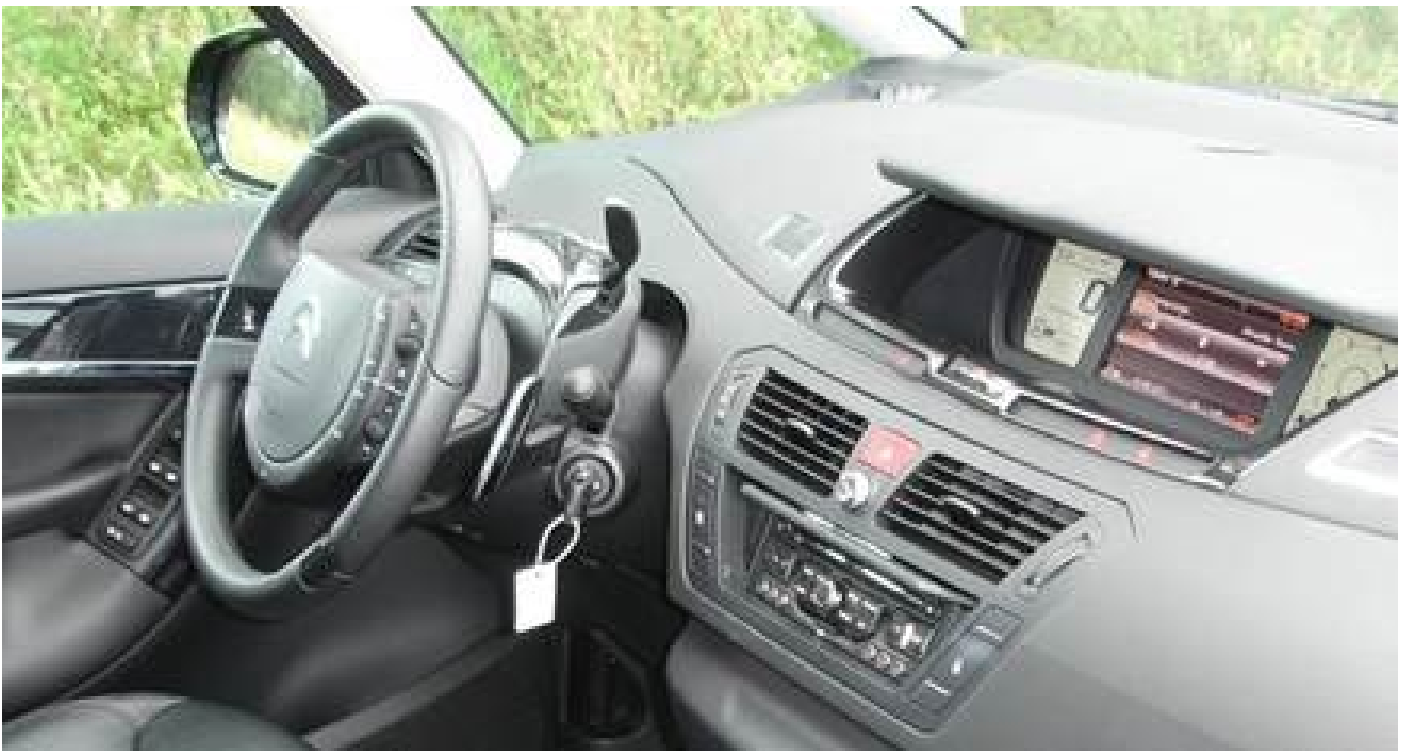
Fig. 1

Wordt de bovenstaande storing door de klant gemeld, kan een slechte stekkerverbinding hiervan de oorzaak zijn. Door het slechte contact geeft het display in de cockpit de rijstand "A1" aan, hoewel de keuzehendel in de neutrale stand staat. Hierdoor is het starten van de motor niet mogelijk. Bovendien kunnen foutcodes m.b.t. de versnellingsbak zijn opgeslagen. In dit geval moet gecontroleerd worden op een probleemloos contact tussen de rijstandschakelaar en de meervoudige stekker, zie afb. 1 en 2. Mocht de stekkerverbinding los zijn, moet deze weer goed worden vastgezet.
