# **Fiat Punto 199 — Ruídos nos travões das rodas traseiras, após fases de travagem mais longas | HELLA**

## **Model type 199**

## **Model year 2005-2010**

## **Noise from the rear-wheel brakes following longer braking phases**

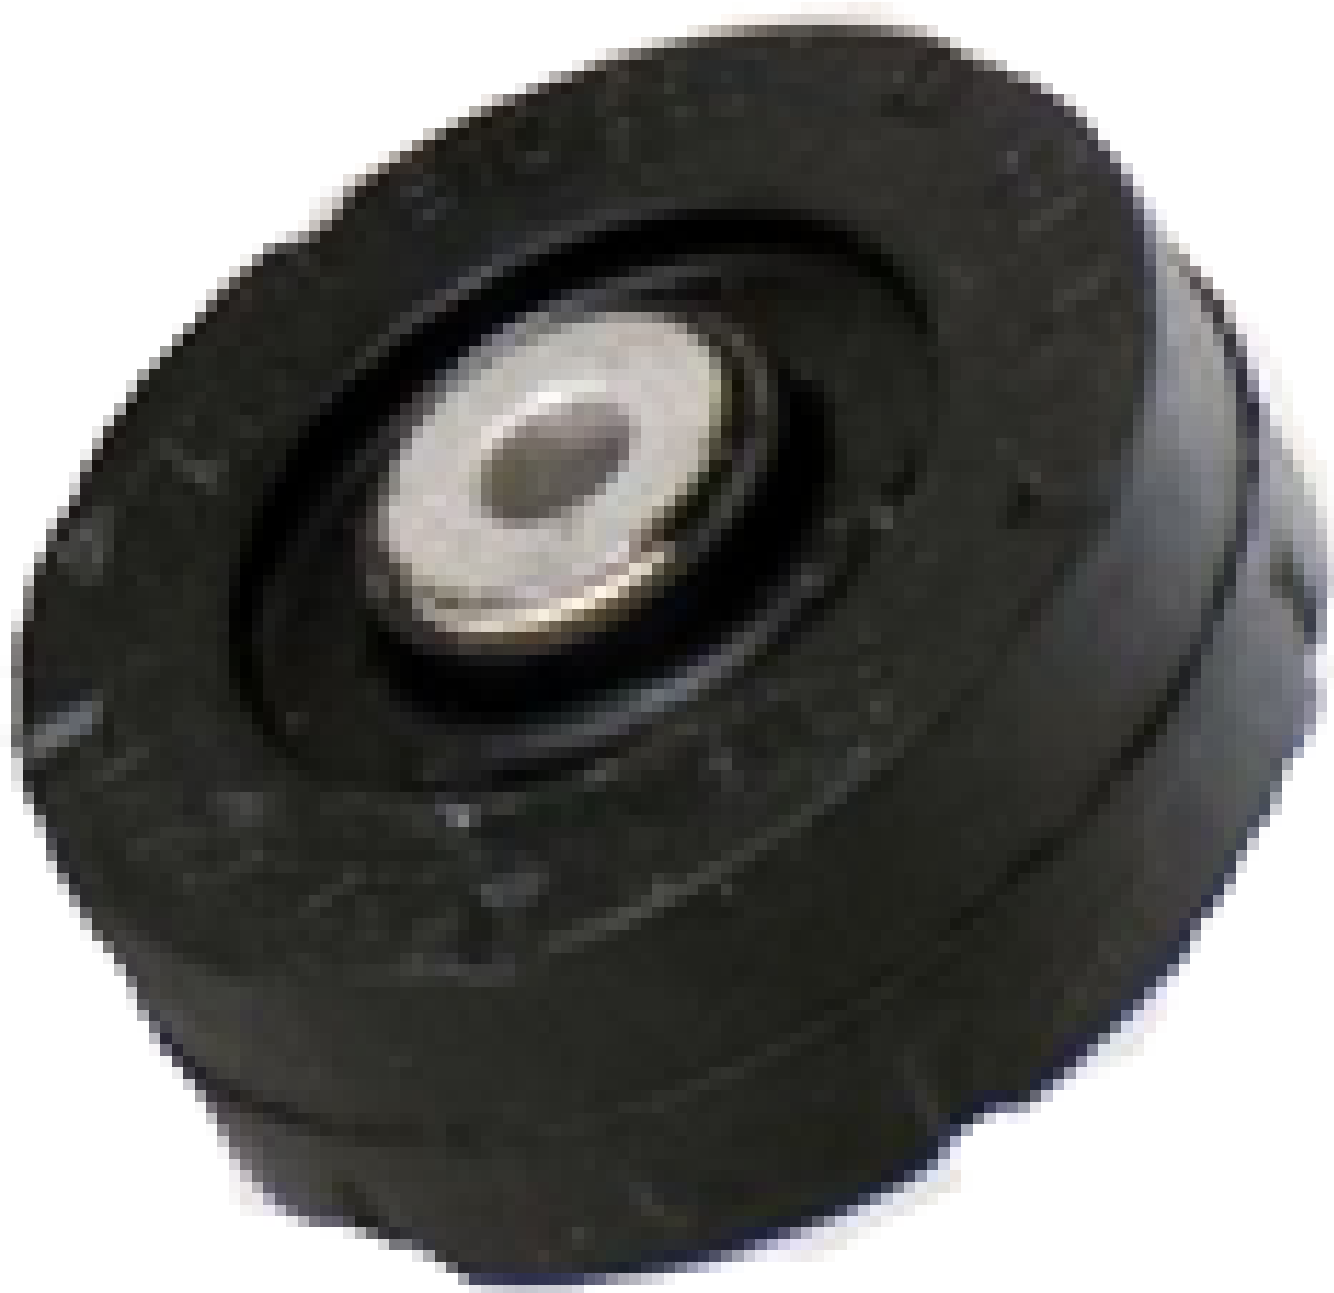
In such cases, the vehicle manufacturer can provide vibration-absorbing weights. These weights suppress unwanted vibrations, and are mounted directly on the brake caliper.

Fiat offers a suitable parts kit under the part number 77364395.
