Informação do produto — Calços de travão modificados | HELLA

8DB 355 009-121 / 8DB 355 011-731

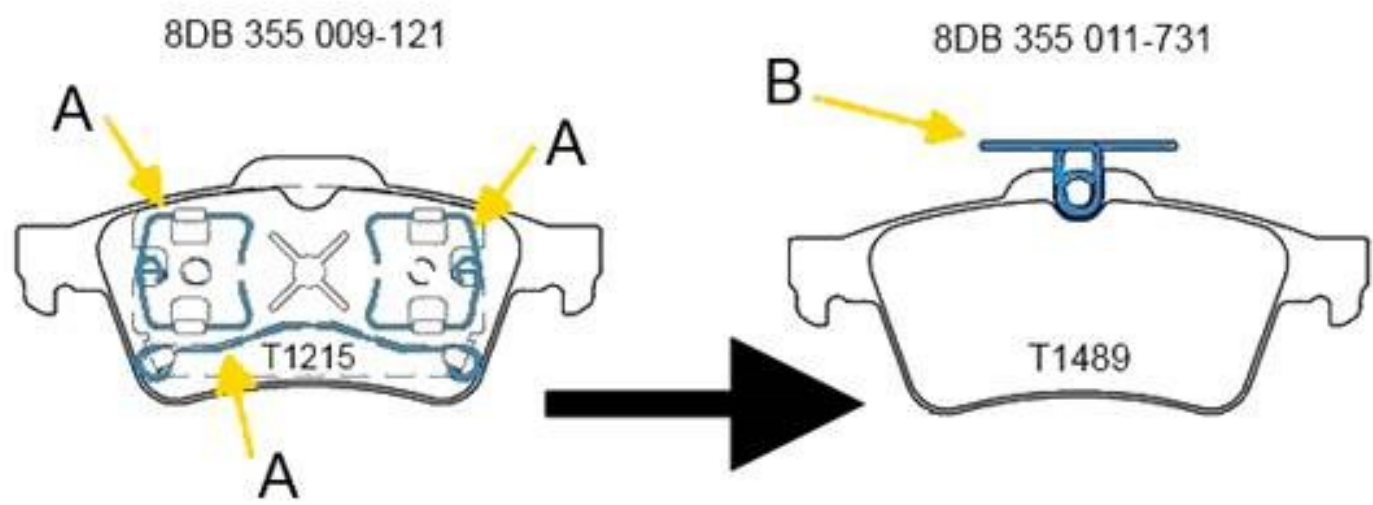
Figures

The brake pad on the piston side with version 8DB 355 009-121 / T1215, has been fixed to the piston using clasps (A) "Mouse traps" for the purpose of avoiding noise and vibration. The technician must practice great care when assembling.

Resulting from assembly faults, the clasps do not engage completely on the piston which leads to extreme tilted wear and increased noise levels.

New: 8DB 355 011-731 / T1489

The equipment of the new brake pad differs significantly from its original version but can be used without question.

Some vehicle manufacturers have reworked this system and have introduced a changed brake pad.

Brake pads with retaining spring (B) must be installed in the brake caliper on the piston side.
