Renault, Citroen, Peugeot - Poor braking with the driving brake | HELLA

Renault, Citroen, Peugeot

All models with drum brakes

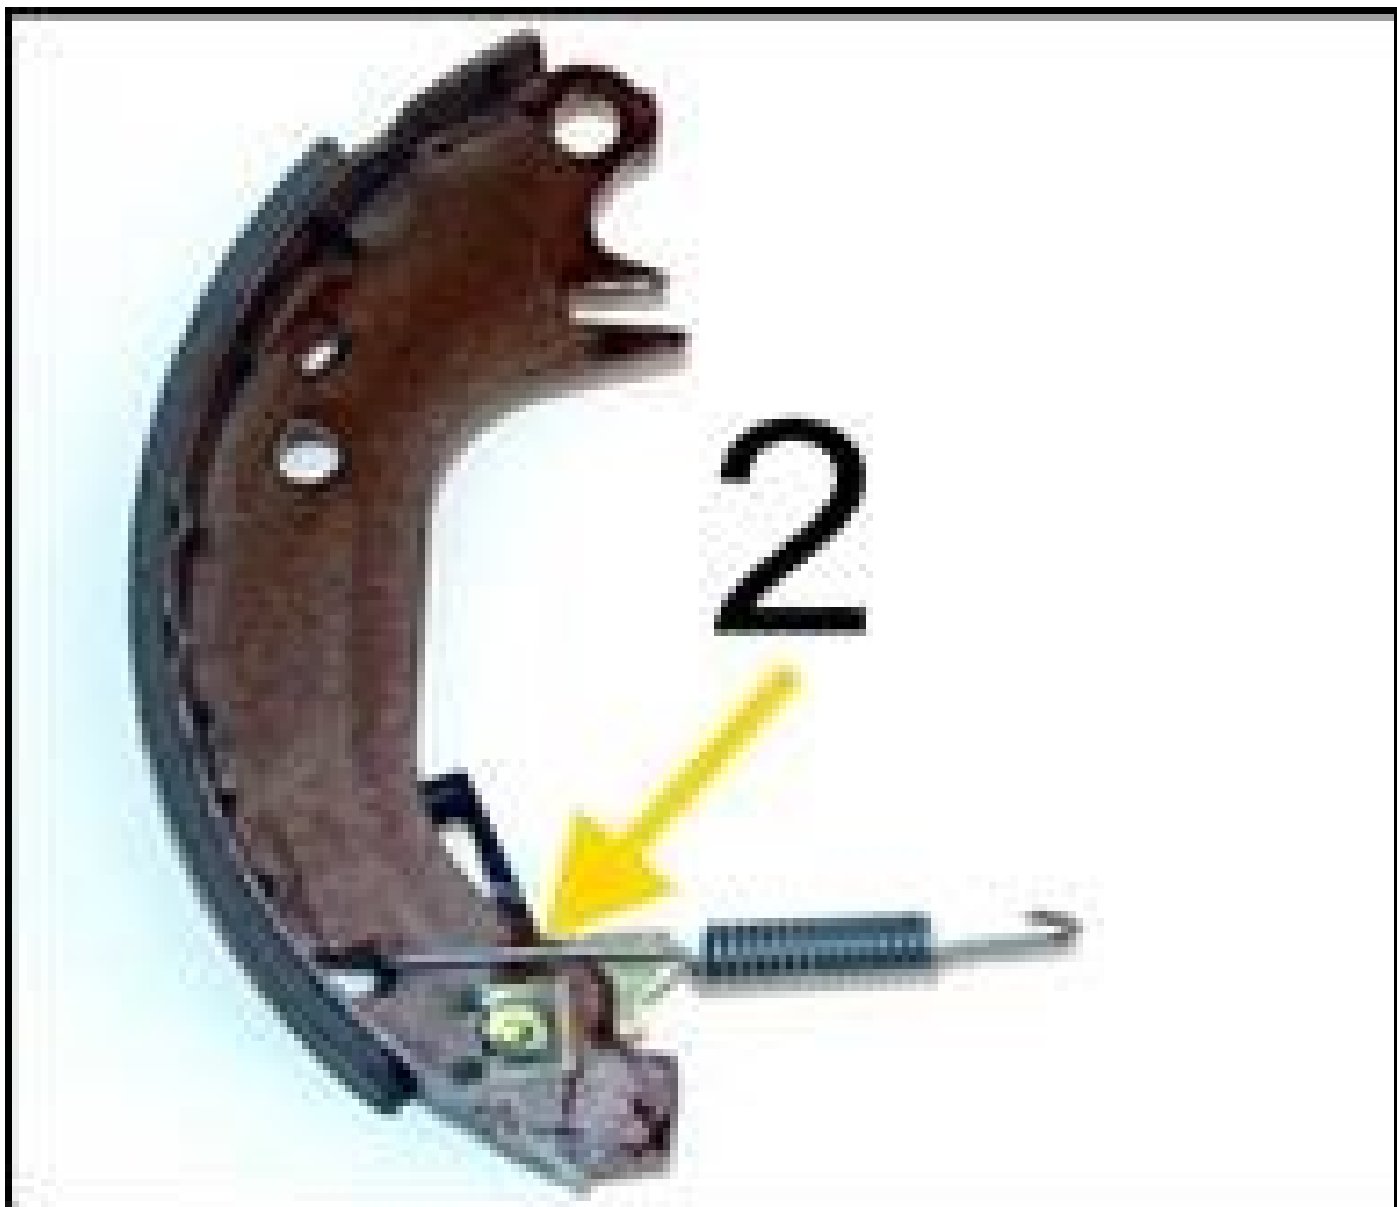
Poor braking with the driving brake and parking brake.

Malfunction of the automatic adjusting device on the rear axle drum brake system.

If one of the errors listed above occurs on these vehicle models, the cause may stem from a vertically mounted safety clip on the brake shoe.(Fig.1)

Please remember to always follow the general assembly instructions for installing and removing drum brakes and other special installation instructions from the brake pad or vehicle manufacturer in this regard.
