# **VW Touareg - Inconsistent electrical malfunctions | HELLA**

**Touareg**

**Engine code: CNRB**

**Inconsistent electrical malfunctions**

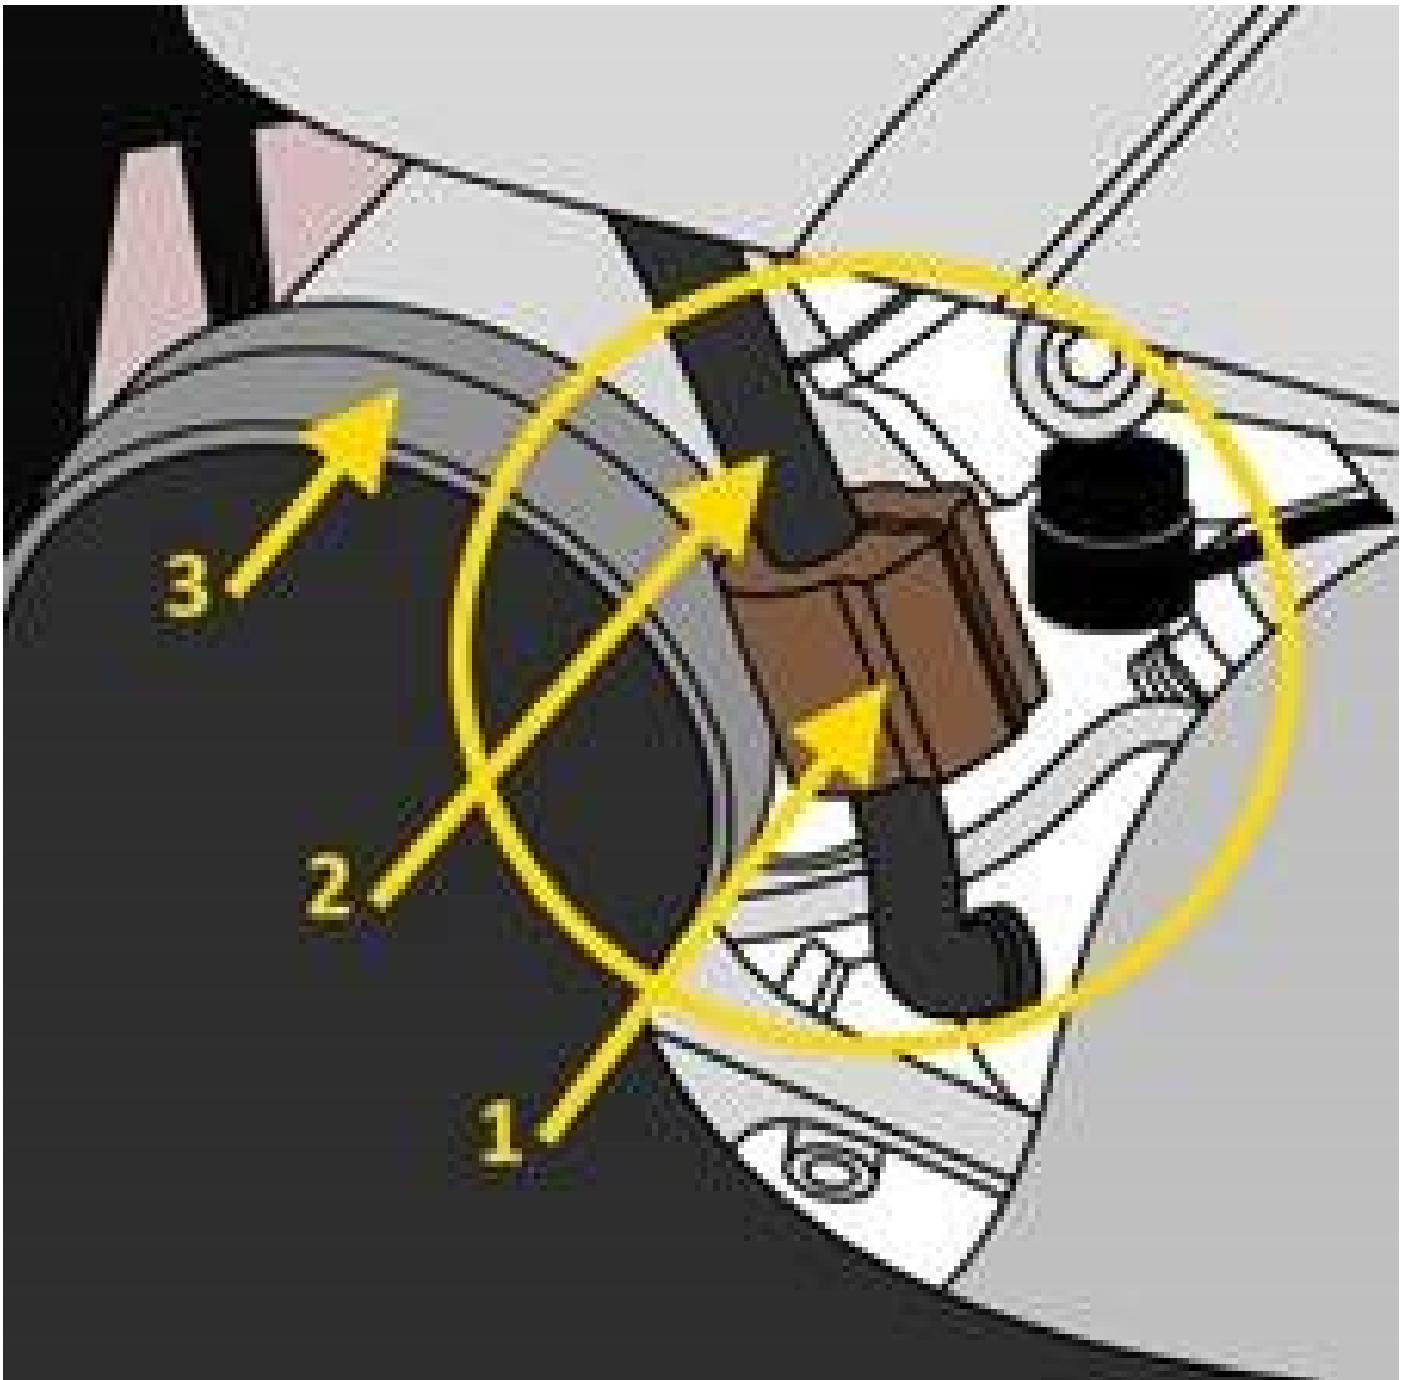
In this case there may be contact between the engine wiring harness (Picture, position 2) and the pressure pipe housing (Picture, position 3).

This can lead to damage being caused to the wiring harness (Picture, position 2), which can subsequently trigger the malfunctions in question.

Firstly, repair or replace the damaged wiring harness (Picture, position 2) according to the vehicle manufacturer's specifications.

If no further malfunctions can be detected, a spacer ring (Picture, position 1) (OE No. N 107 162 01) can be fitted as a protection against repeat damage.
