# **Citroen Xsara Picasso - Direction indicator switch does not reset automatically | HELLA**

**Xsara Picasso**

**All models from 2005 - 2011**

## **Direction indicator switch does not reset automatically.**

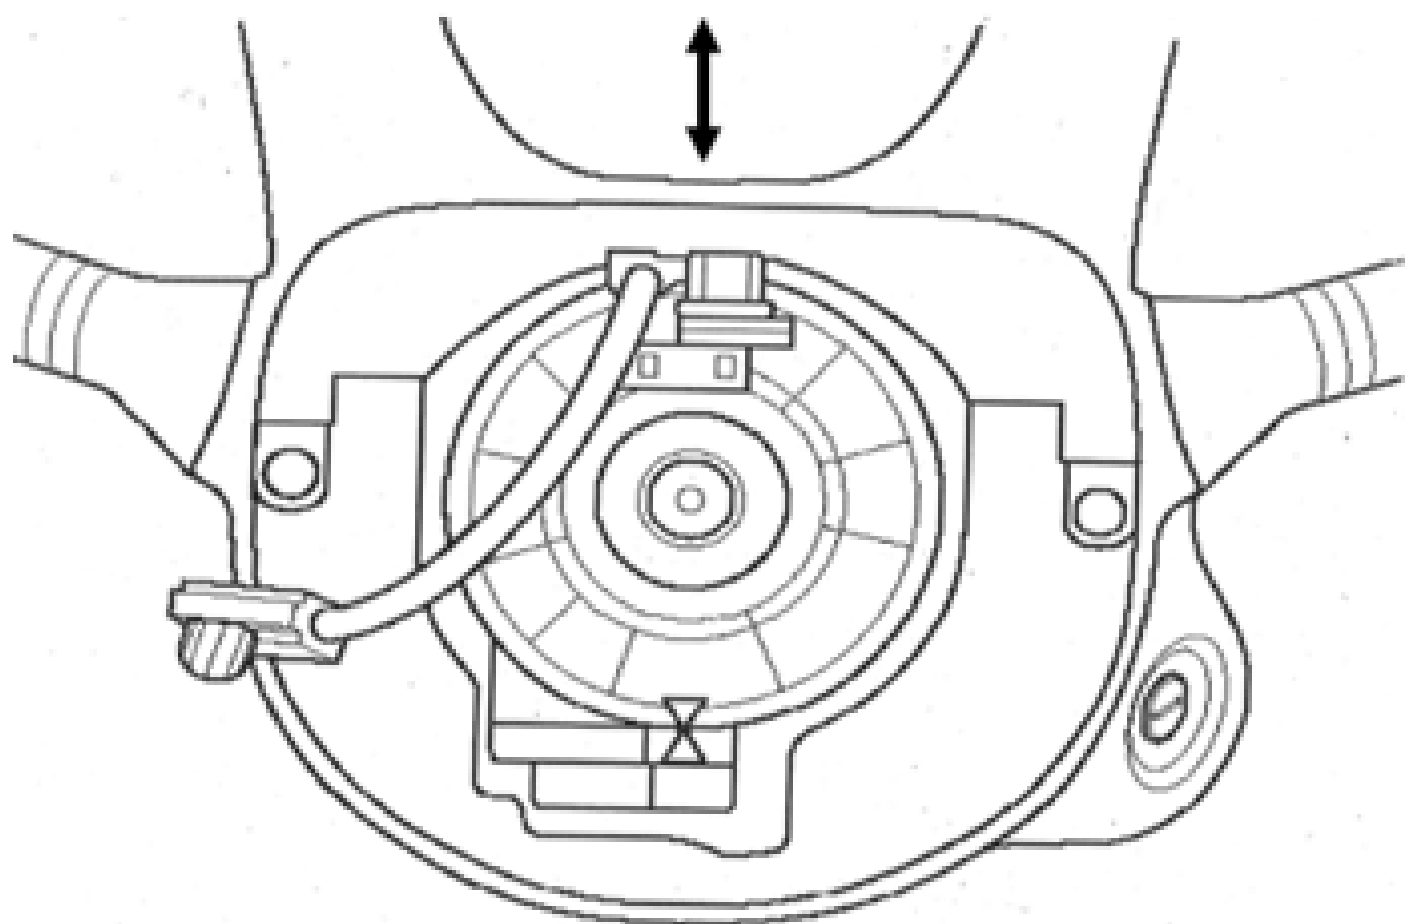
In case of complaints on these vehicles that the direction indicator switch (direction indicator stalk - automatic reset mechanism) does not reset automatically, an incorrectly installed / positioned coiled spring in the steering wheel may be the cause. To rectify this problem it is to be checked that the electrical connection on the coiled spring in the steering wheel is at the

"12 o'clock position" (see figure). If not, place coiled spring in the correct position.

Note: the driver's airbag is only to be fitted by

appropriately qualified personnel.
