# BMW 2 Series Active Tourer - changing the cabin air filter

| Vehicle model | 2 Series Active Tourer (F45) |

## Pollen filter replacement for the BMW 2 Series Active Tourer

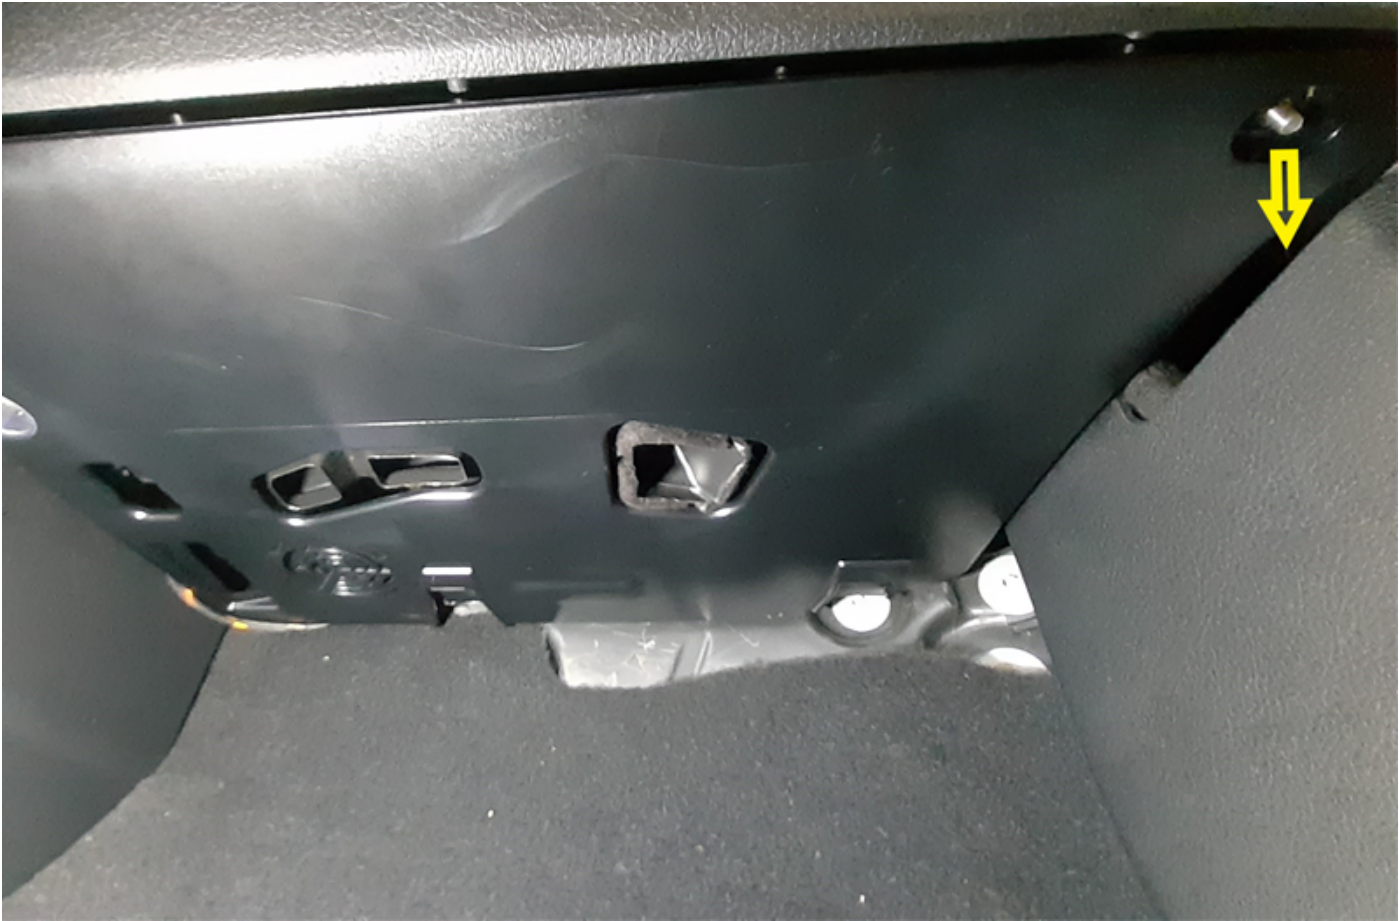
- Figure 1: Remove the trim in the footwell on the passenger side by first of all removing the screws (2x).
  - Figure 2: Remove the left cover in the footwell on the passenger side, again by first removing the two screws
  - Figure 3: Remove the air outlet by removing the screw (1x) and pulling the air outlet to the right
  - Figure 4: Pull off the hose from the heating/air-conditioning housing to the right
  - Figure 5: Unlock and remove the cover from the heating/air-conditioning housing
  - Figure 6: Pull out the cabin filter
- In order to install the new filter, proceed as above but in reverse order.
