# Fiat Panda - Low beam not functioning | HELLA

Fiat Panda

Model year: 2003 up to 2013

## Low beam not functioning

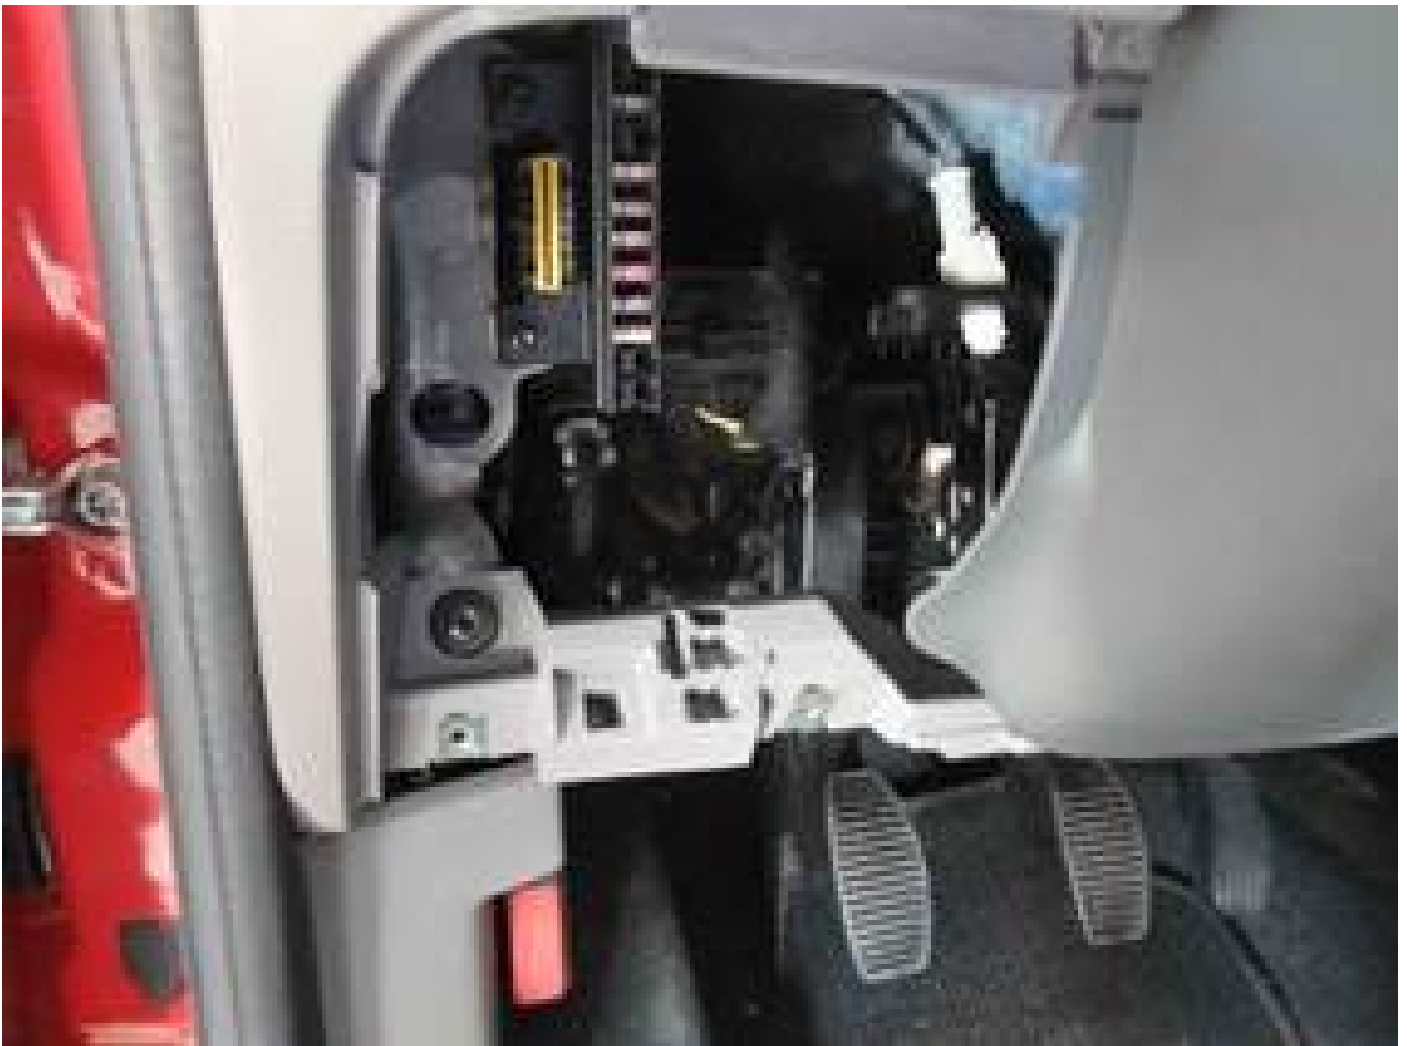
Fig.1

If the above-mentioned problem is detected, it may be caused by a poor contact between the connection socket and the fuse box (Fig.1).
